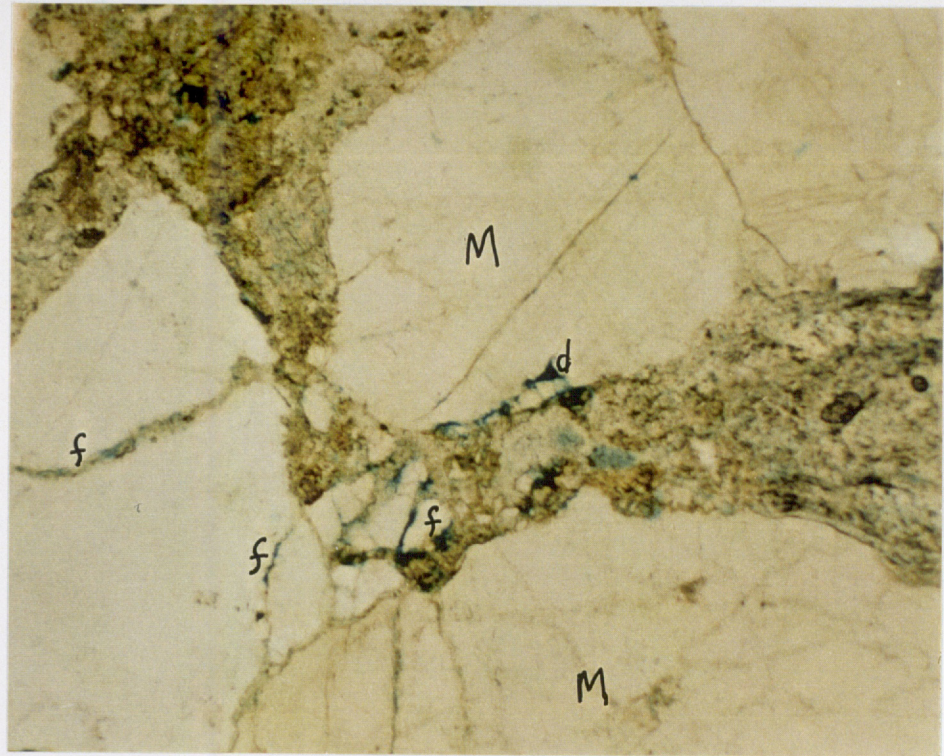
Figure 1 - Anemone #1A - junk sub sample, 4575m. This section micrograph in plane polarized light showing secondary porosity associated with fracture (f) and dissolution (d). Microporosity gives the brown clay areas a bluish tinge. The large microcline grains (M) display discolouration due to alteration.
