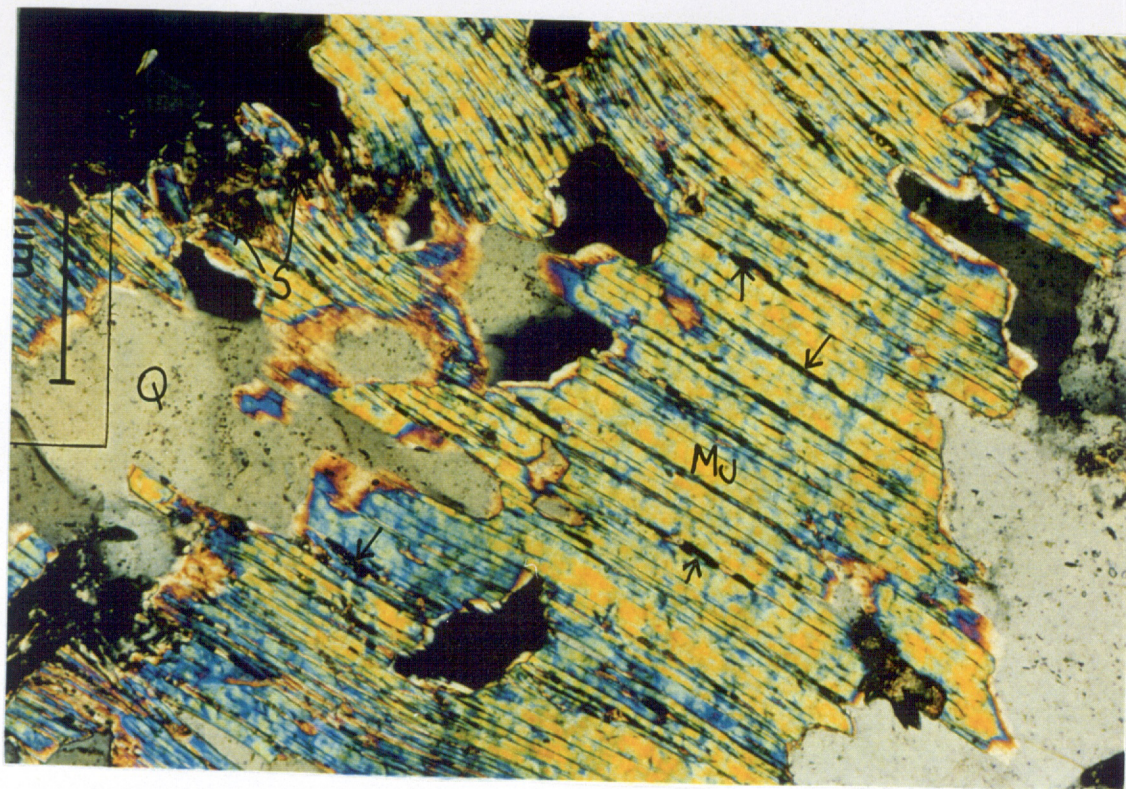
Figure 5. Anemone #1A, junk sub sample, 4575m. Detail of muscovite (Mu) corroding vacuolated quartz (Q) in an igneous fragment, under crossed polars. Carbonate spar (S) and fine opaque minerals arrowed (pyrite?) have precipitated along micaceous cleavage.
