PE906881

2-98 Anemone 1A

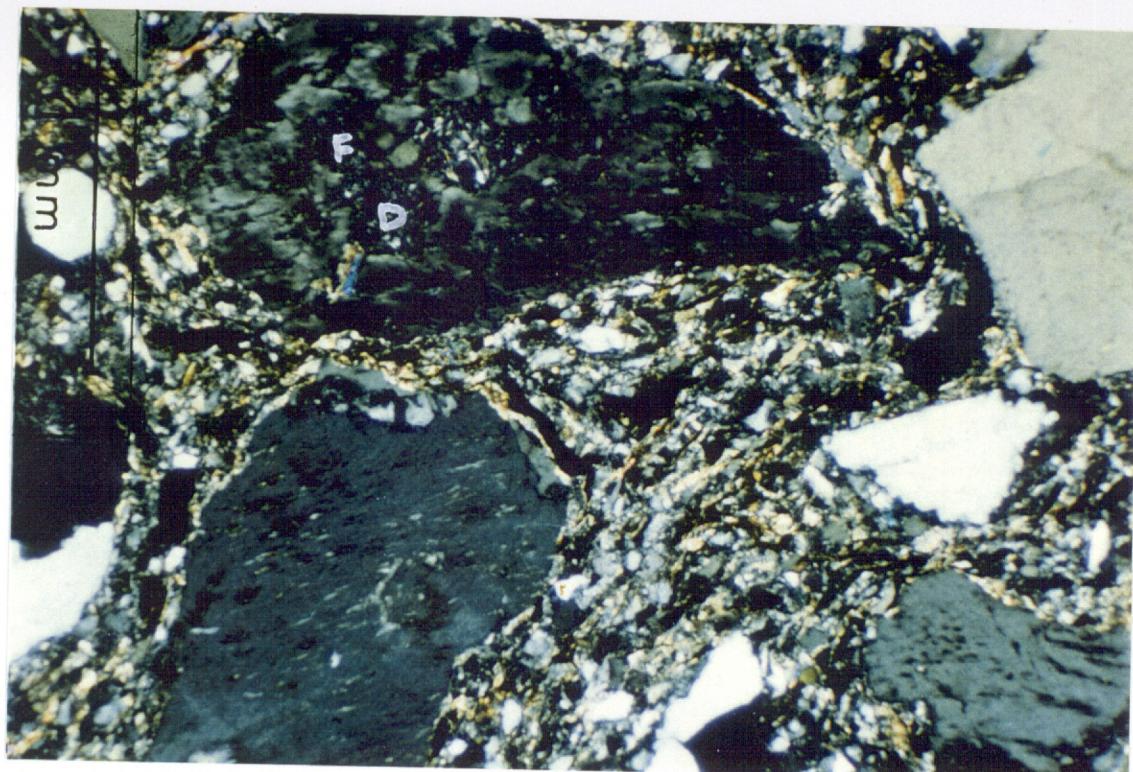
Figure 13 - Anemone #1A, junk sub sample, 4676am. View under crossed polars of feldspar (F) displaying considerable alteration to dickite (D) and minor development of sericite along cleavage.
