2-98 Anemone 1A

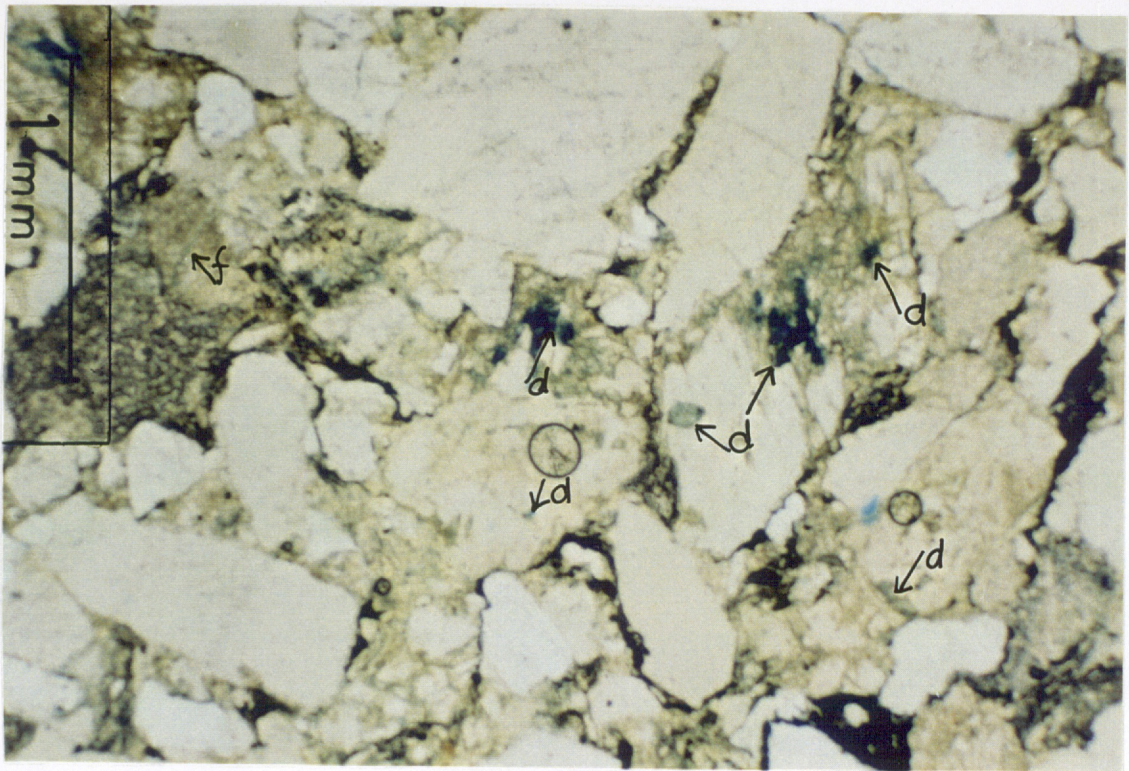
Figure 16. Anemone #1A, junk sub sample, 4676b m. Thin section micrograph in plane polarized light demonstrating areas of secondary dissolution porosity (d) and fracture porosity (f). Microporosity may well be present. The stylolitic nature of organic matter (and opaques?) is evident. At the left of the photo is a concentration of spar crystals (S).
