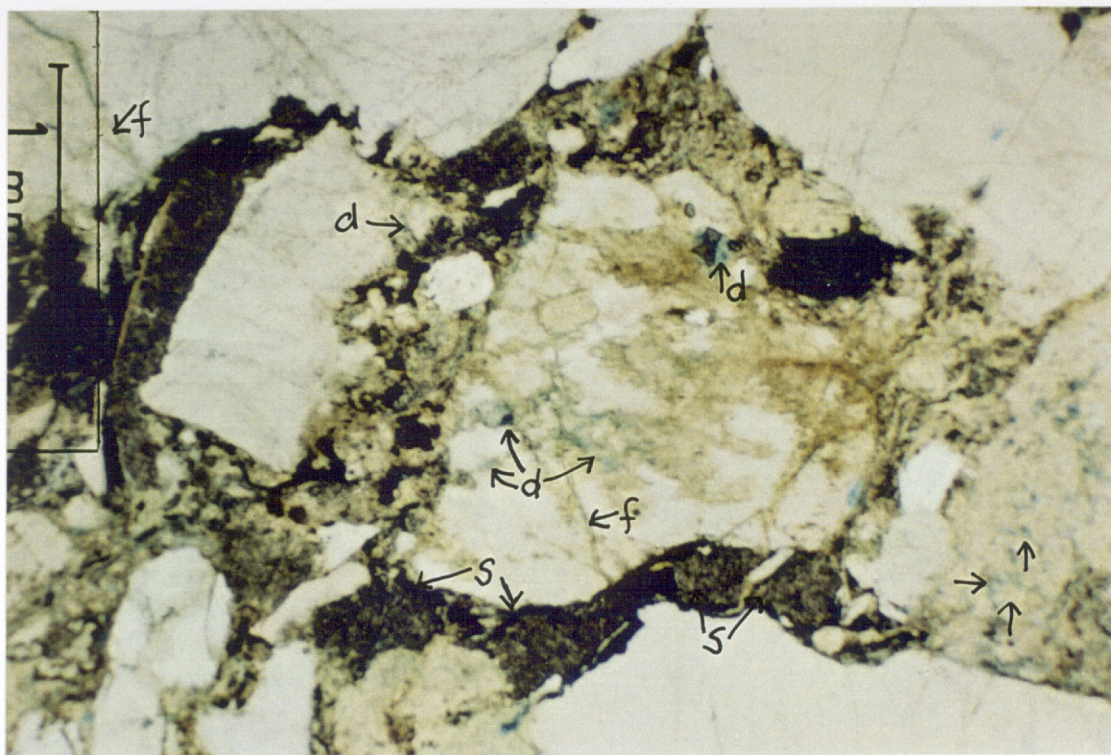
Figure 21, Anemone #1A, junk sub sample, 4676c m. Thin section micrograph demonstrating secondary dissolution porosity (d), especially in the highly altered feldspar, and fracture porosity (f). Microporosity is arrowed in the grain on the right. Organics and aggregates of small anhedral-euhedral spar scalenohedra (S) occur in the matrix.
