2-98 Anemone 1A

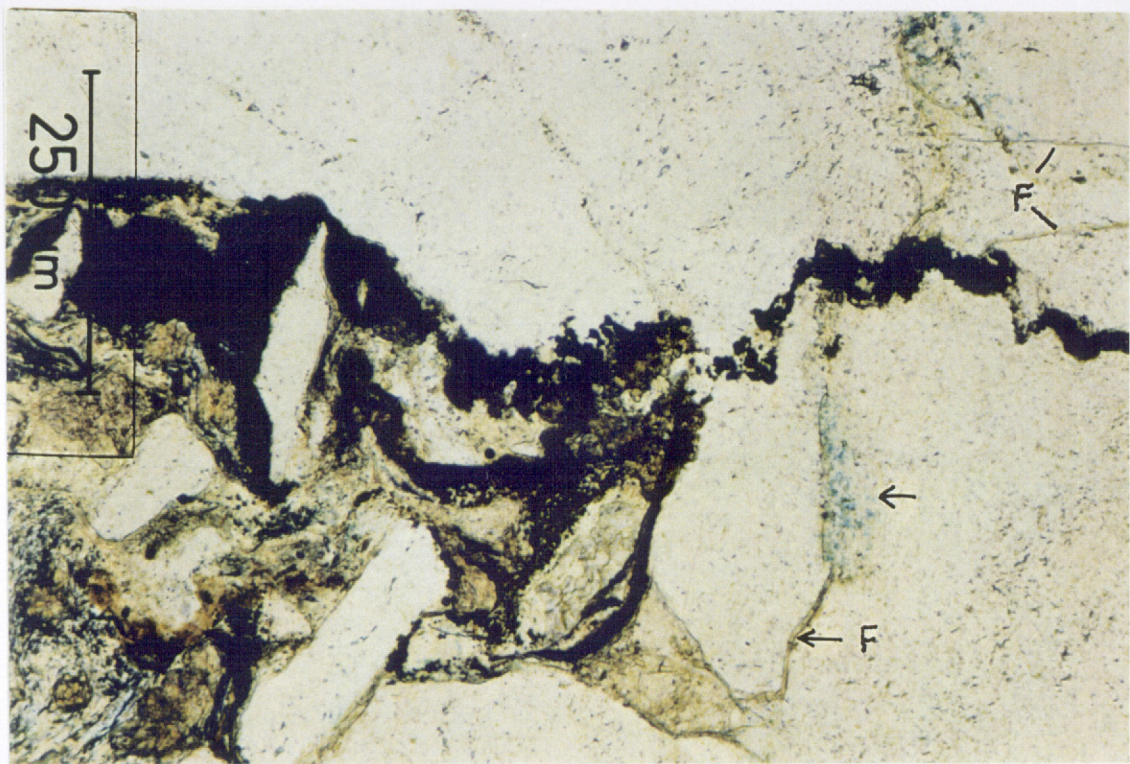
Figure 24 - Anemone #1A, junk sub sample, 4676c m. Detail from Figure 23 of finely divided pyrite and organics along a sutured contact and grain boundaries. Fracture porosity is indicated (f).
