PE905943

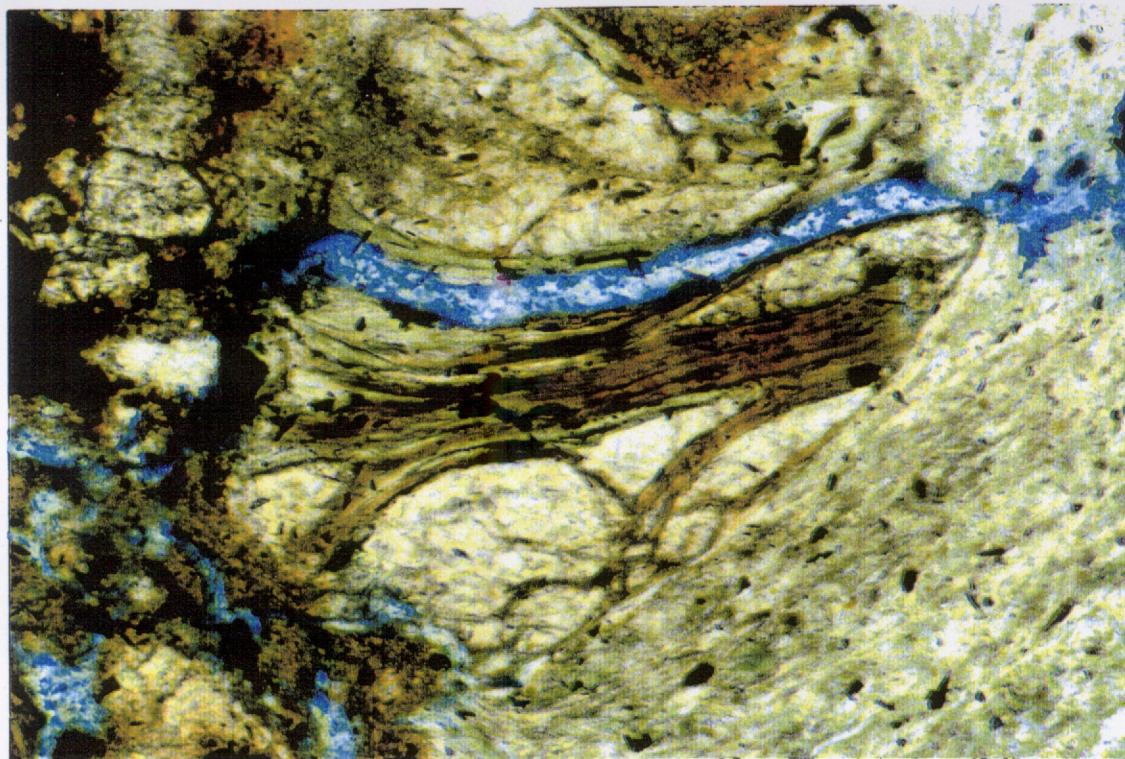
Figure 3. The displacive influence of carbonate cement is demonstrated by this splayed biotite. Chlorite (pale green) has selectively replaced some flakes of the biotite. Opaques concentrating along these flakes are probably reaction products of this alteration. Blue dye highlights fracturing caused by sidewall collection. Devilfish #1, sidewall core 2, depth 2020m. Plane light. Field of view 0.45mm.
