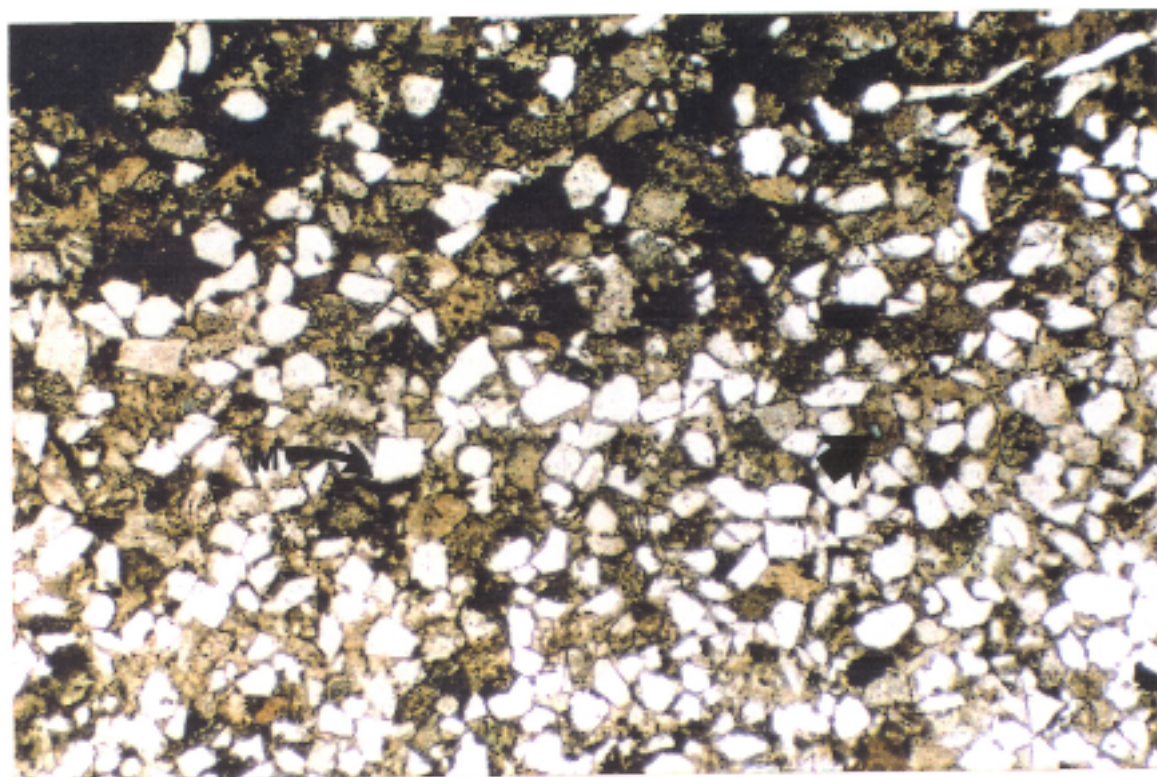
Figure 4a. Thin section photomicrograph of carbonate cemented sublitharenite. Clear (bottom) and dirty (top) carbonate are present. Opaque patches are iron rich carbonate which also coats framework grains (M). Rare porosity (arrow) is evident. Warracbarunah #5, Sample 8, core 11a, depth 1342.99-1347.84m. Plane light. Field of view 2.72mm

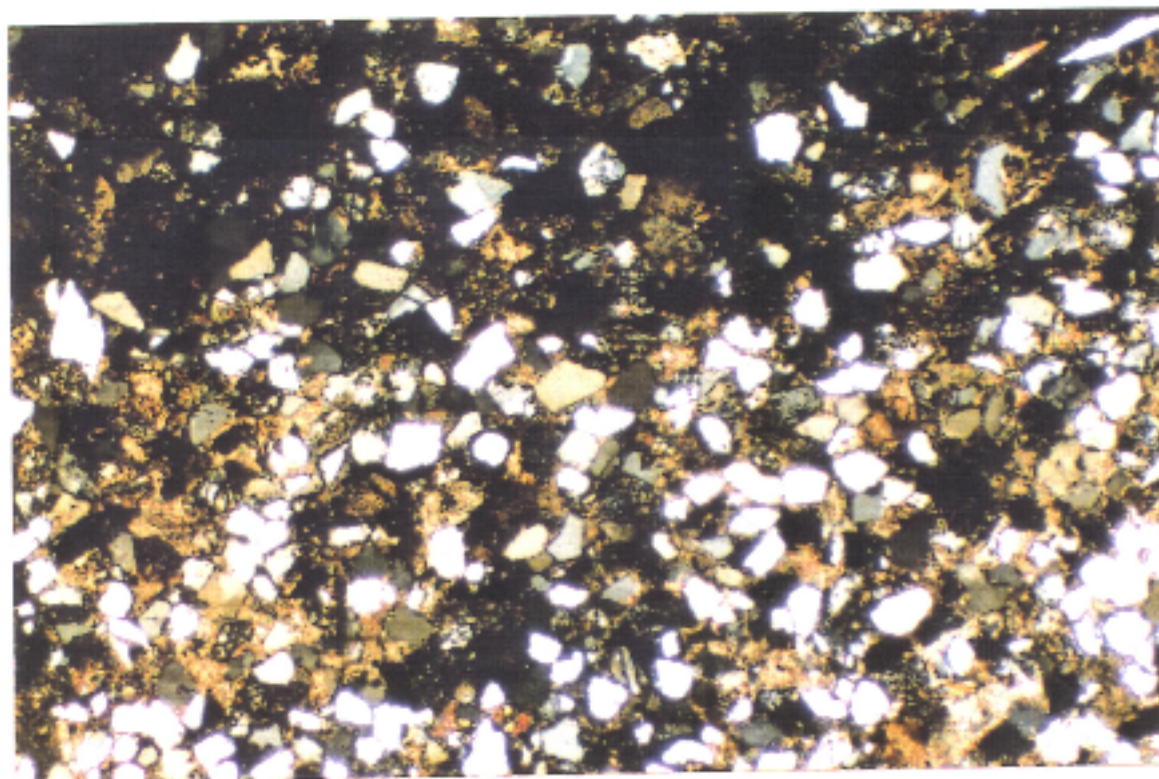
Figure 4b. Same field of view as Figure 4a in crossed nicols.
