2-98 Anemone 1A

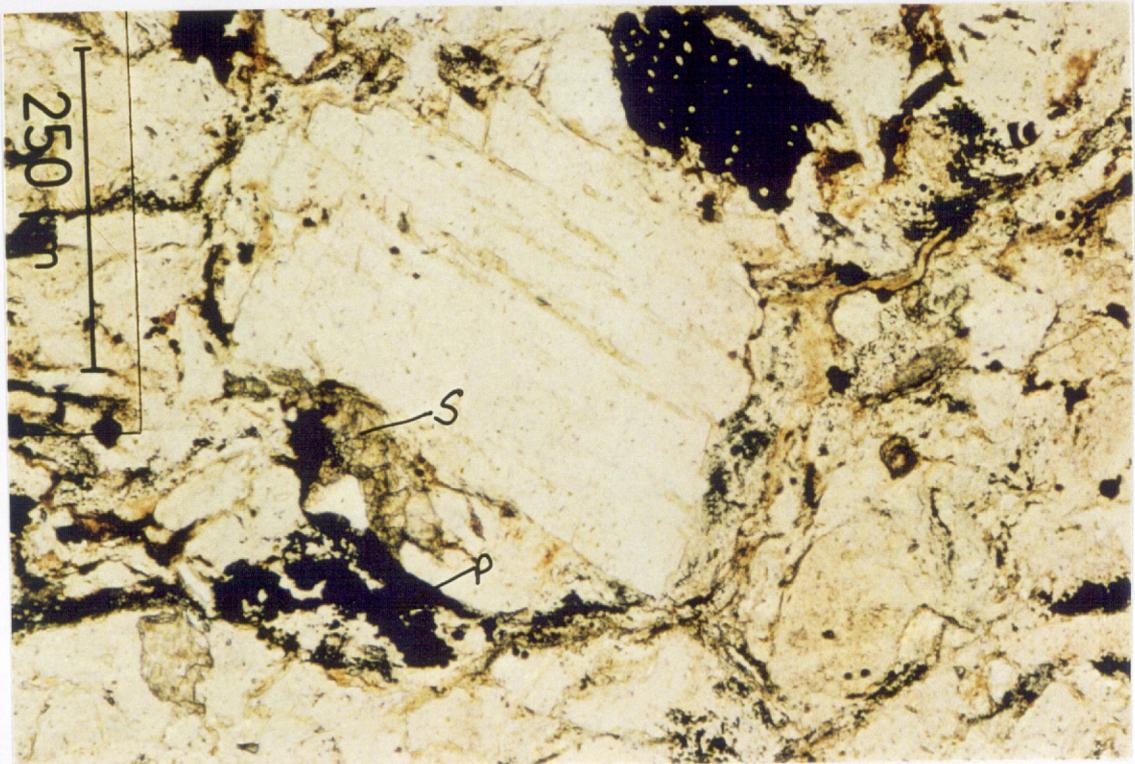
Figure 11 - Anemone #1A, junk sub sample, 4676a m. The central feldspar cleavage fragment shows alteration along cleavage in plane polarized light. Carbonate spar (S) is mildly corroding the feldspar. A structured organic fragment (?wood) occurs at the top right of the field of view and an aggregate of pyrite crystals (P) is visible.
