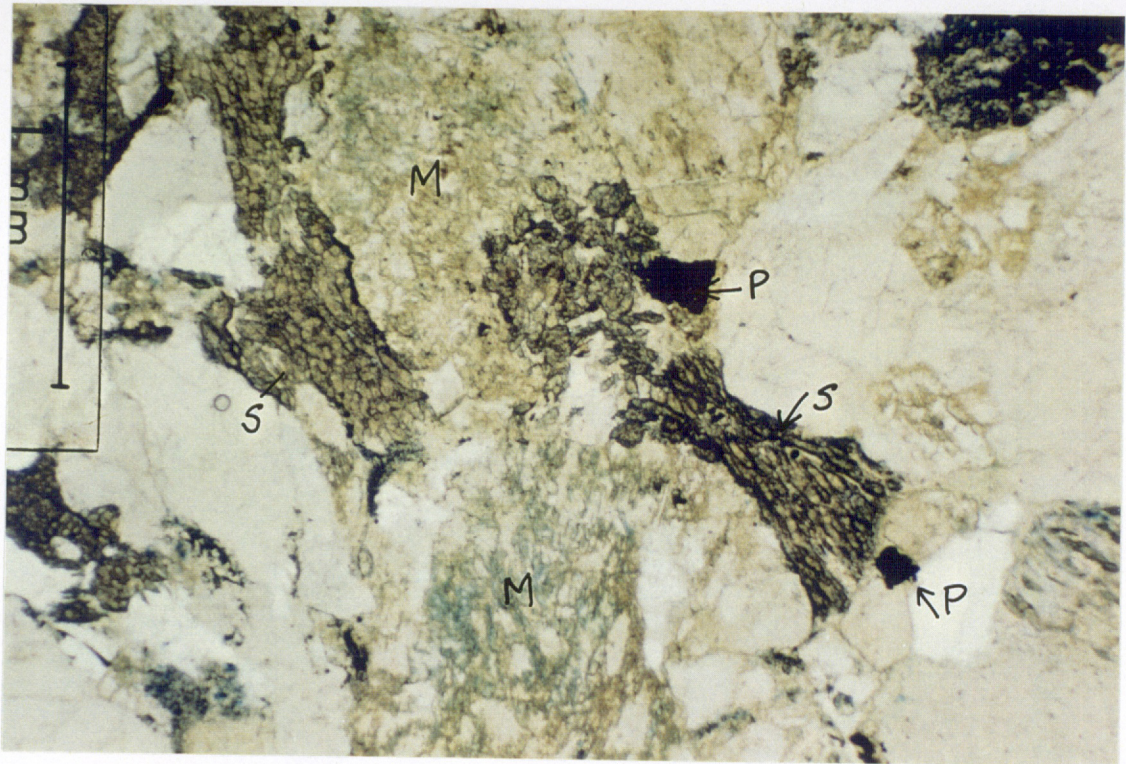
Figure 59 - Anemone #1A, junk sub sample, 4676f m. General view in plane polarized light showing secondary dissolution porosity associated with highly altered microcline (M). Aggregates of spar scalenohedra (S) and pyrite (P) are evident.
