2-98 Anemone 1A

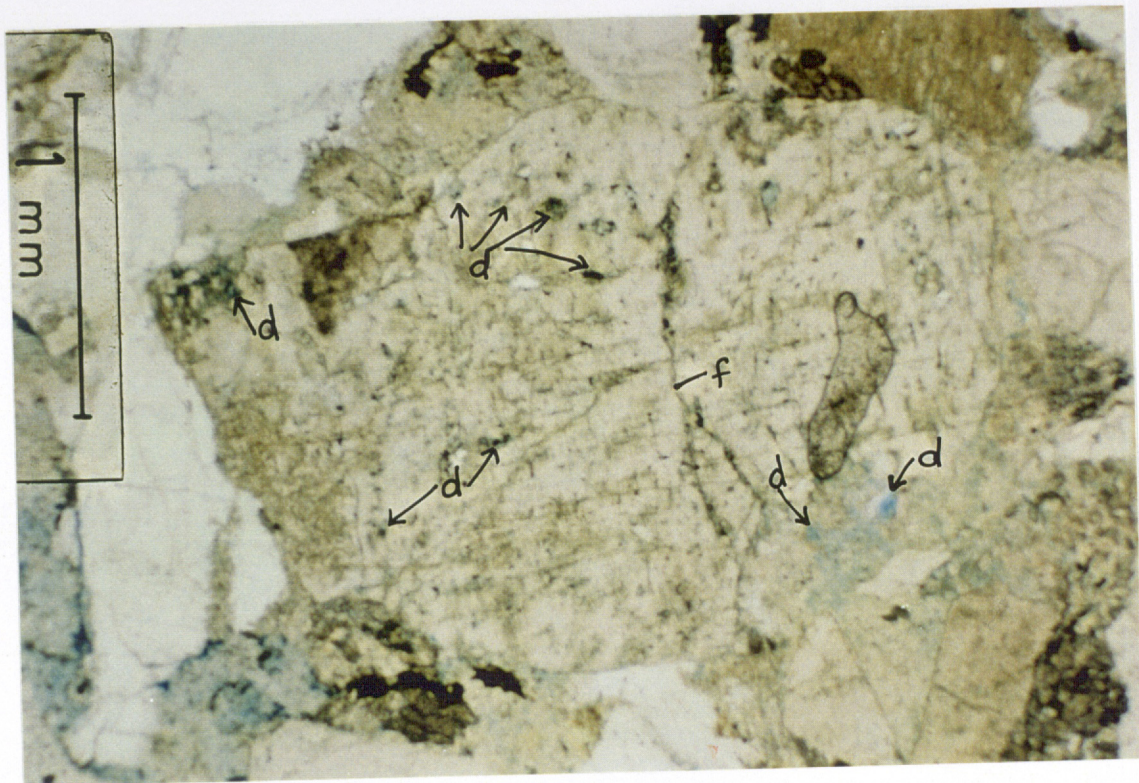
Figure 61 - Anemone #1A, junk sub sample, 4676f m. Feldspar grain displaying extreme alteration along cleavage and some secondary dissolution (d) and fracture (f) porosity development. Zones of bluish haze probably represent microporosity.
