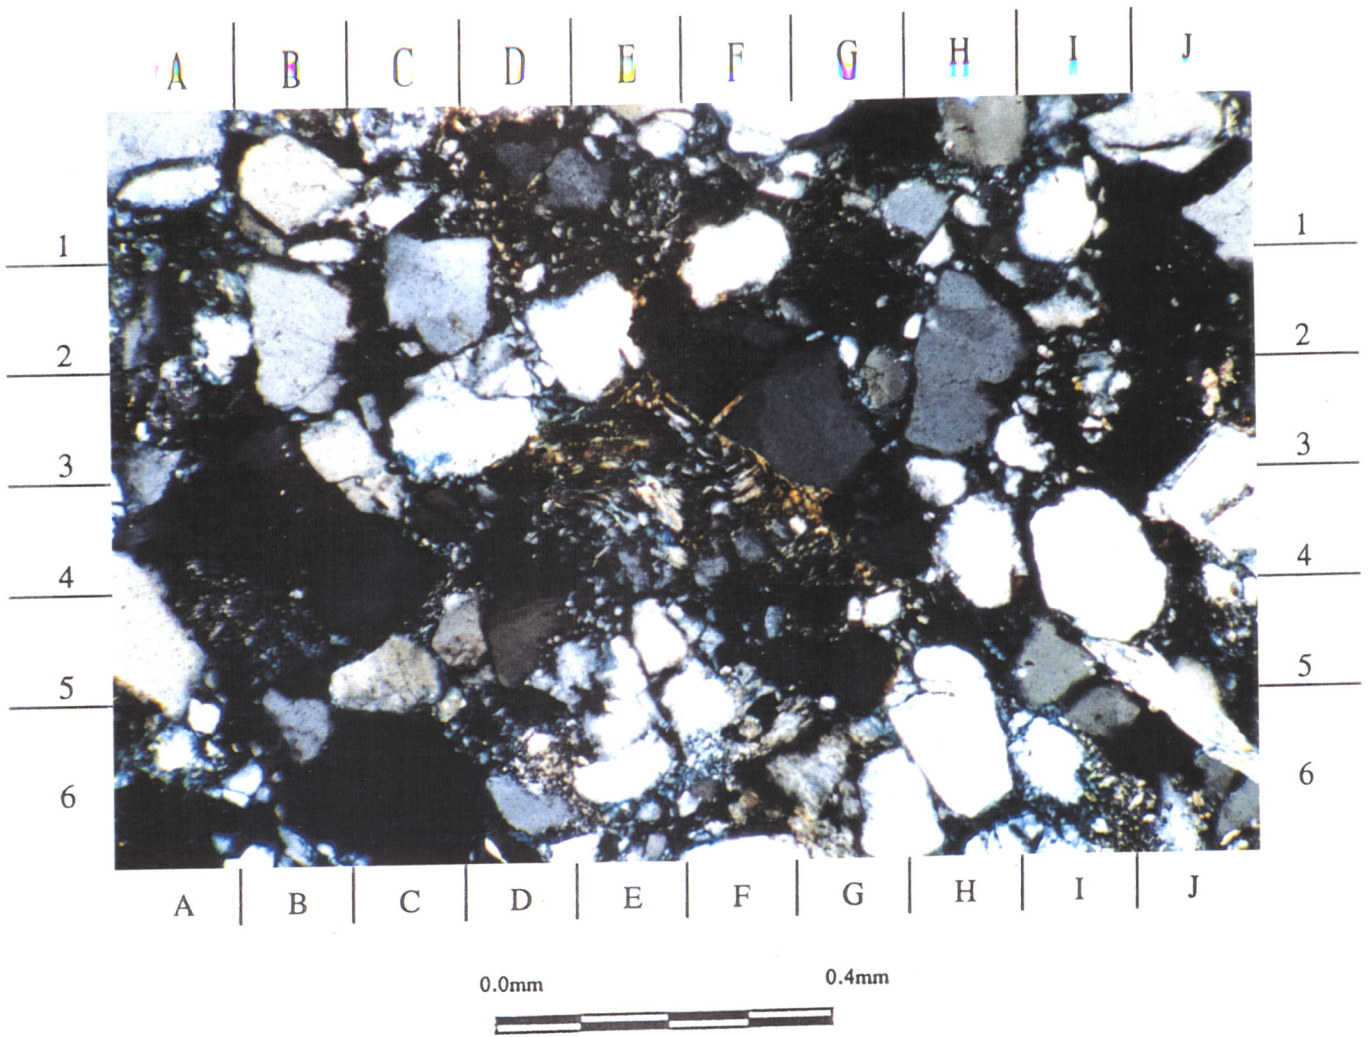
Figure 15. 1808.0m x75.6 XPL  
 Massive micaceous sandstone. The sample can be seen to be predominantly disaggregated. A partially kaolinised mica is evident at F3. An exfoliated biotite is also visible at E3.
