VELOCITY SURVEY
OF
FLAXMAN'S NO. 1
VICTORIA, AUSTRALIA

FOR
FROME BROKEN HILL CO, PTY. LTD.

BY
ROBERT H. FLAY SERVICE COMPANY, INC.
HOUSTON, TEXAS

ATTACHMENT TO WCR
FLAXMAN'S-1
(W466)

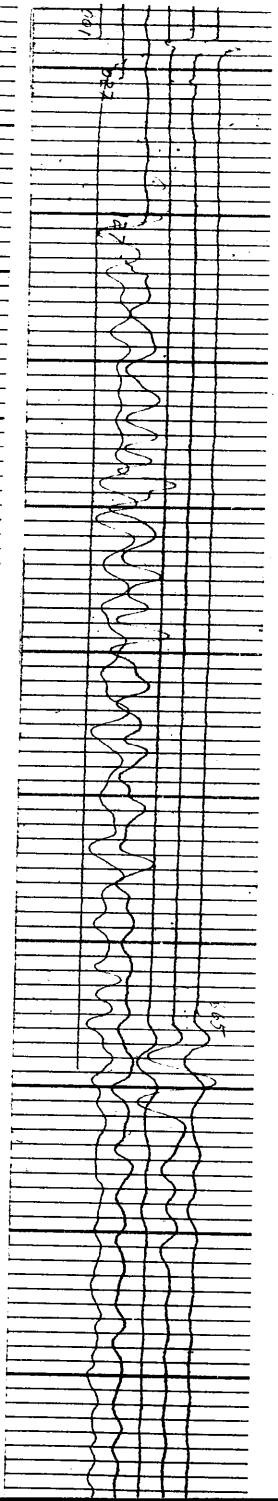
Velocity Survey
FLAXMAN'S HILL NC. 1
Shot 6 2 East 50 lbs. 62-74'
Well Geophone: 5570 ft.
June 20, 1961

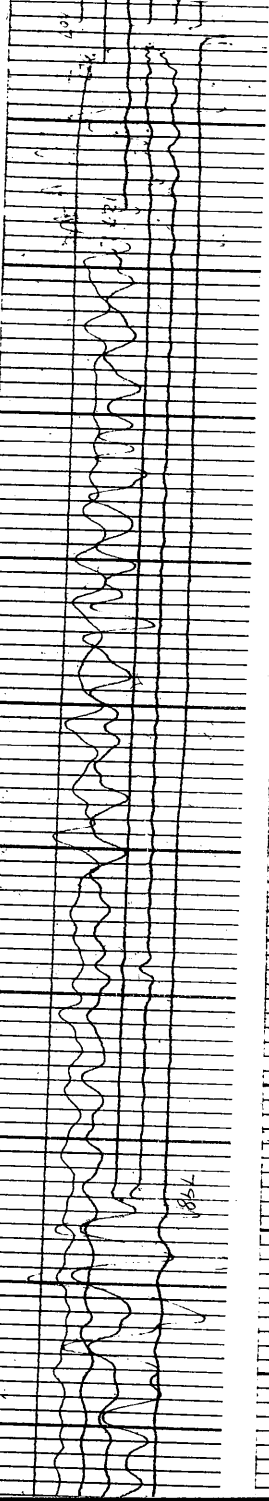
Velocity Survey
FLAXMAN'S HILL NC. 1
Shot 7 2 East 75 lbs. 68-74'
Well Geophone: 6986 ft.
June 20, 1961

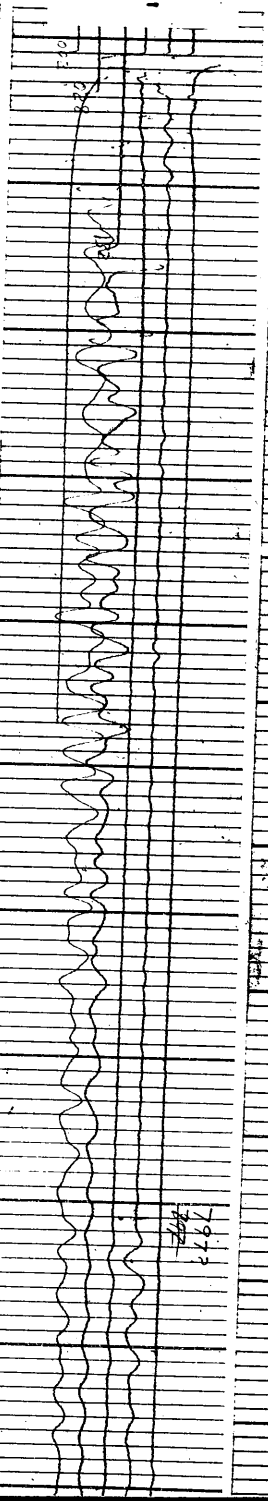
Velocity Survey
FLAXMAN'S HILL NO. 1
Shot 8 1 West 50 lbs. 54-74'
Well Geophone: 6962 ft.
June 20, 1961

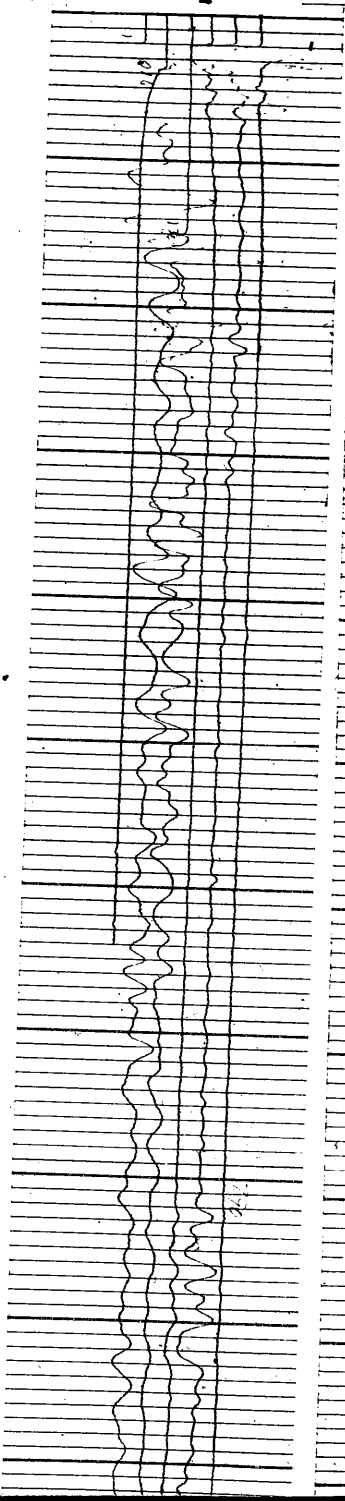
Velocity Survey
FLAXMAN'S HILL NC. 1
Shot 9 2 West 100 lbs. 38-78'
Well Geophone: 6878 ft.
June 20, 1961

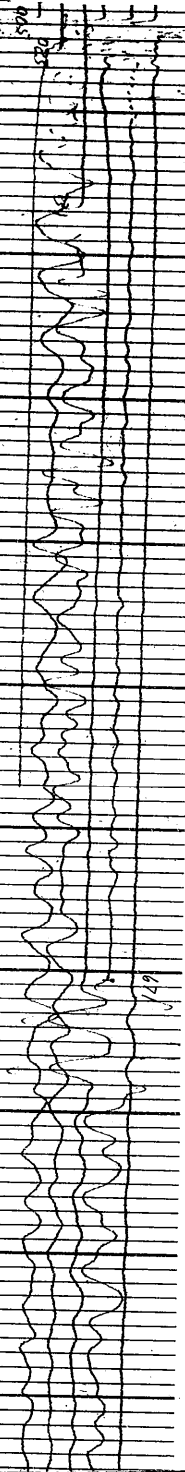
Velocity Survey
 FLAXMAN'S HILL NO. 1
 Shot 10 2,3 West 100 lbs. 52-82'
 Well Geophone: 5570 ft.
 June 20, 1961

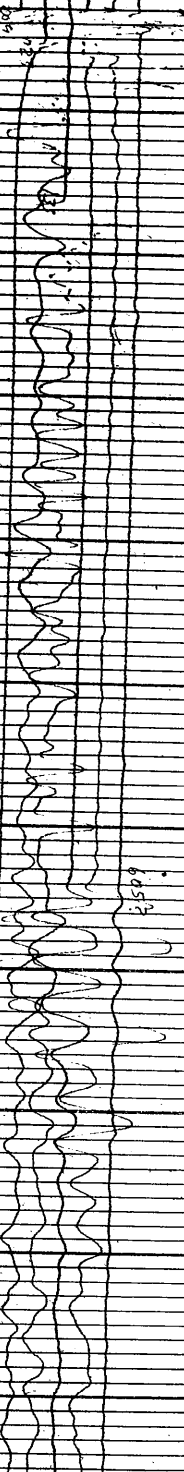
Velocity Survey
 FLAXMAN'S HILL NO. 1
 Shot 11 3 West 50 lbs. 60-70'
 Well Geophone: 4833 ft.
 June 20, 1961

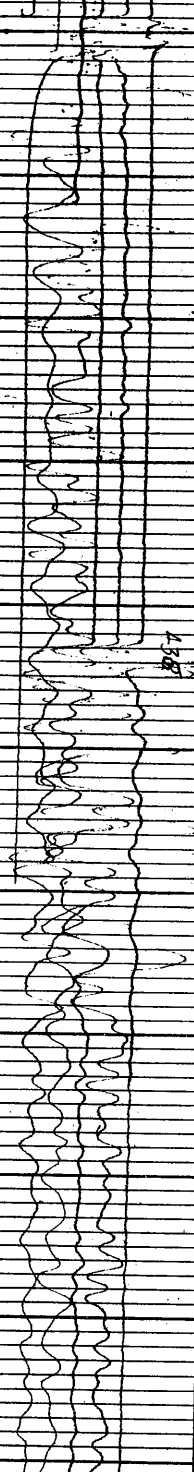
Velocity Survey
 FLAXMAN'S HILL NO. 1
 Shot 12 3 West 40 lbs. 54-64'
 Well Geophone: 3180 ft.
 June 20, 1961

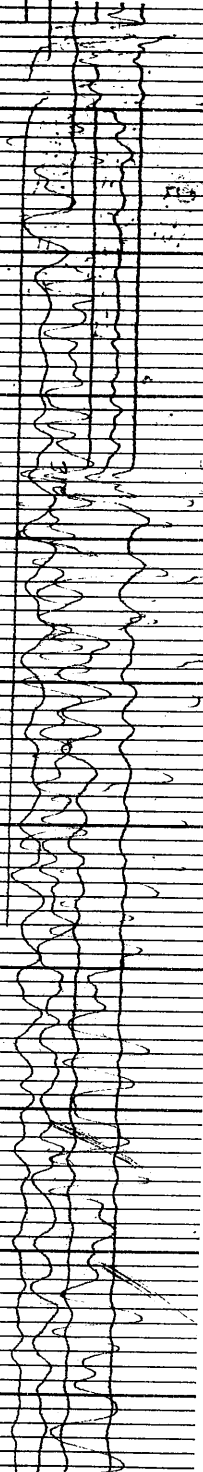
Velocity Survey
 FLAXMAN'S HILL NO. 1
 Shot 13 3 West 25 lbs. 58-64'
 Well Geophone: 2008 ft.
 June 20, 1961

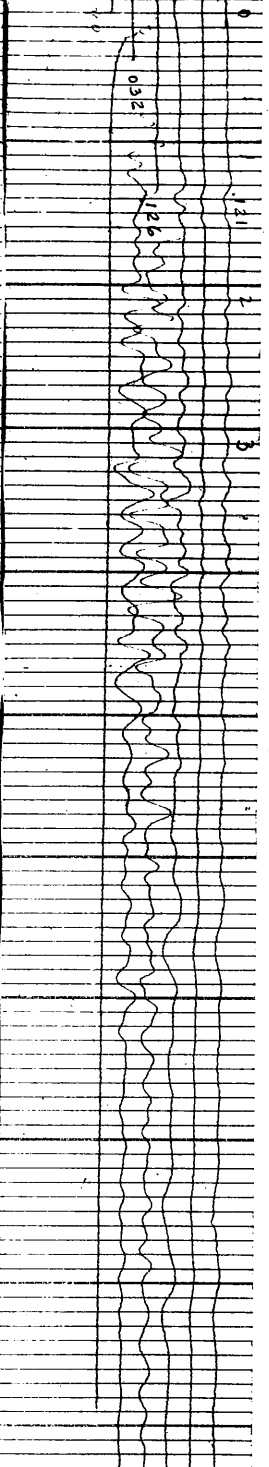
Velocity Survey
FLAXMAN'S HILL NO. 1
Shot 2 3 East 10 lbs. 80-84'
Well Geophone: 500 ft.
June 20, 1961

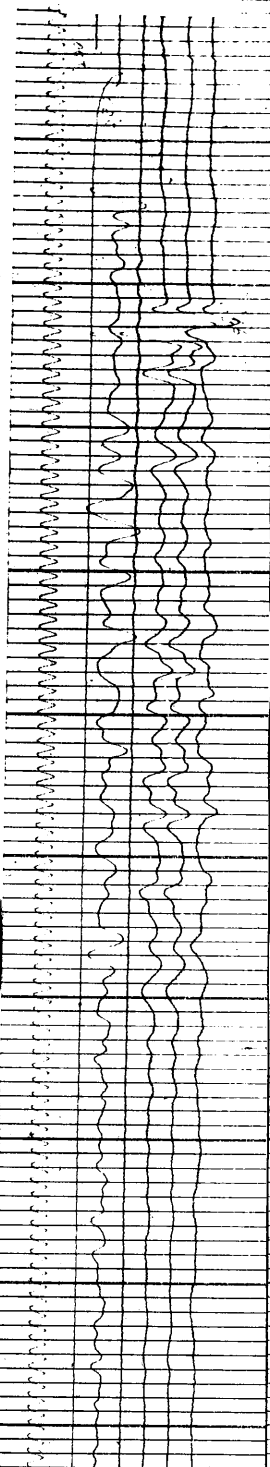
Velocity Survey
FLAXMAN'S HILL NO. 1
Shot 3 1 East 25 lbs. 64-74'
Well Geophone: 1050 ft.
June 20, 1961

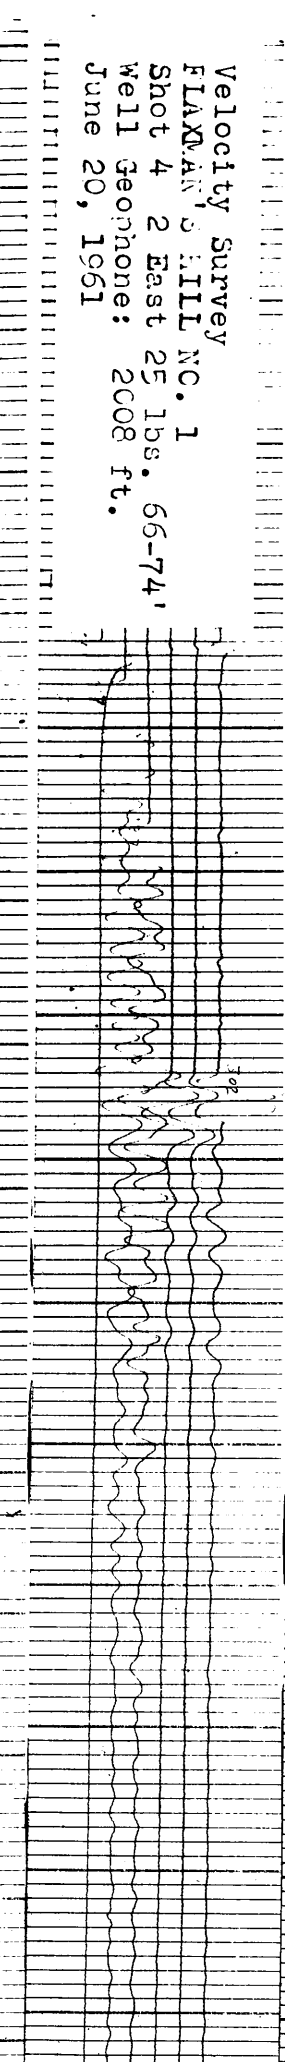
Velocity Survey
FLAXMAN'S HILL NO. 1
Shot 4 2 East 25 lbs. 66-74'
Well Geophone: 2008 ft.
June 20, 1961

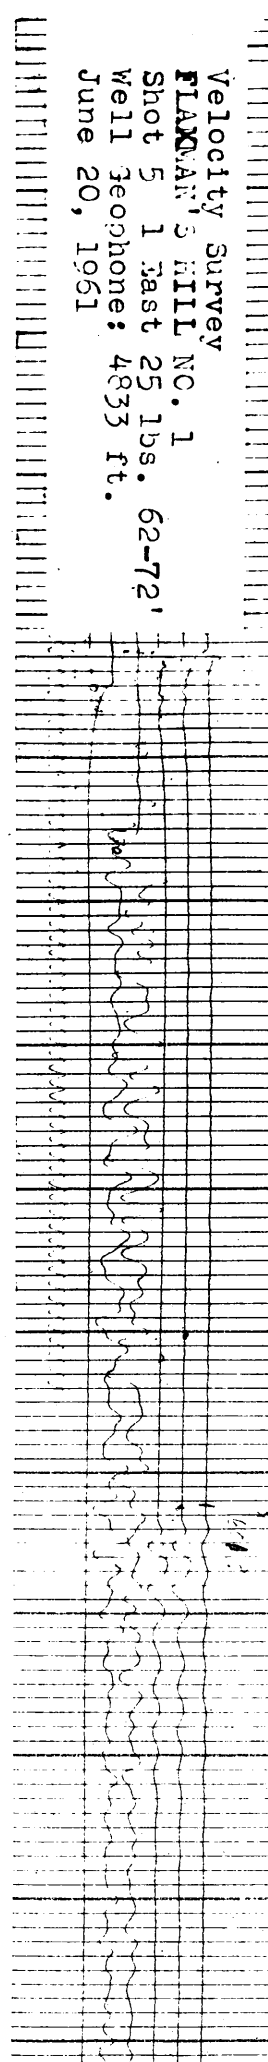
Velocity Survey
FLAXMAN'S HILL NO. 1
Shot 5 1 East 25 lbs. 62-72'
Well Geophone: 4833 ft.
June 20, 1961

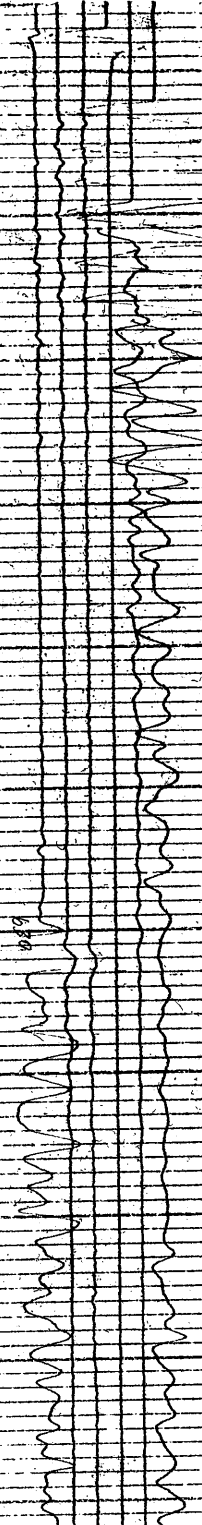
Velocity Survey
FLAXMAN'S HILL NO. 1
Shot 1 1A East
50 Lbs. 230-250'
Well Geophone: 5570 ft.
August 25, 1961

The survey of the test hole was continued on August 25. Two deep shot holes had been drilled at a point 600 feet southeast of the location, each being loaded with fifty pounds at 230-250 feet. A shot was taken from one of these holes with the well geophone at 5570 feet. A weak break resulted which could not be considered reliable. Twenty-five pounds were lowered over the cliff and the previous depth repeated for comparison. This shot produced a strong geophone break and ten pound charges were subsequently used for most shots as being ample. However, as the survey continued, leakage developed in the recording system. Since the geophone checked out satisfactory when brought to the surface it was decided that the leakage was in the cable and head connections. After the cables were checked out to a satisfactory condition the survey was continued on August 26. Difficulty with high leakage again developed at depth;

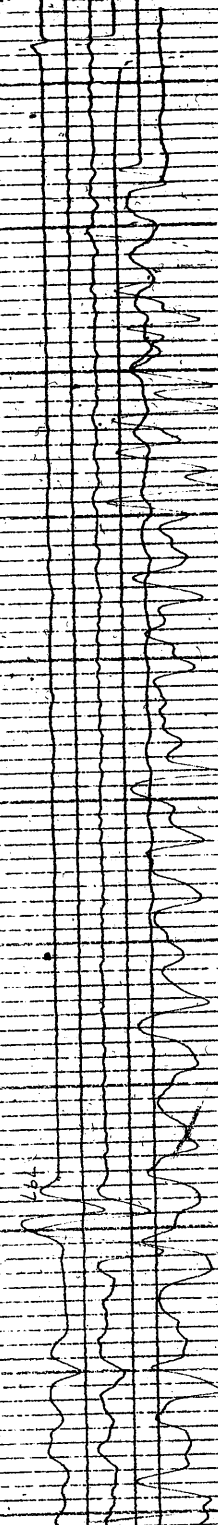
Velocity Survey
FLAXMAN'S HILL NO. 1
Shot 2 10 lbs. Sea
Well Geophone: 7330 ft.
August 25, 1961

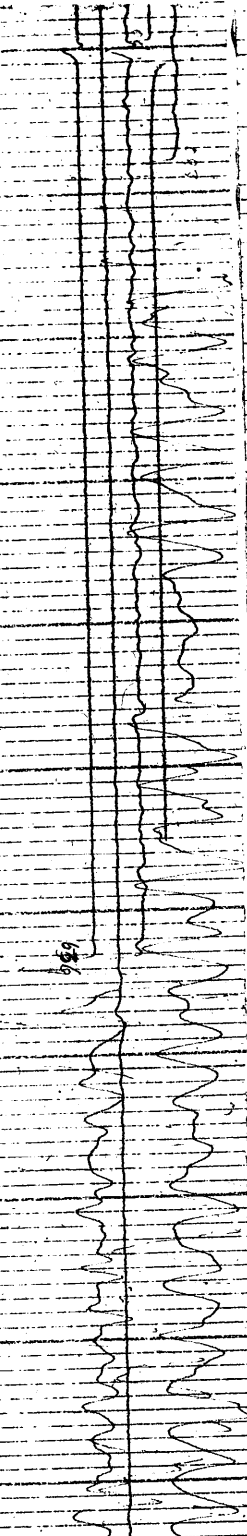
Velocity Survey
FLAXMAN'S HILL NO. 1
Shot 1 10 lbs. Sea
Well Geophone: 5570 ft.
August 26, 1961

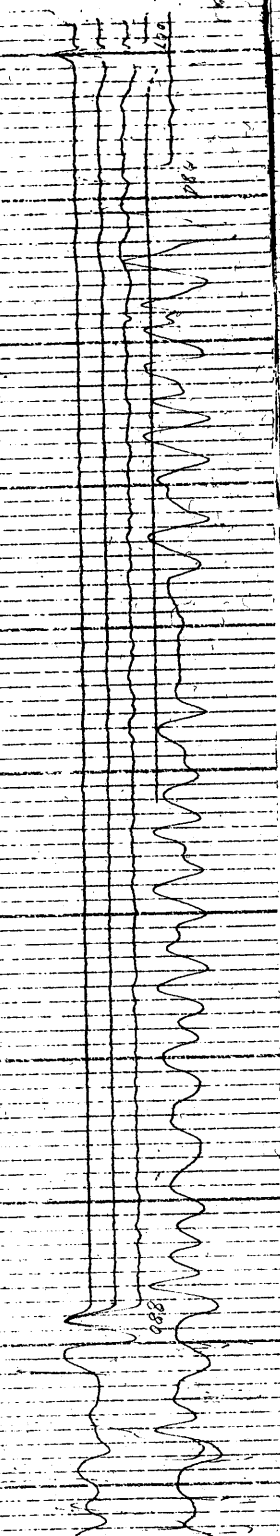
Velocity Survey
FLAXMAN'S HILL NO. 1
Shot 2 10 lbs. Sea
Well Geophone: 8500 ft.
August 25, 1961

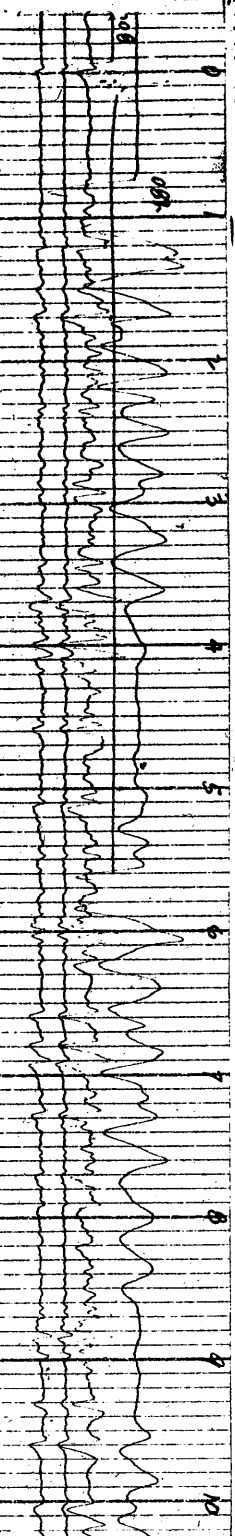
Velocity Survey
FLAXMAN'S HILL NO. 1
Shot 3 10 lbs. Sea
Well Geophone: 11,527 ft.
August 26, 1961
