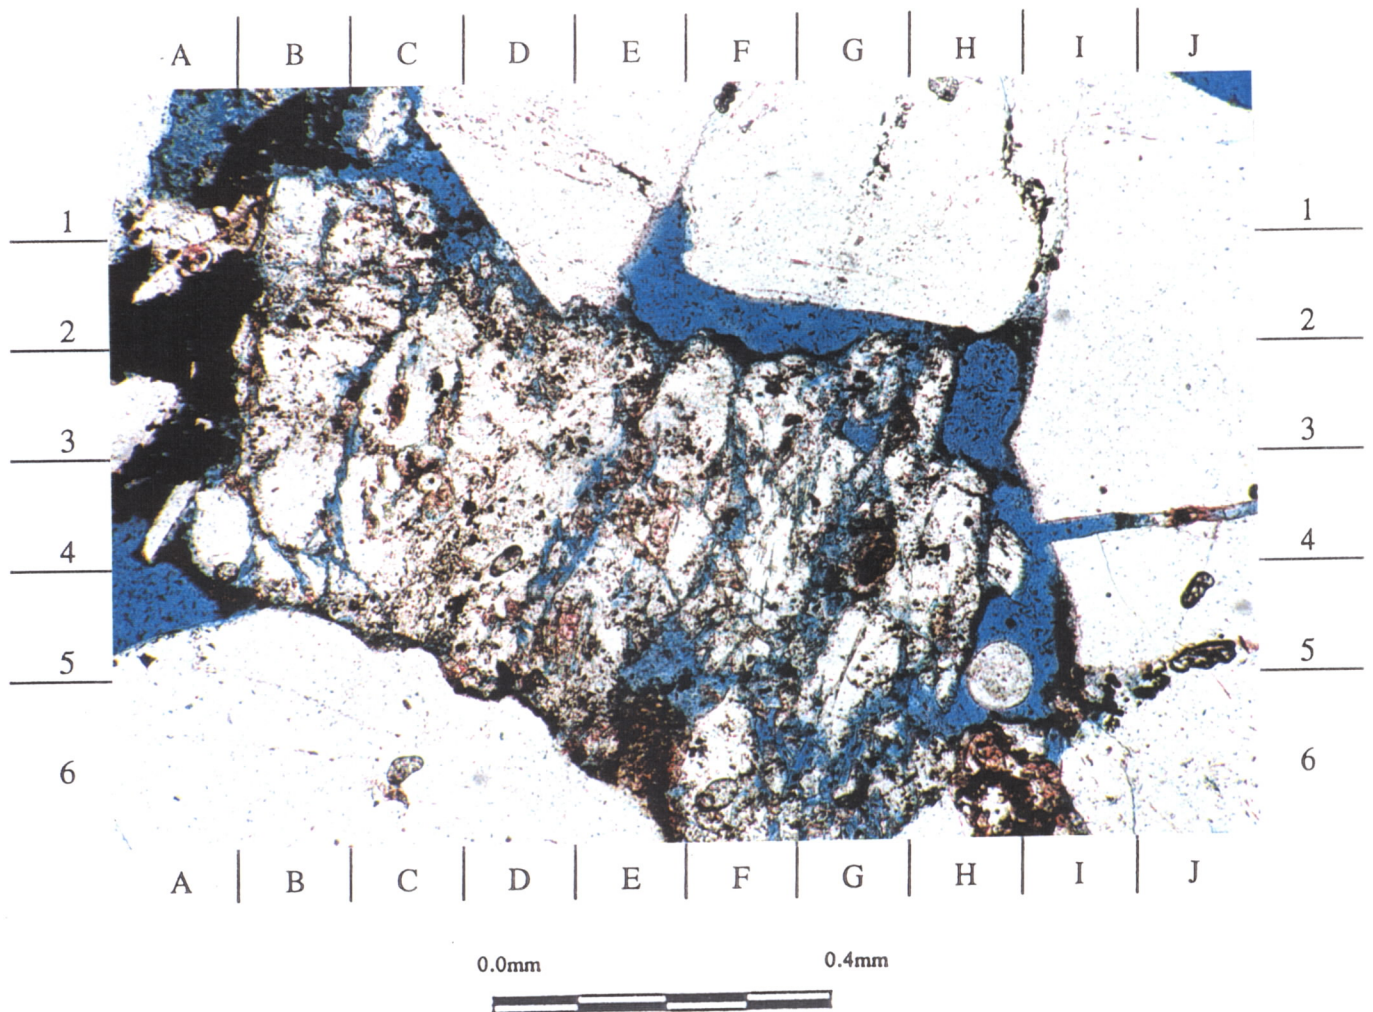
Figure 5. 1746.3m x75.6 PPL

Quartz sandstone with good intergranular porosity (stained blue). Secondary porosity is also evident within the heavily leached feldspar at F4. Thin detrital clays are also visible coating the primary pore space at H3.
