2-98 Anemone 1A

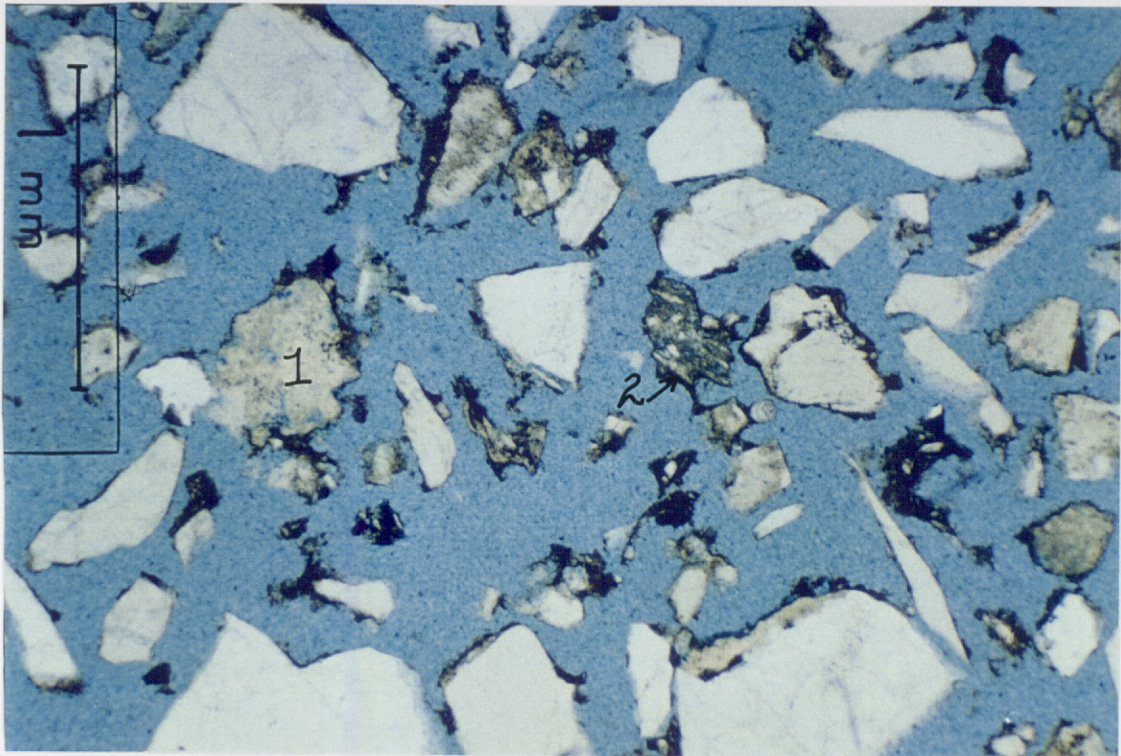
Figure 3 - Anemone #1A, cuttings, 4530 - 35m. (plane polarized light). The unwashed sample shows a dark globular rim of drilling mud adhering to the chips. Secondary dissolution porosity is evident in an altered perthite grain (1) and a heavily corroded microcline (2).
