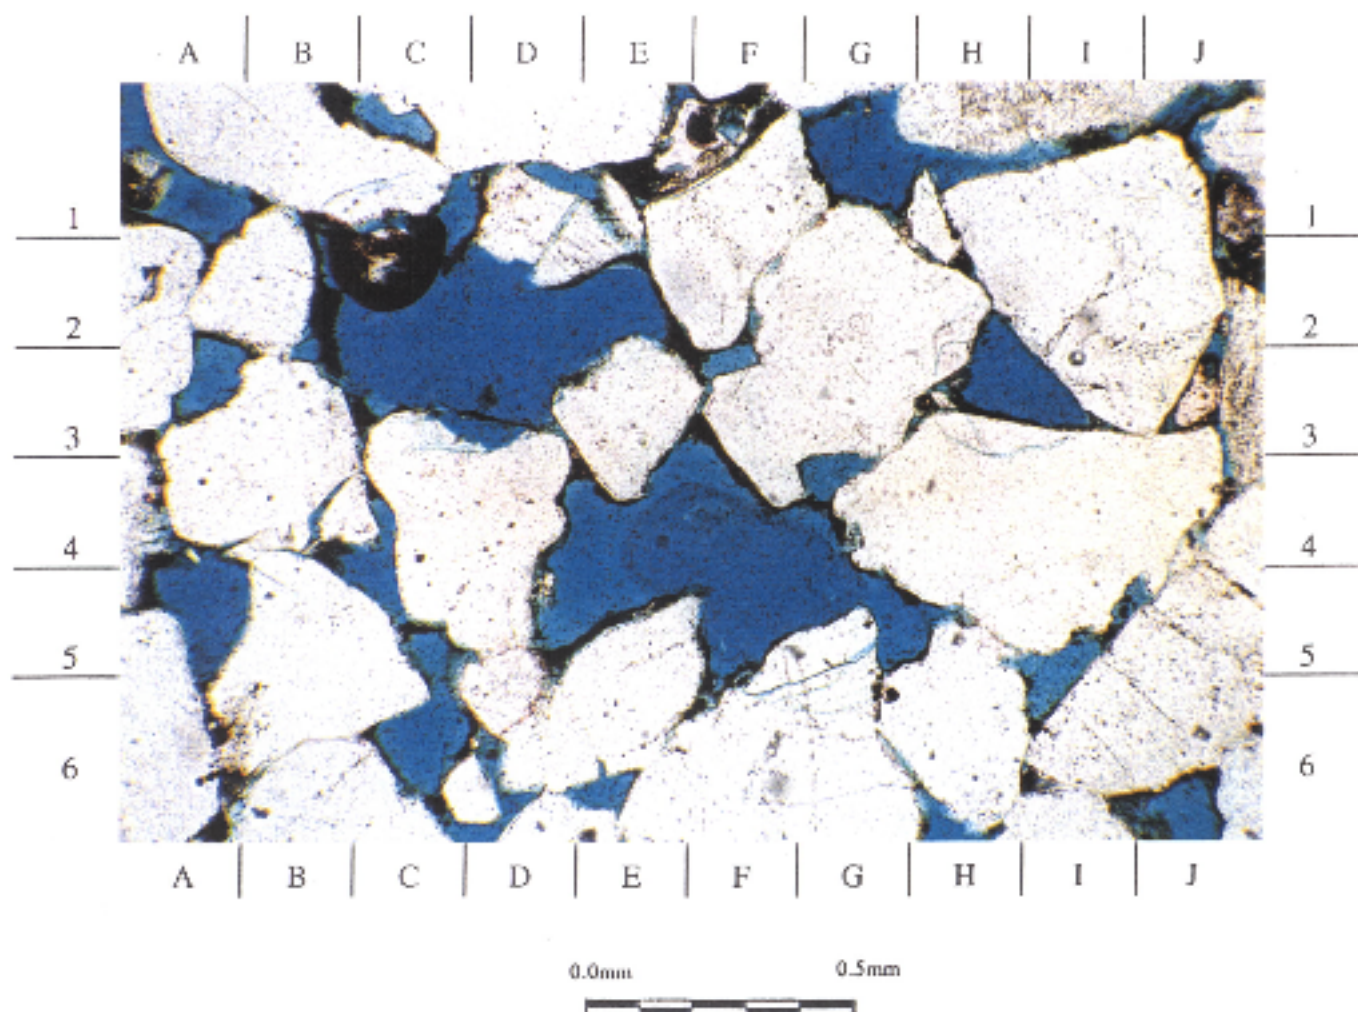
Figure 11. 1754, 15m x48 PPL.

Massive quartz sandstone. Good primary porosity is evident (stained blue). Detrital clays can be clearly seen coating the quartz grains and partly blocking pore throats.
