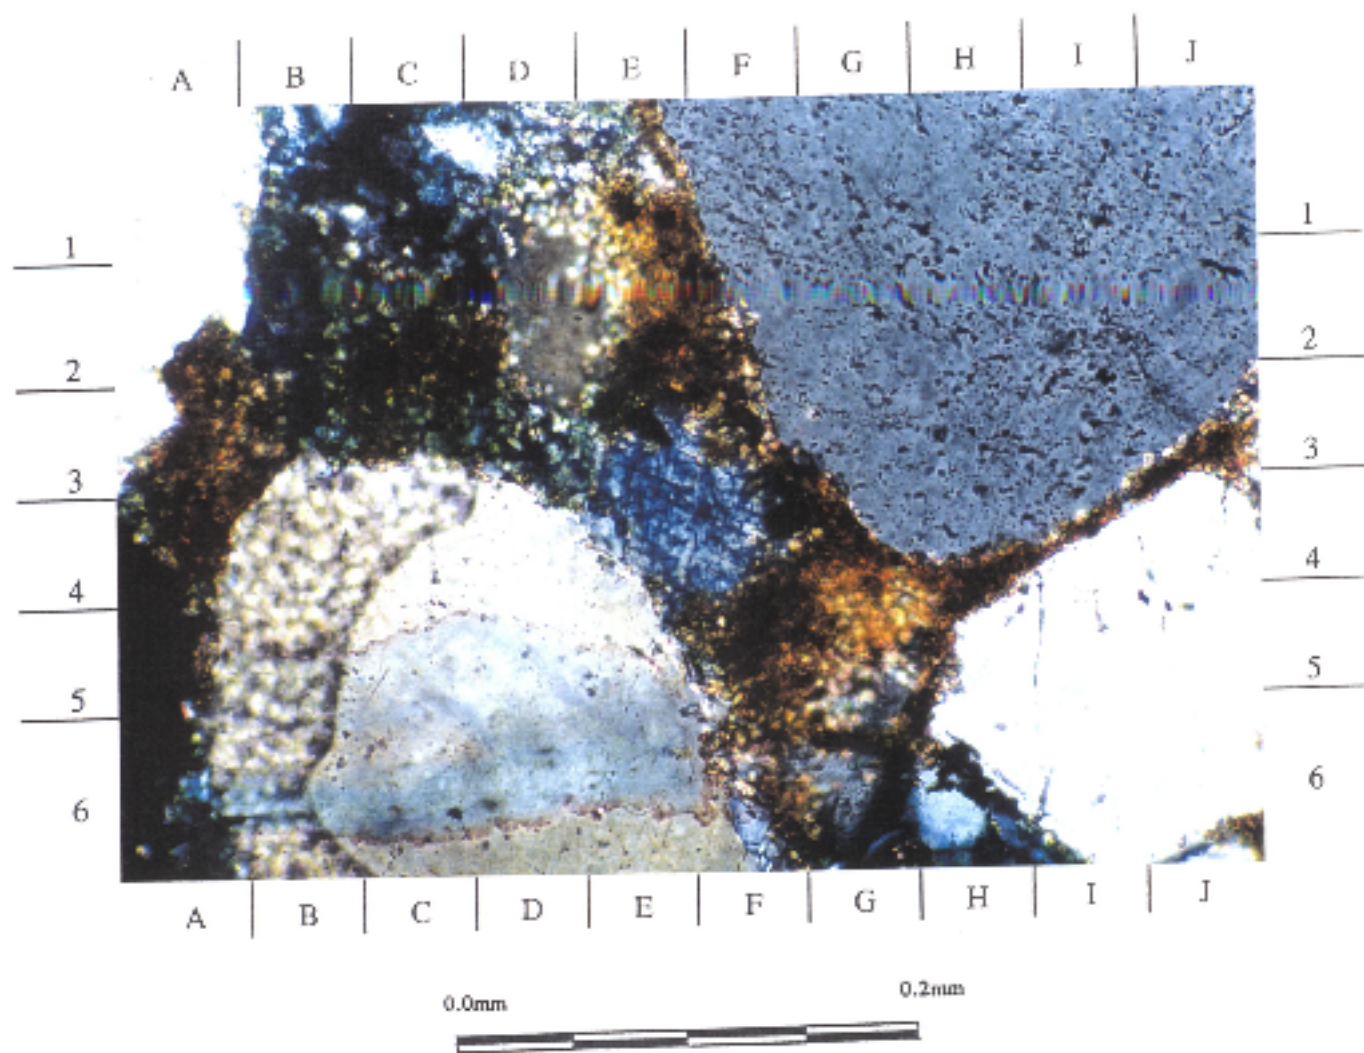
Figure 14. 1784.0m x192 XPL  
 Authigenic ferroan calcite E3 (stained blue) surrounded by authigenic siderite. The corrosive nature of the siderite towards the quartz is clearly visible at F2.
