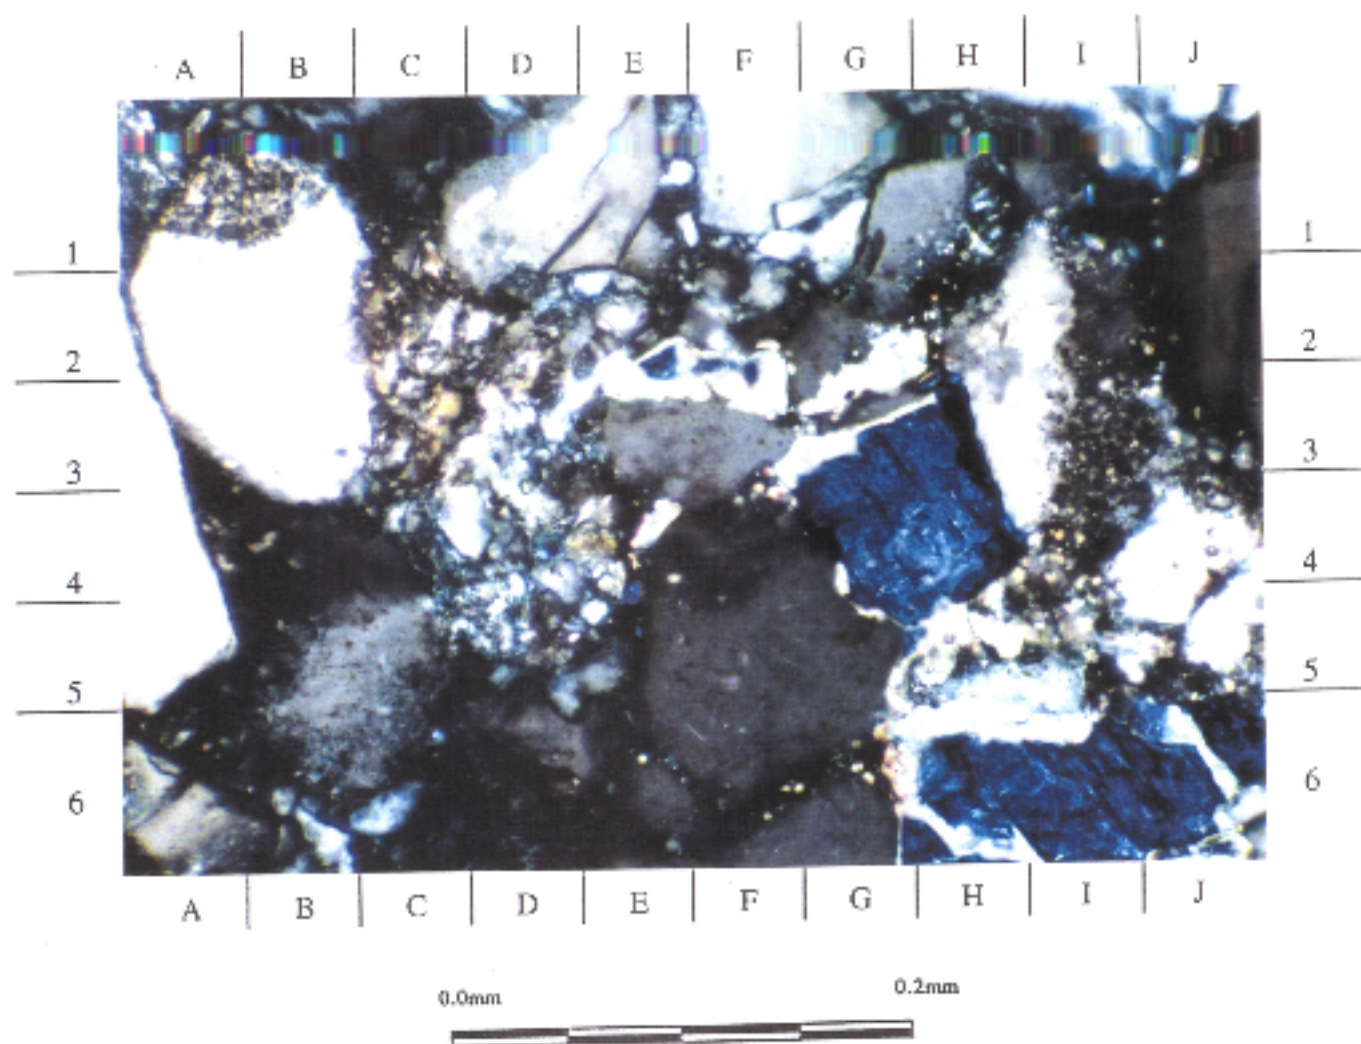
Figure 16. 1808.0m x192 XPL

Massive sparry ferroan calcite is evident at H3. This can be seen to display highly corrosive contacts with the detrital quartz grains. Shattered grains and drill mud are visible at D2.
