Figure 18. 1818.5m x75.6 XPL.

PE906714

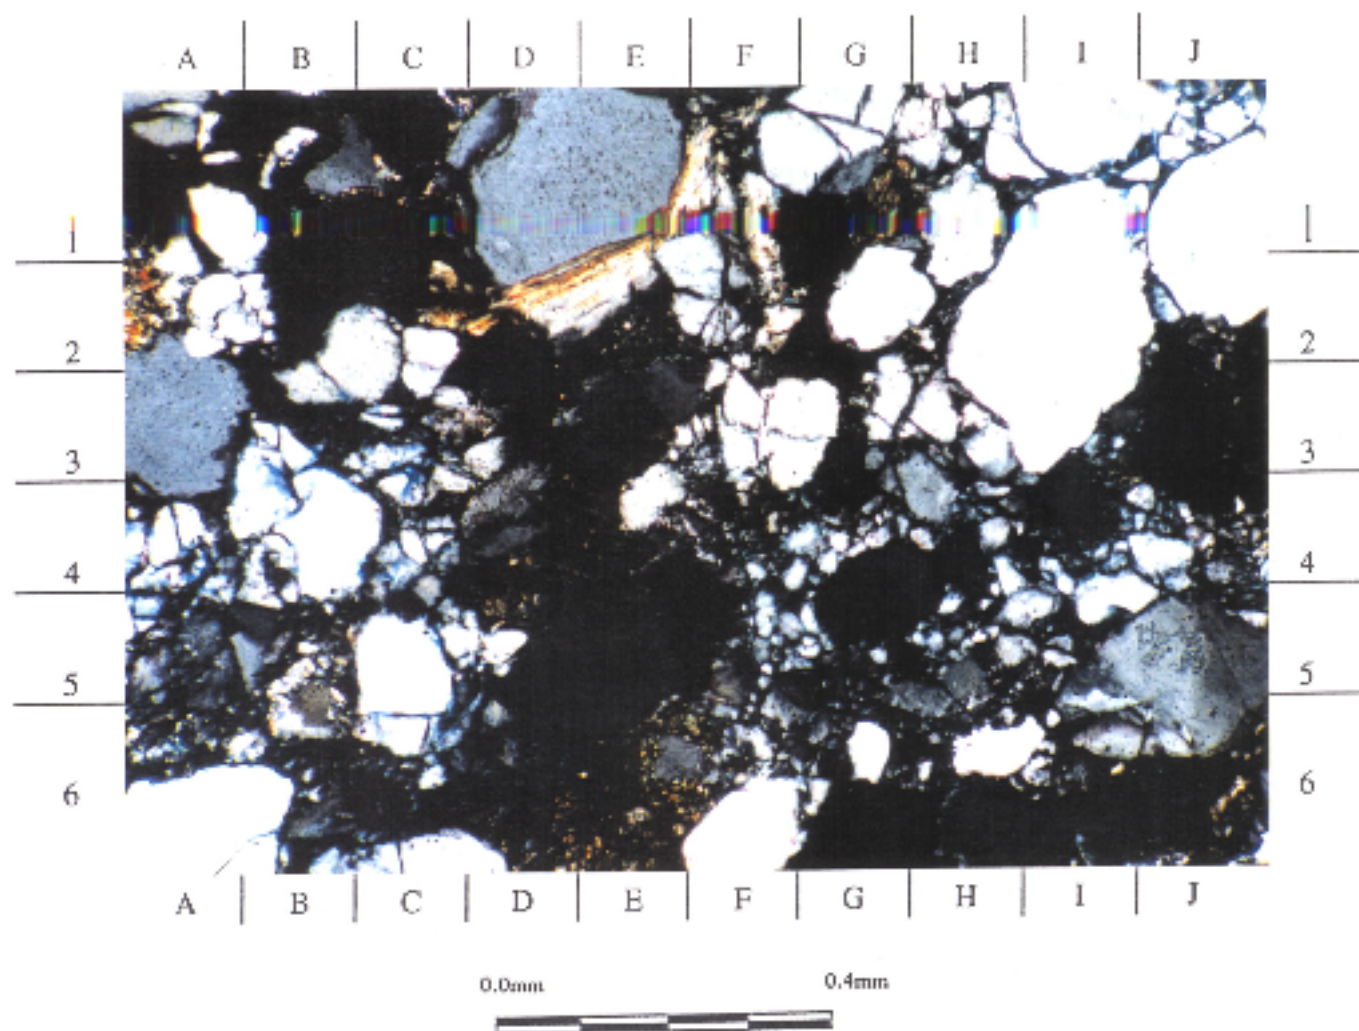
The shattered and disaggregated nature of the sample is clearly evident. A muscovite lath at E2 can be seen to be expanding to fill pore space due to kaolinisation along its cleavage planes.
