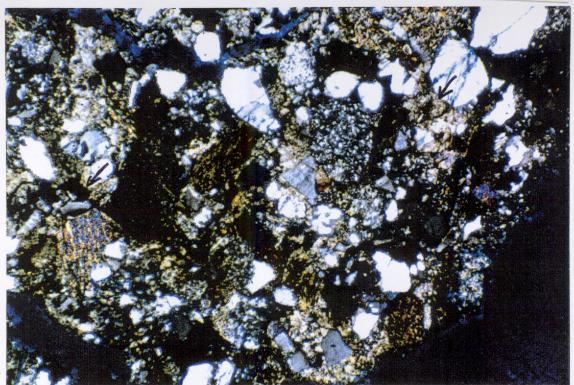
FIGURE 2a. Litharenite with abundant siltstone and shale clasts cemented by sparry carbonate (arrows). Quartz grains are subangular to subrounded. Fractures are probably the result of sidewall collection. Devilfish #1, sidewall core 2, depth 2020m. Crossed nicols. Field of view 2.72mm.

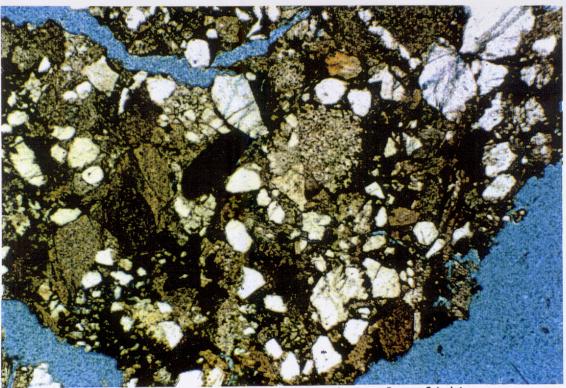
FIGURE 2b. Same field of view as Figure 2b in plane light.
