# Madfish-1 VISION Service 500MD RT

IDEAL Version: ID13\_OC\_08 <MD > Vertical Scale: 1:500 Graphics File Created: 10-Dec-2008 02:41

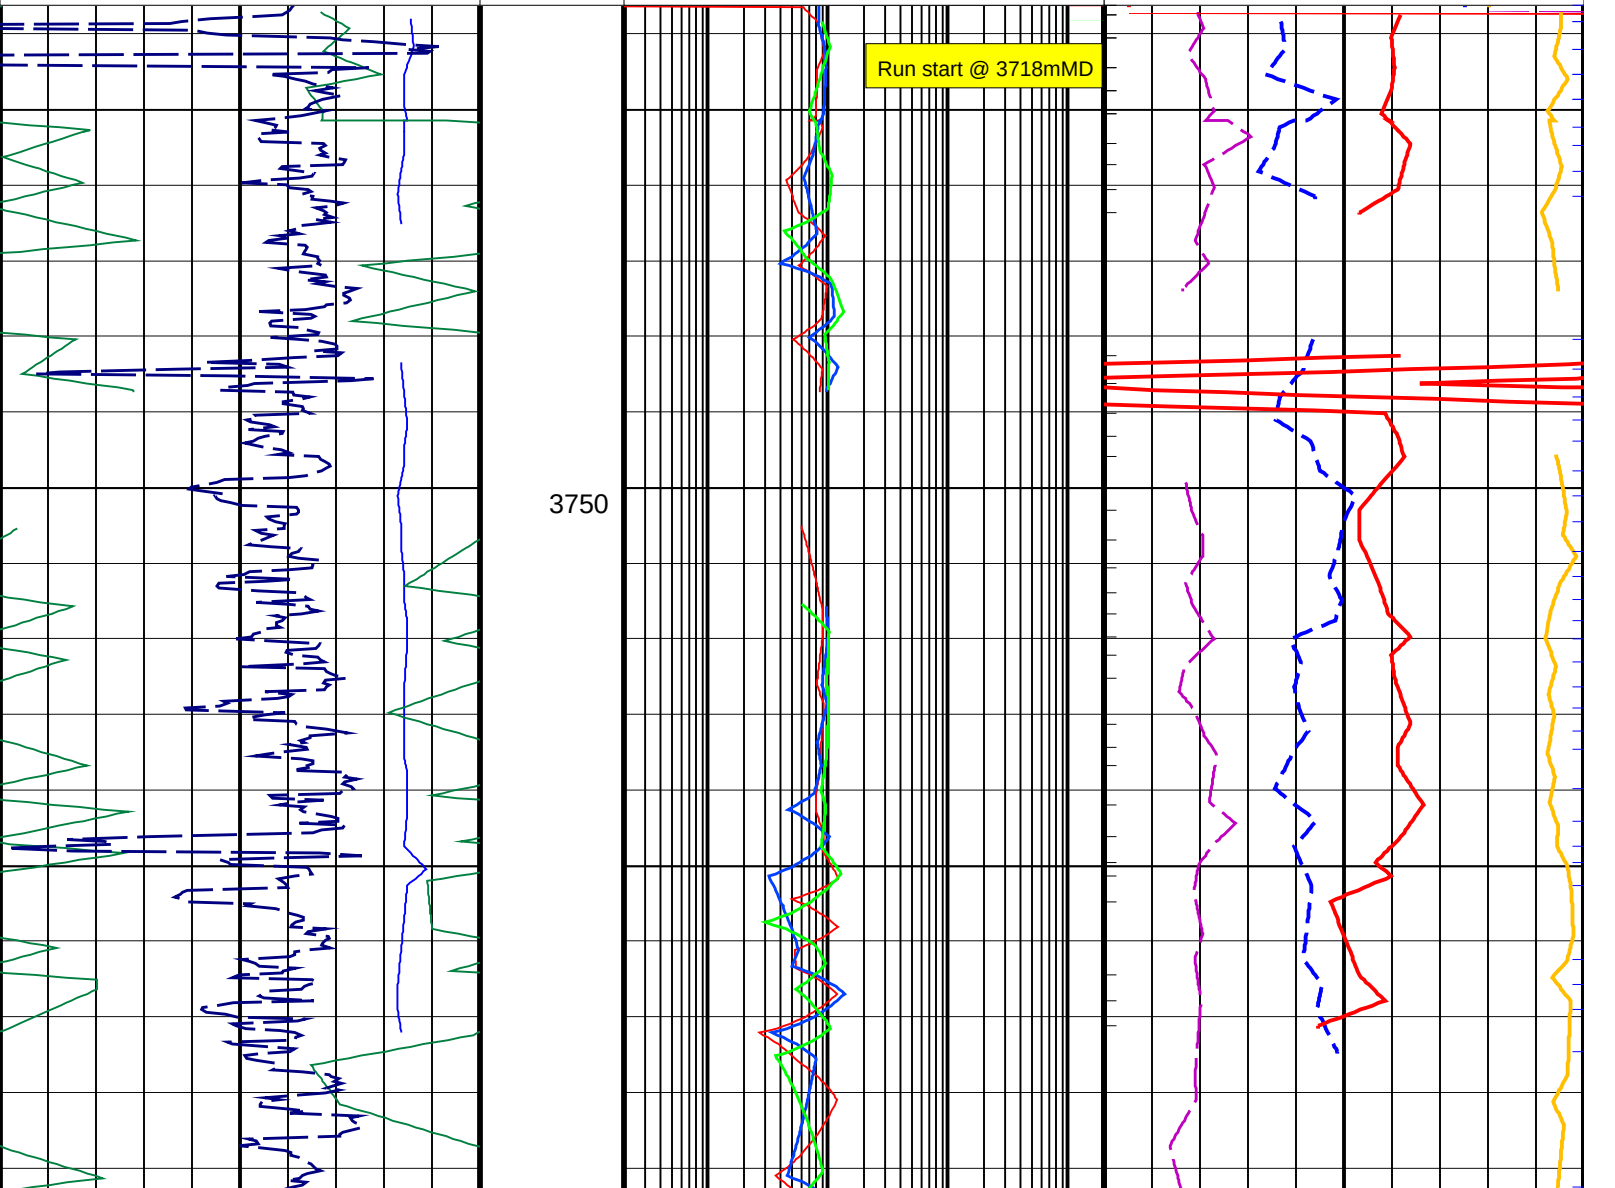
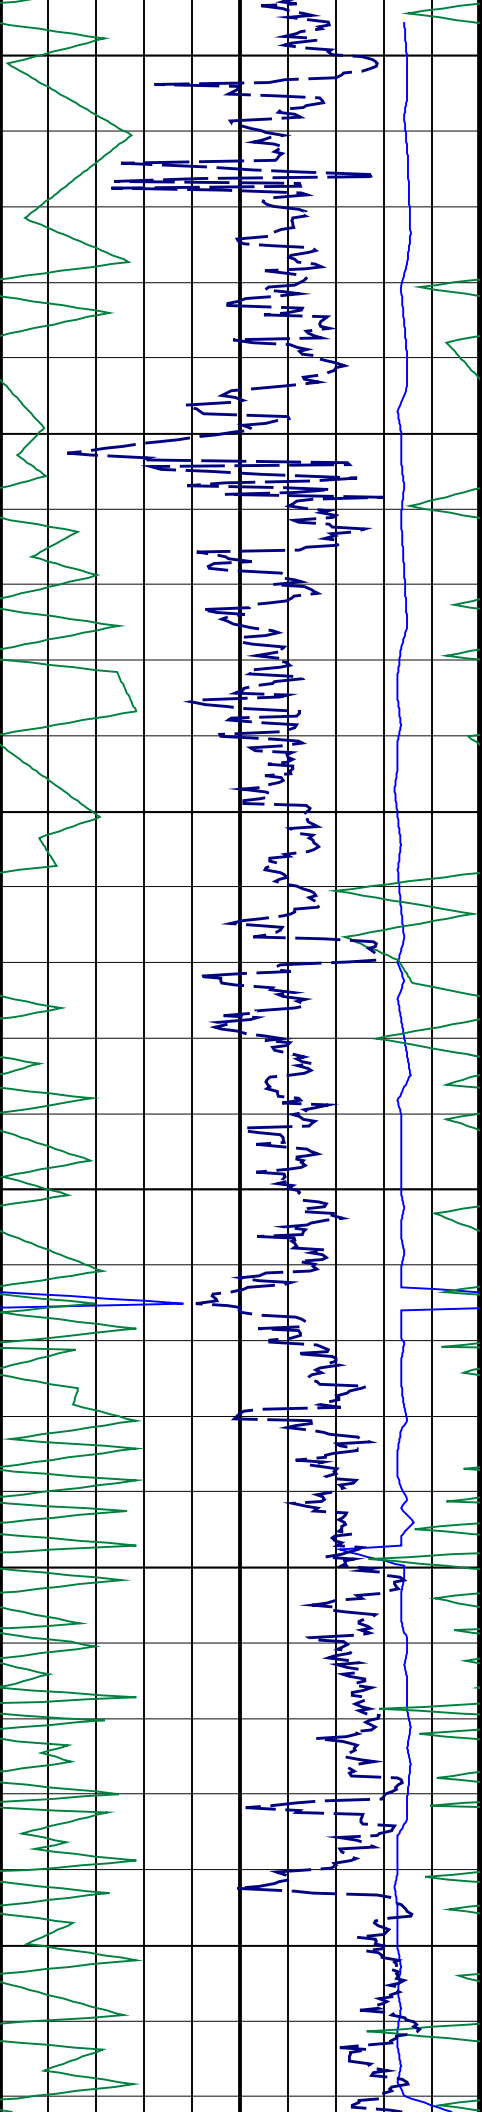
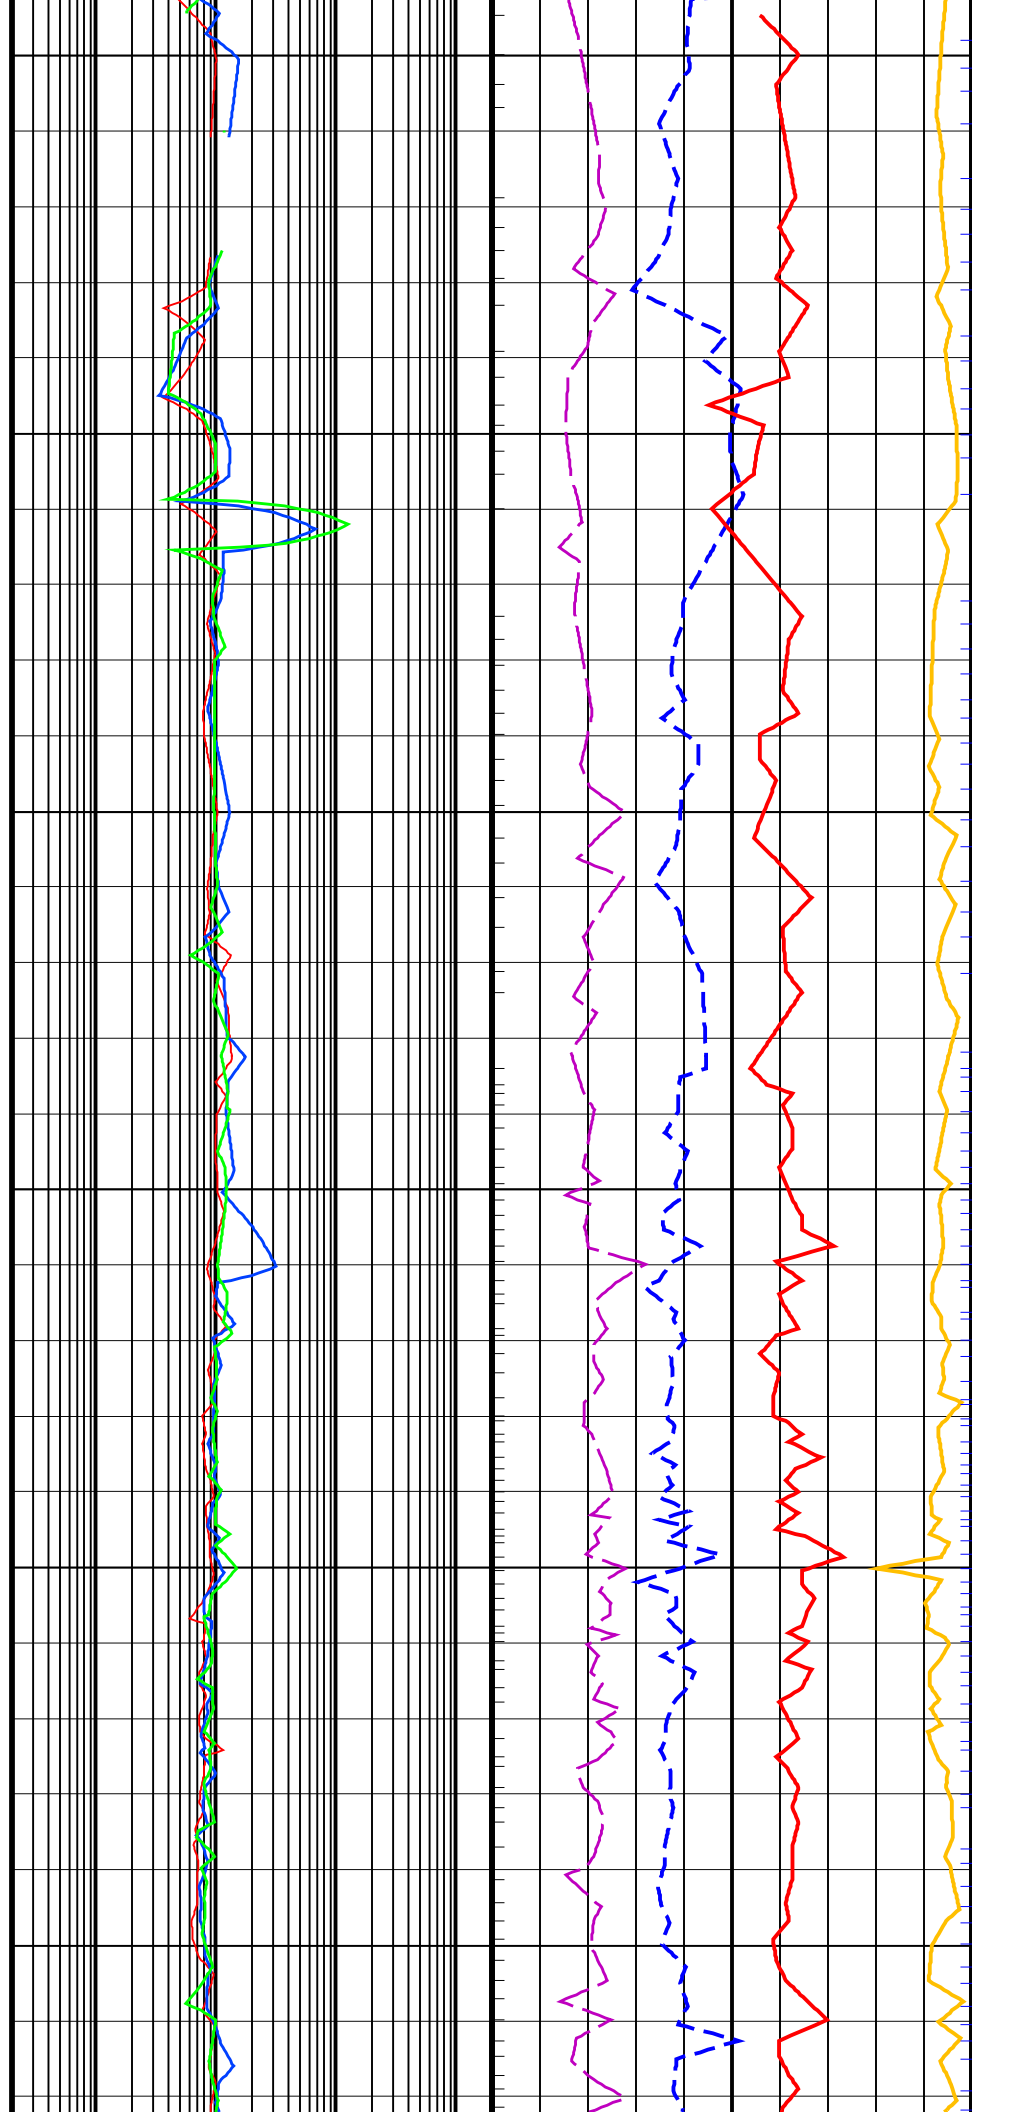
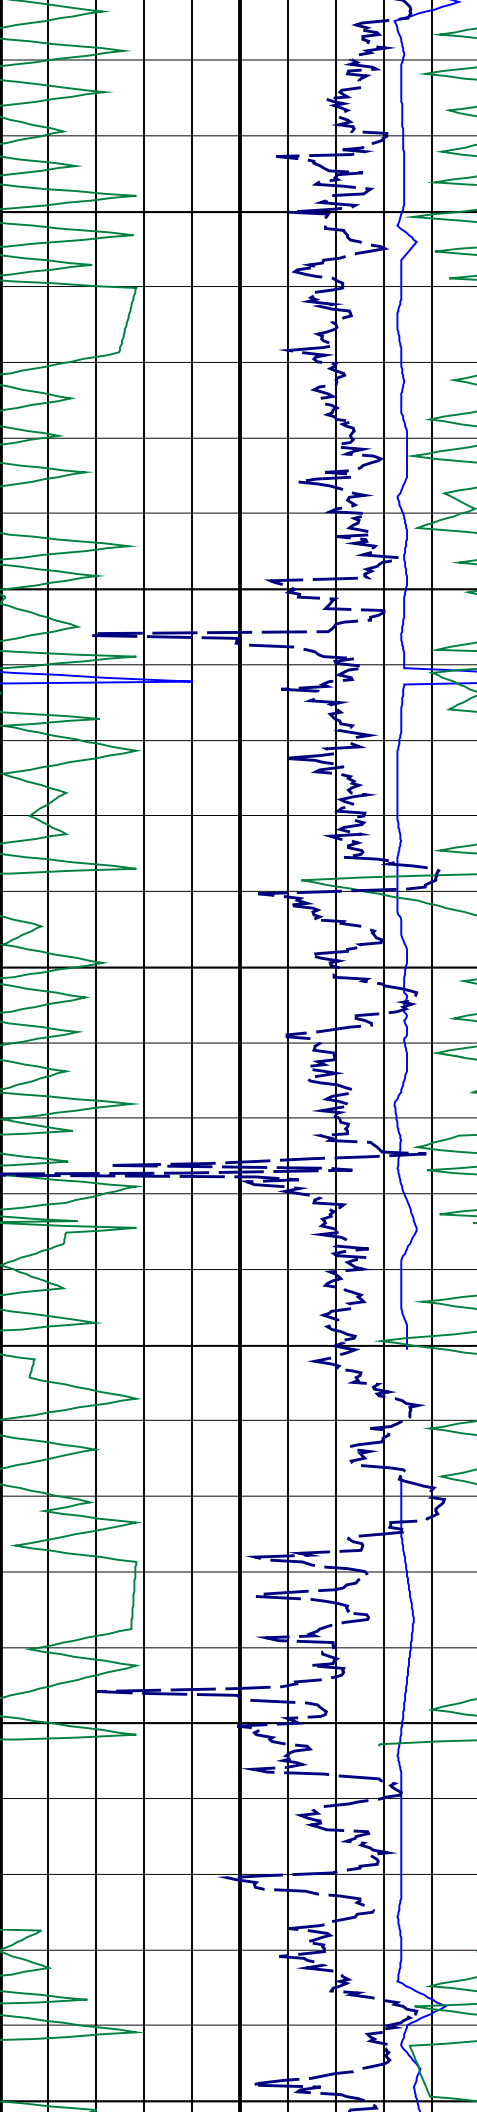
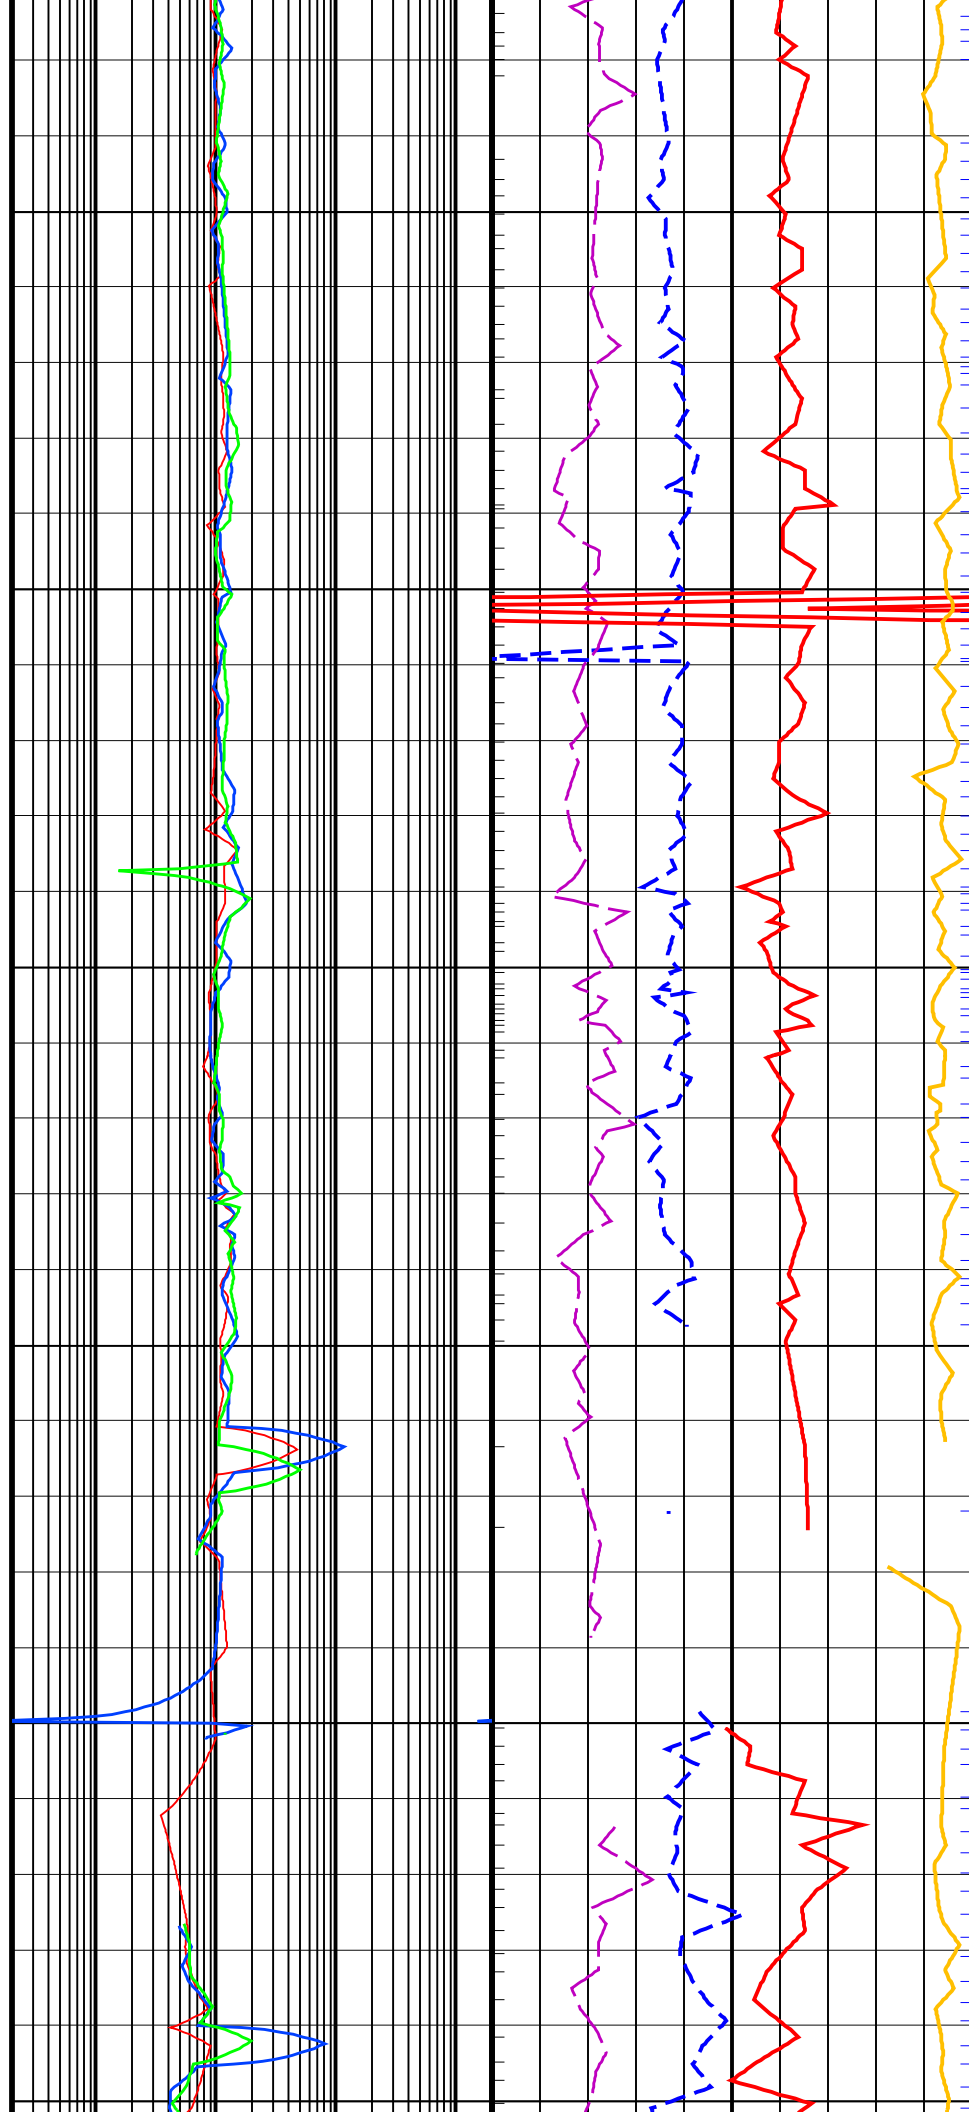
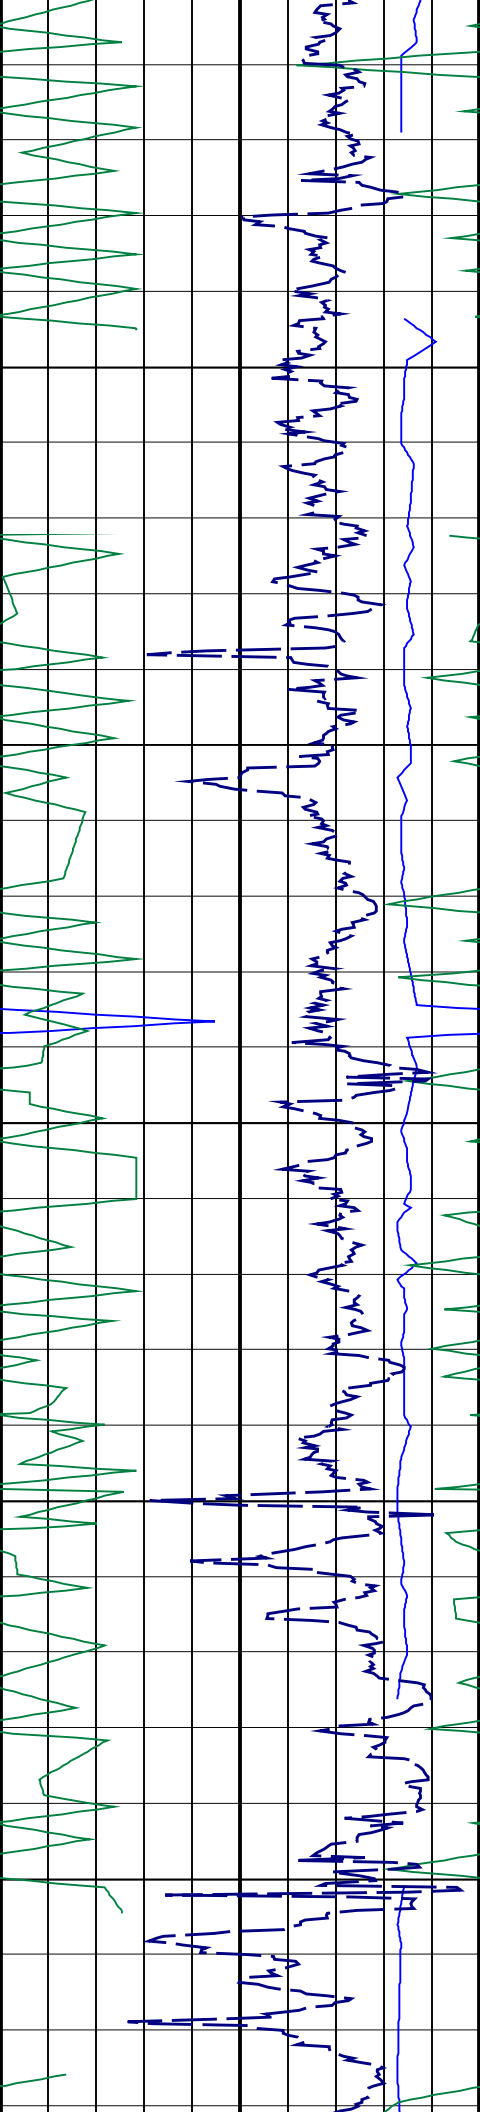
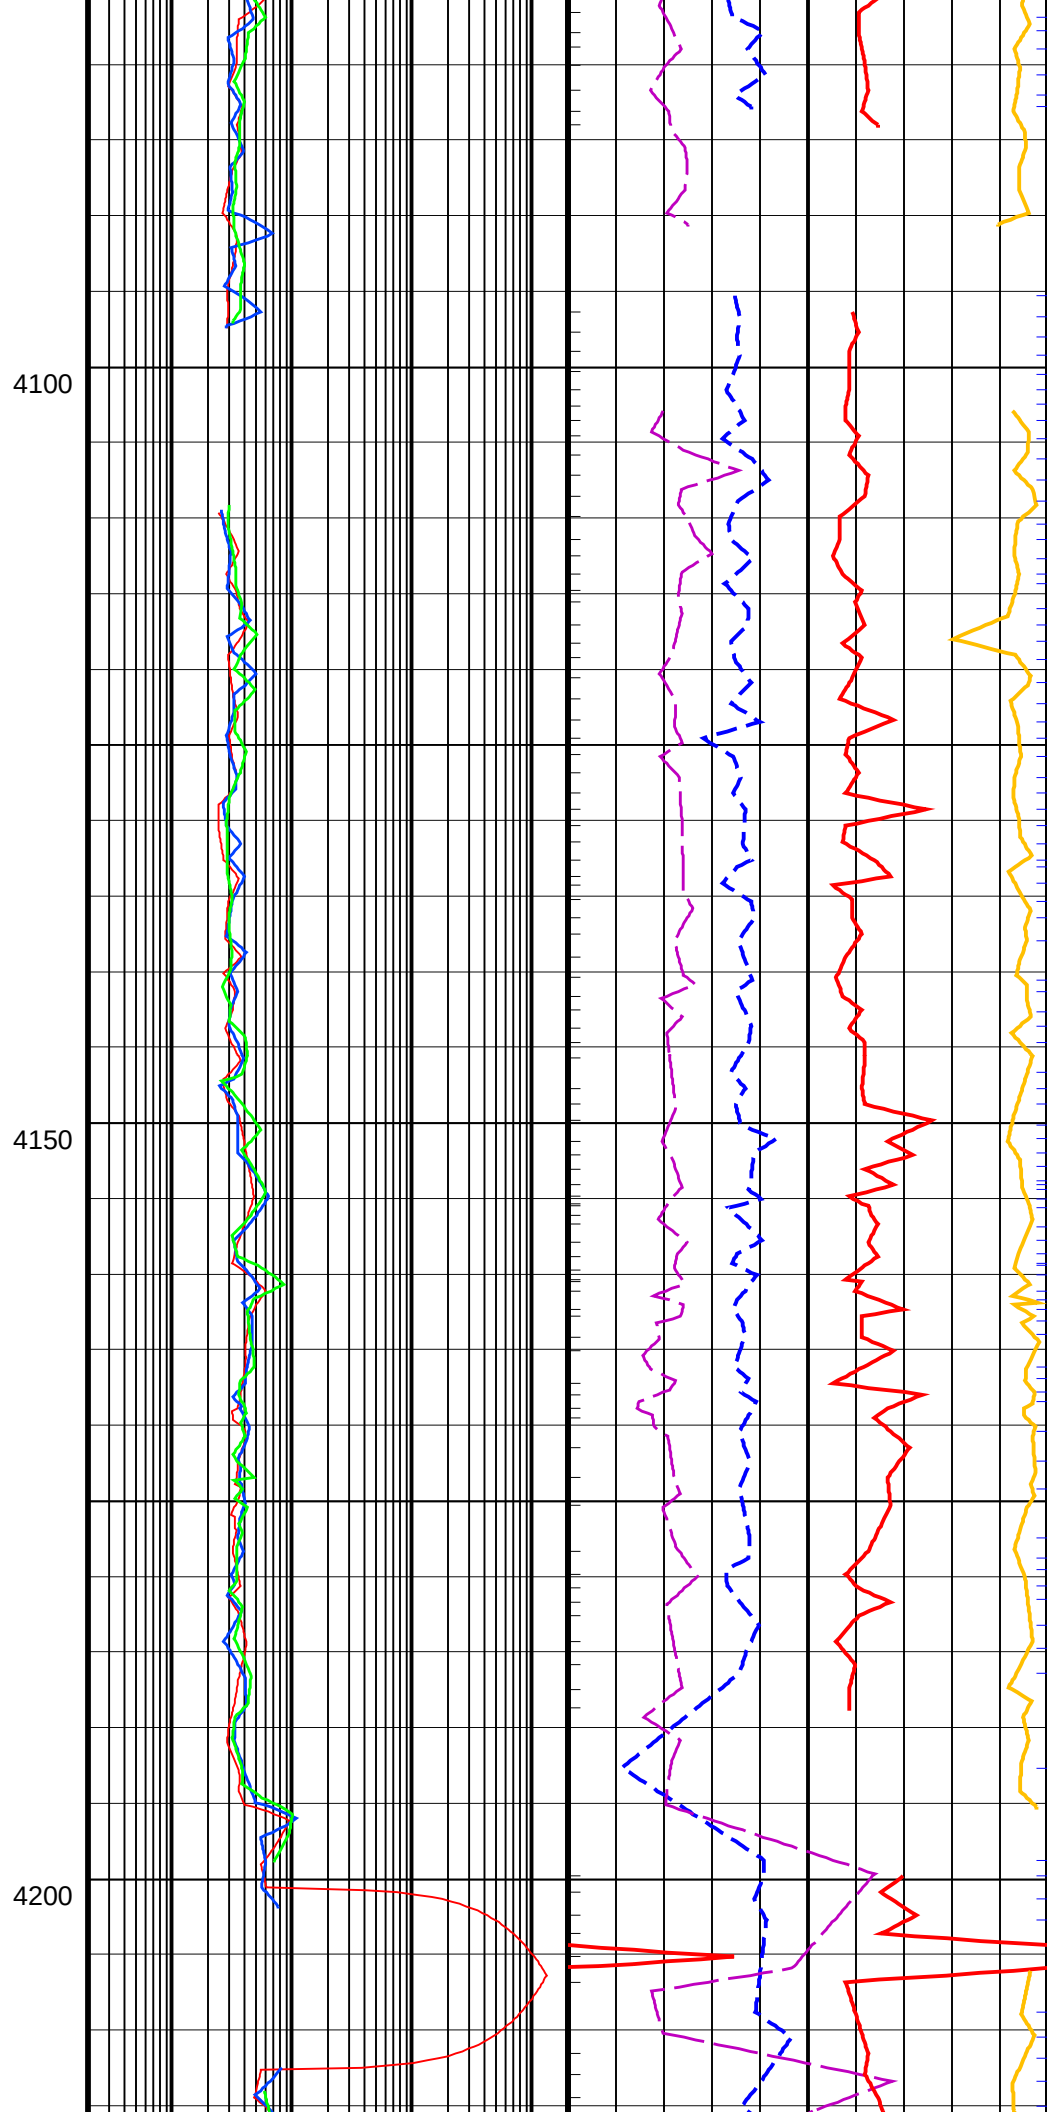
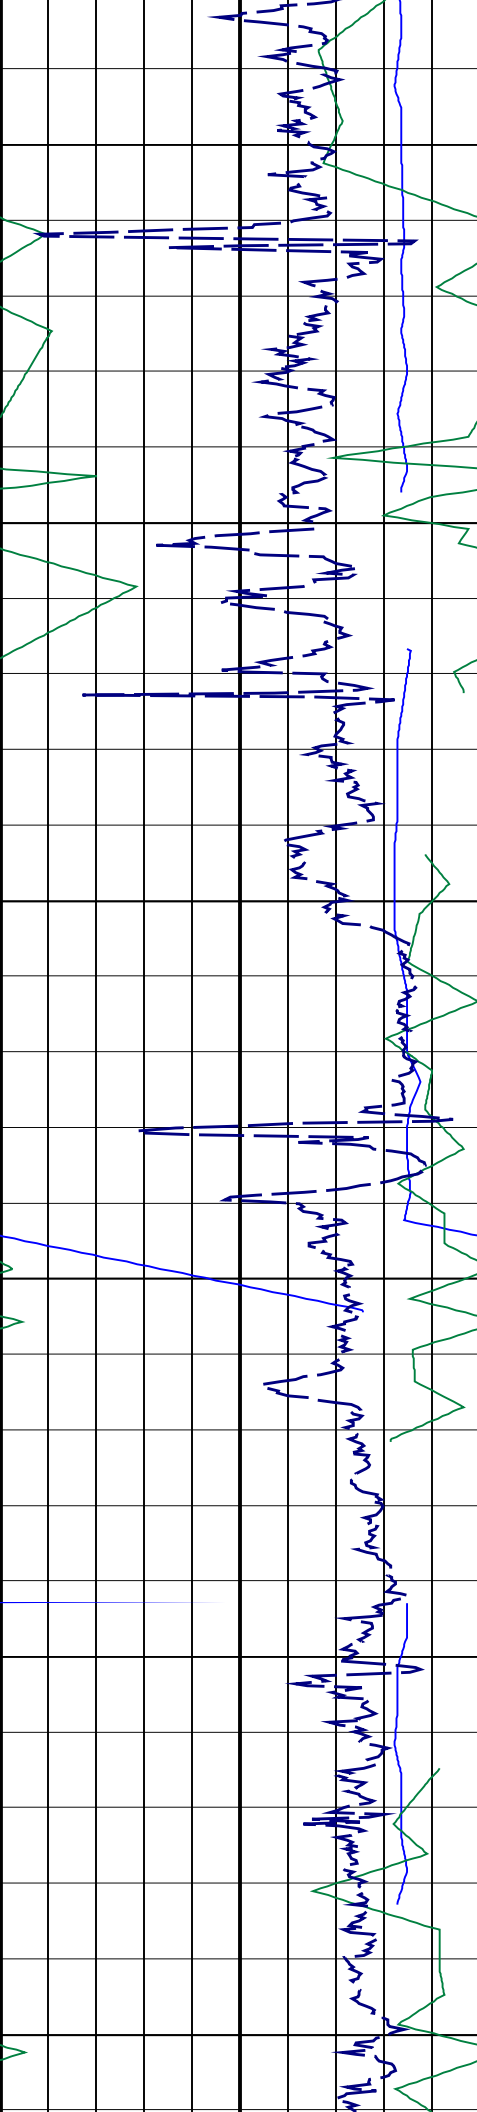
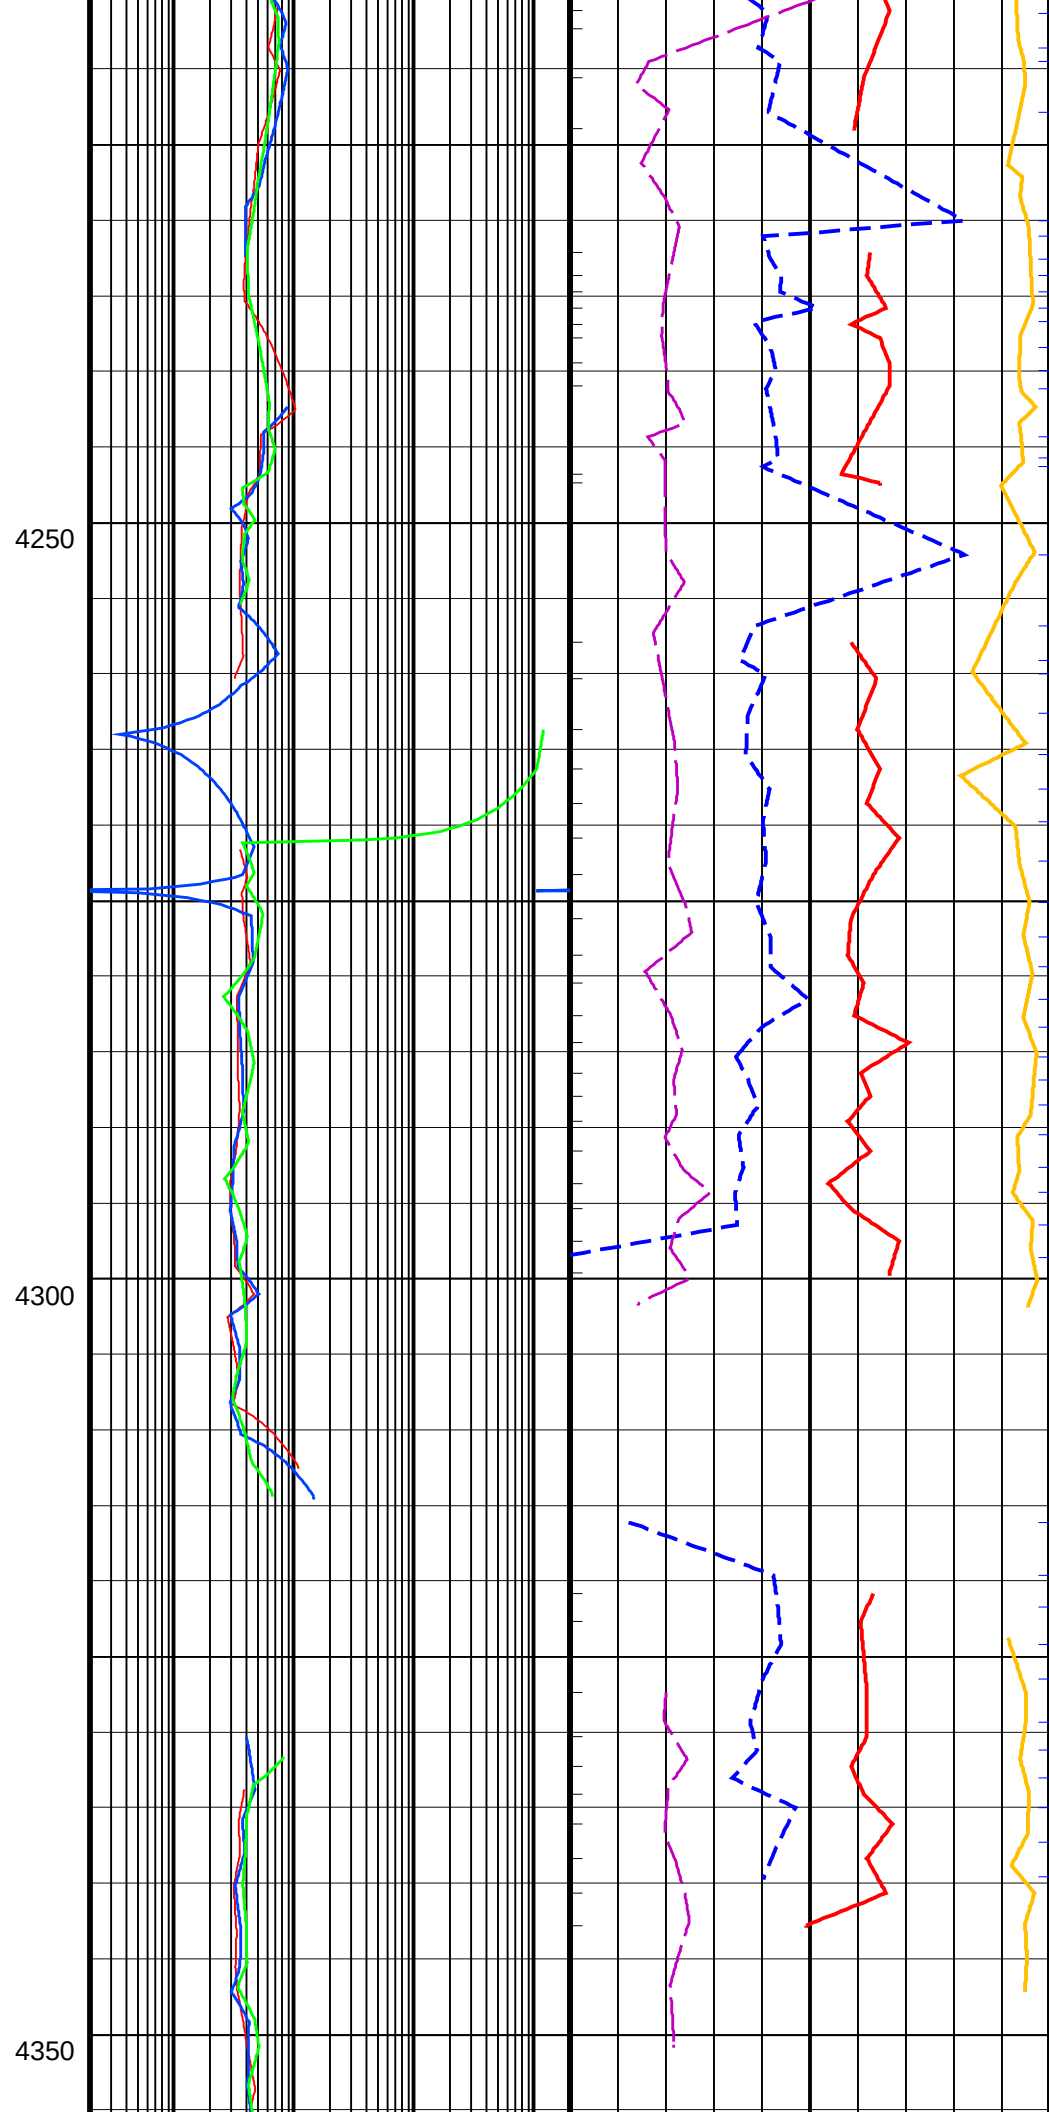
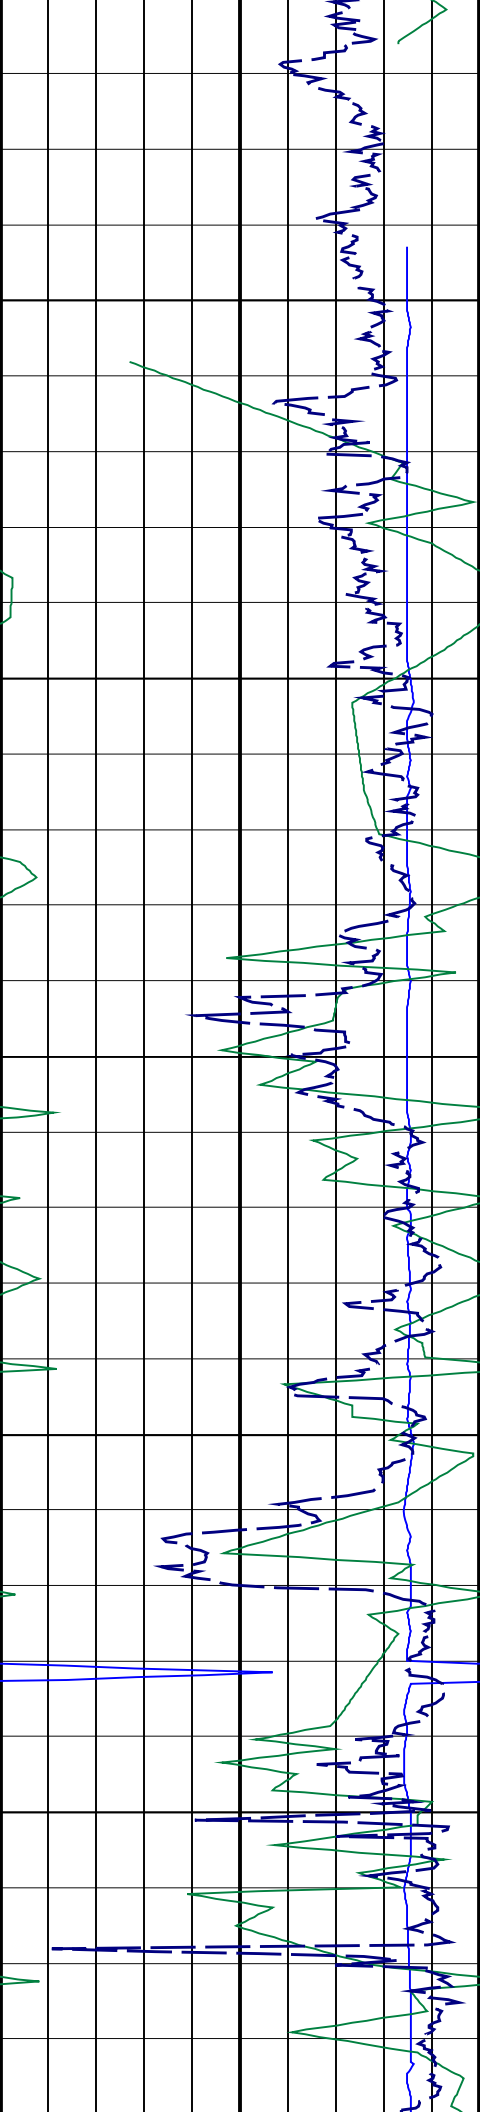
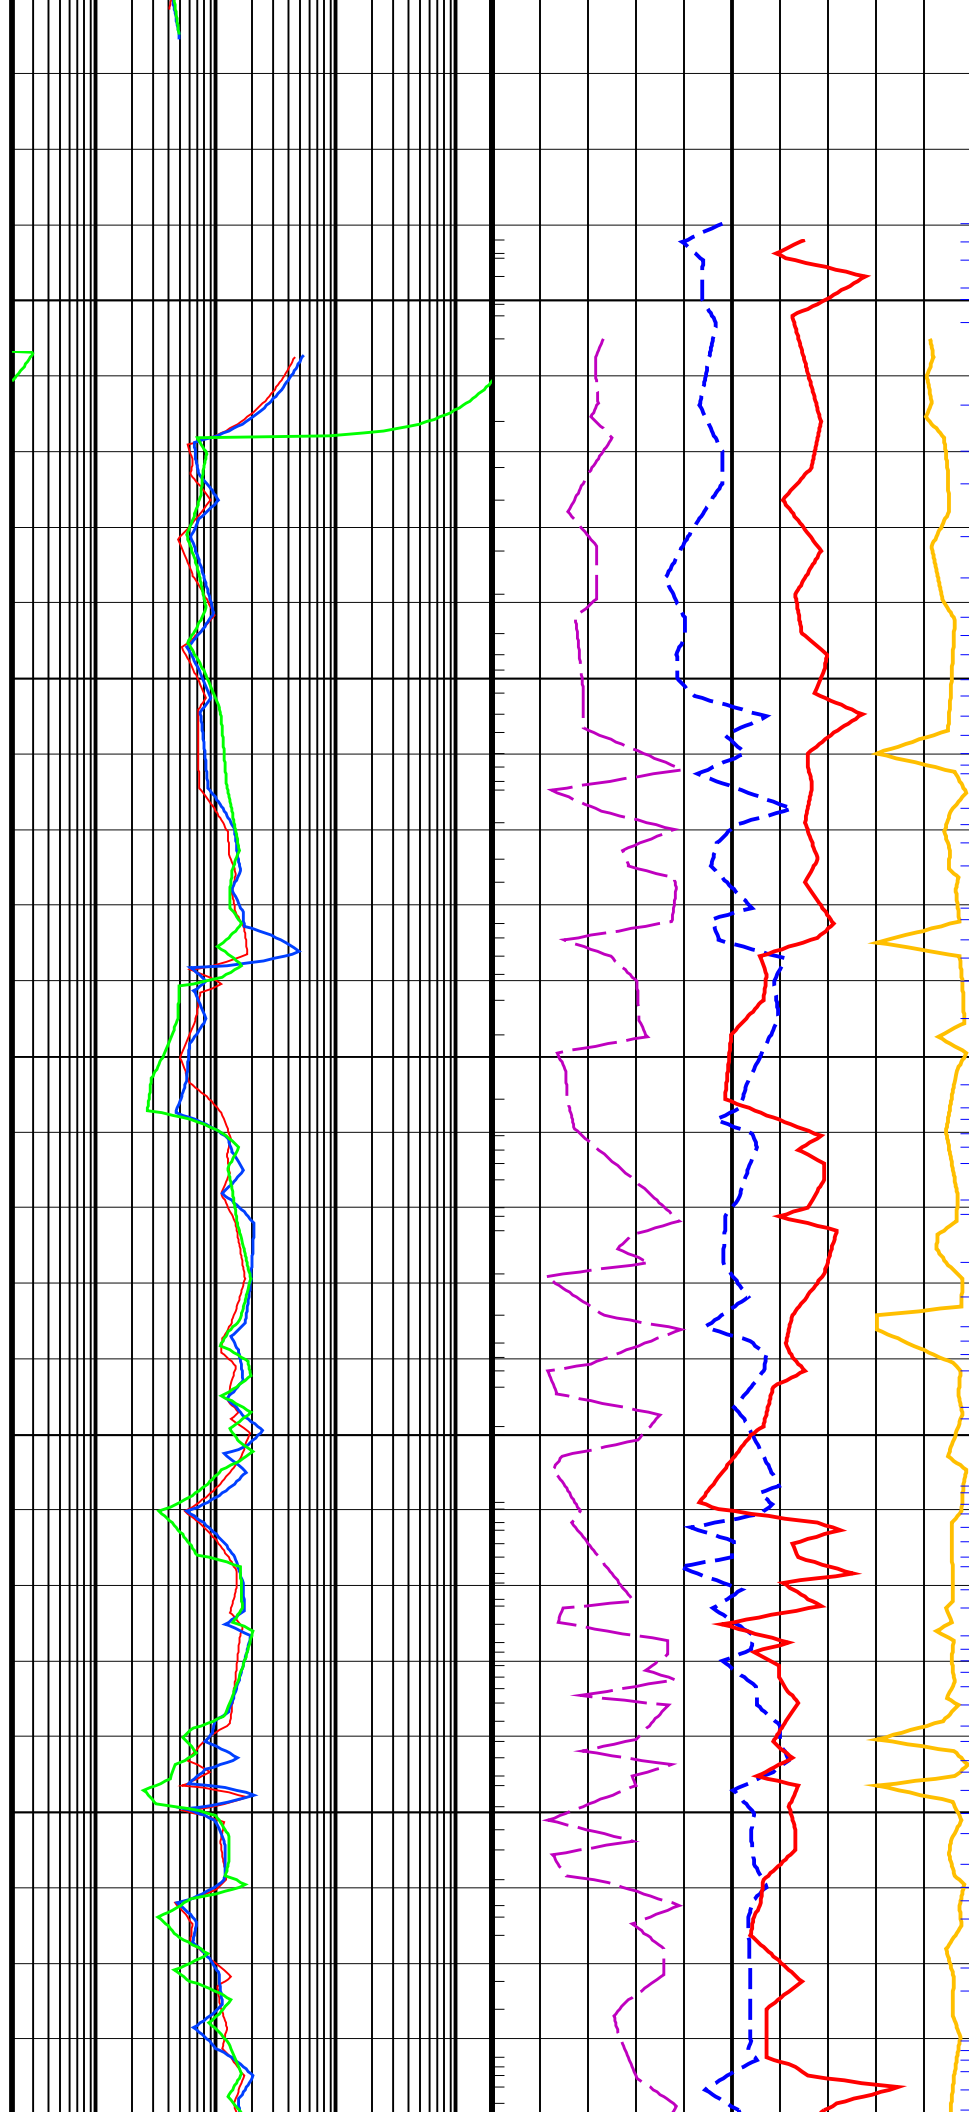
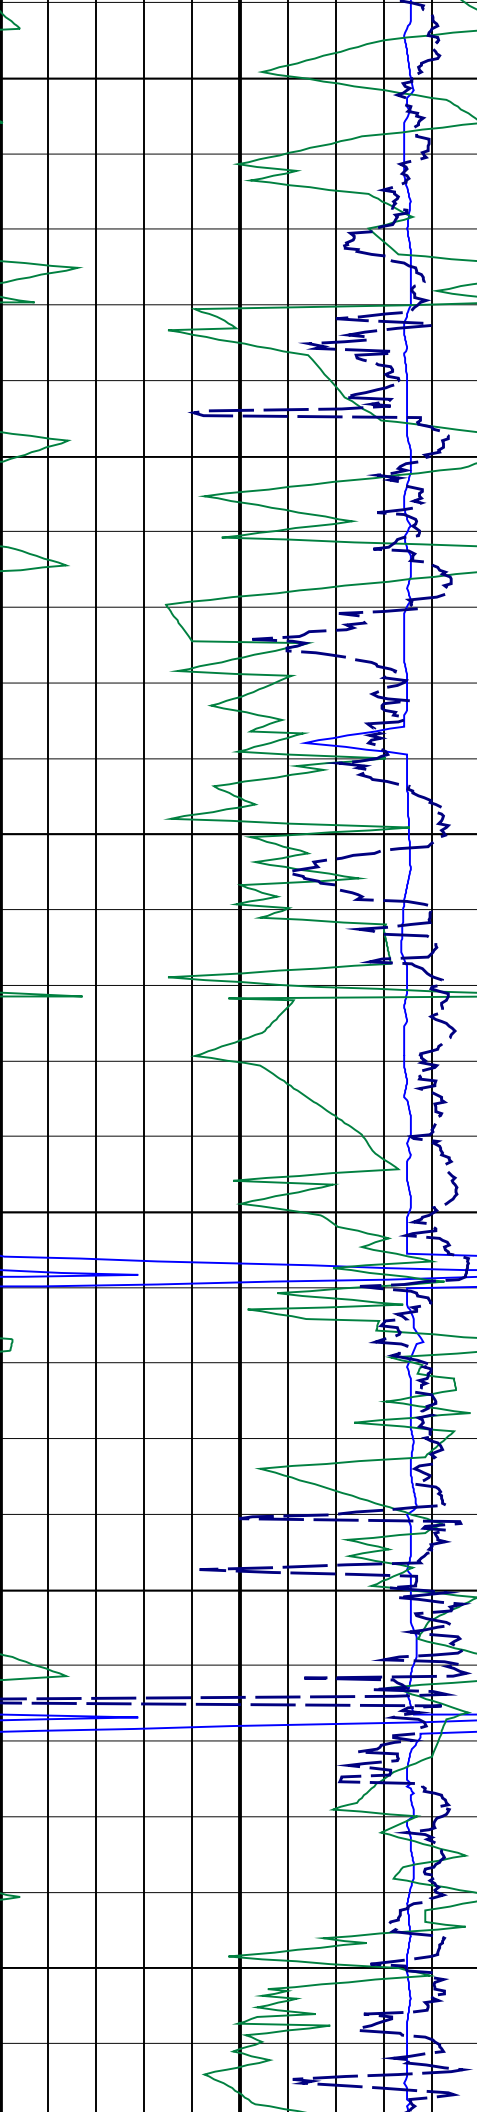
Missing data throughout run due to bad signal

| | | | Coherence at Compressional Peak, Real-Time (CHCO_RT) | | |
| RAB Gamma Ray, Real-Time (GR_RAB_RT) | | | Bulk Density, Bottom, Real-Time Computed Downhole (ROBB_DH_RT) | | |
| Average Borehole Diameter, Real-Time (ADIA_ADN_RT) | | | Thermal Neutron Porosity, Real-Time (TNPH_ADN_RT) | | |
| ROP*5 (ROP5) | | | Delta-T Compressional, Real-Time (DTCO_RT) | | |
| Shallow Button Resistivity, Real-Time (RES_BS_RT) | | | Ring Resistivity, Real-Time (RES_RING_RT) | | |
