PE906892

2-98 Anemone 1A

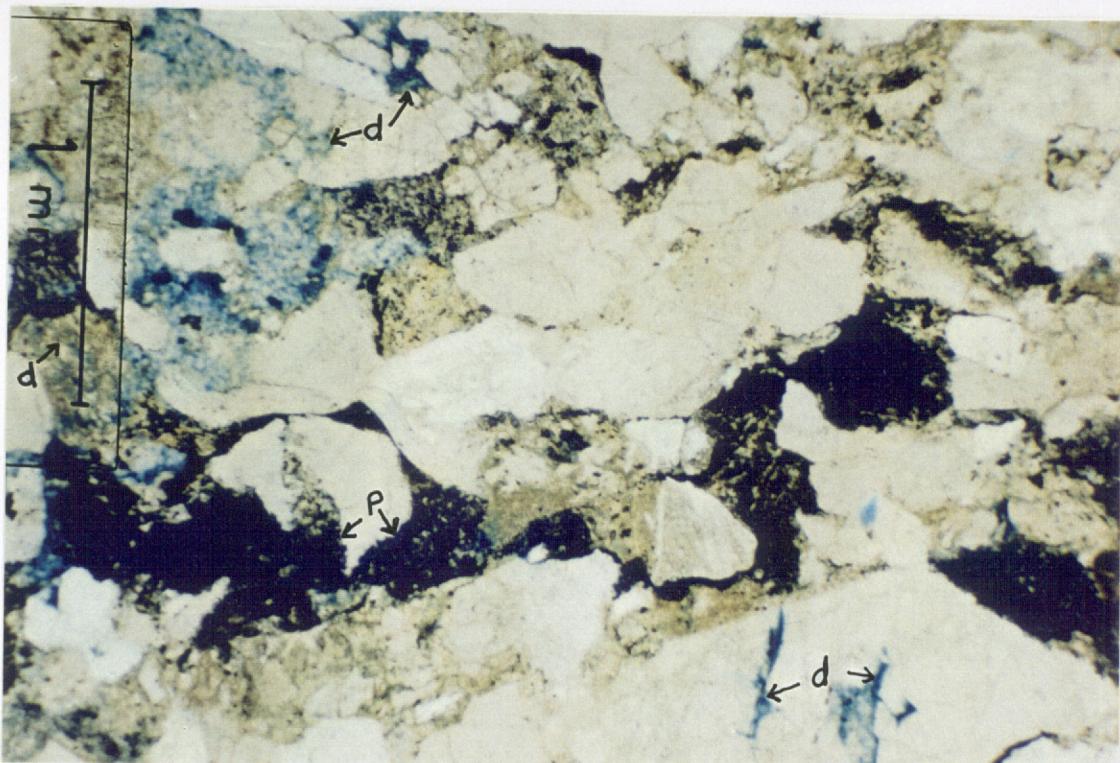
Figure 40 - Anemone #1A, junk sub sample, 4676d m. Thin section micrograph in plane polarized light showing high porosity which is partly dissolution porosity (d) but largely an artifact of slide preparation. Pyrite crystals occur in aggregates (P).
