2-98 Anemone 1A

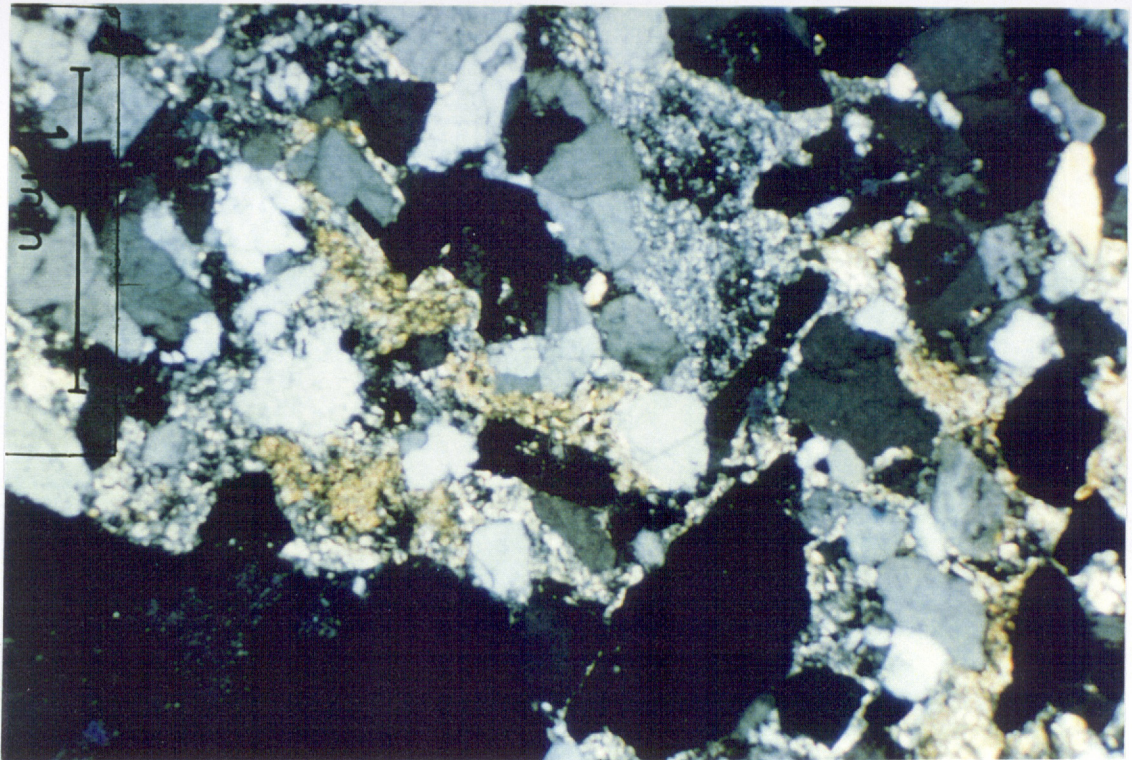
Figure 55 - Anemone #1A, junk sub sample, 4676e m.  
Microporosity is seen to be associated with a sericitized grain.  
Patches of spar scalenohedra are highlighted under crossed  
polars.
