2-98 Anemone 1A

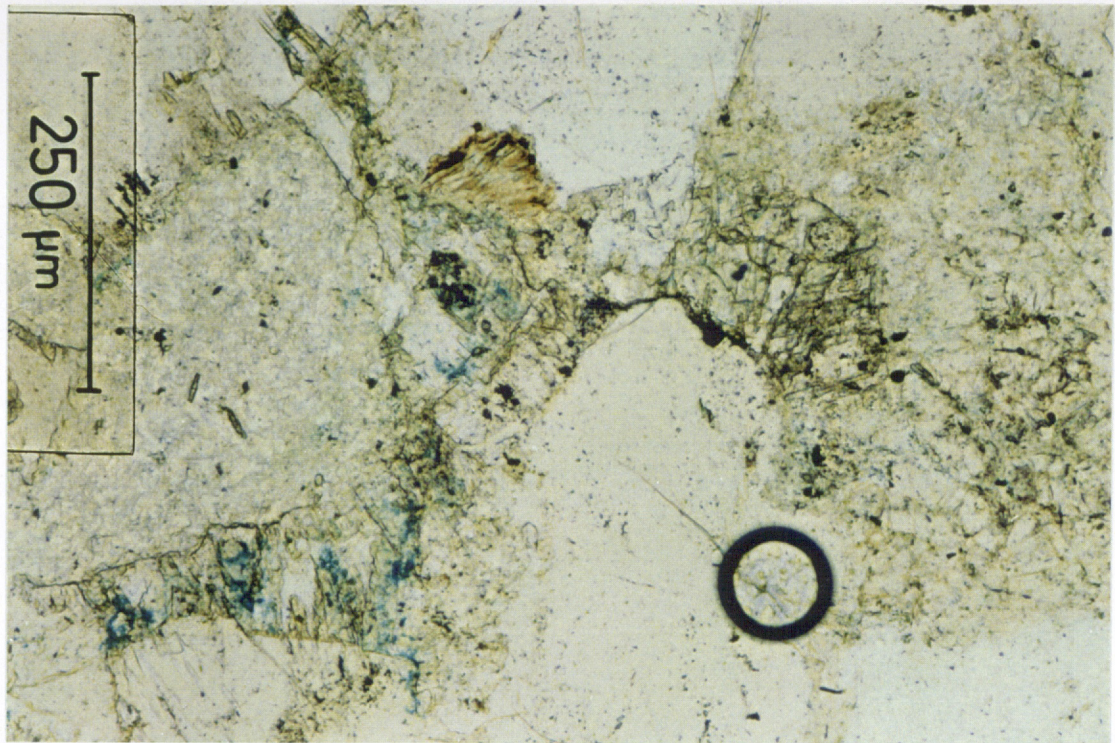
Figure 56 - Anemone #1A, junk sub sample, 4676e m. Extensive dissolution of feldspar grains has produced secondary porosity on the left of the field of view. Clay areas on the right have flecks of microporosity associated. Plane polarized light.
