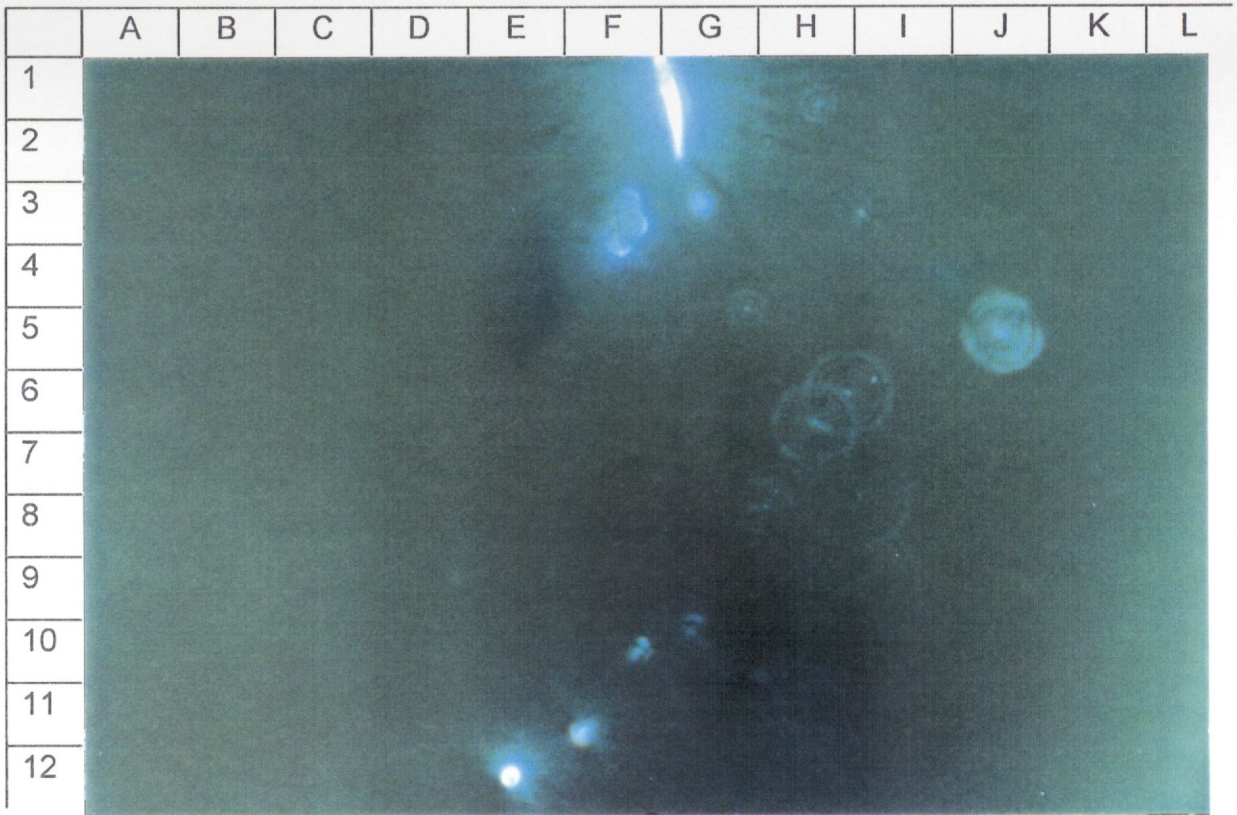
Figure 6A Blue fluorescing oil (F:1), gas + oil (F:3) and oil + water (E:12) inclusions on fractures in detrital quartz. Veilfin-1, 3370-75 m ctgs sample, dark field image under UV illumination (10 μm = 7.1 mm).

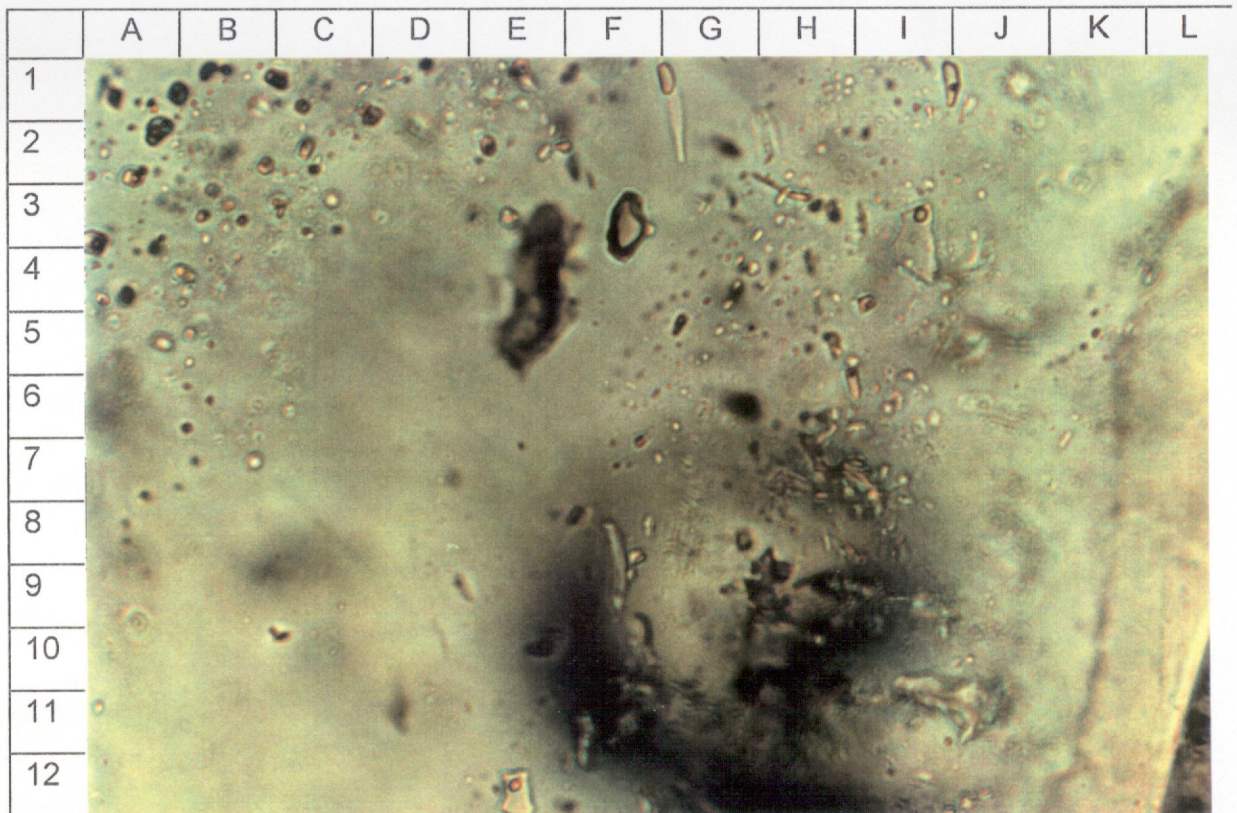
Figure 6B Same subject as 6A taken in transmitted light. Note the low refractive index of the dark gas bubble in the inclusion at F:3. Inclusions containing mostly gas could either represent condensate or mixing of oil and gas.
