CRUSADER RESOURCES N.L.

VICTORIA
PEP 123

**STRINGY BARK PROSPECT
TIME STRUCTURE MAP
NEAR TOP
LATROBE GROUP**

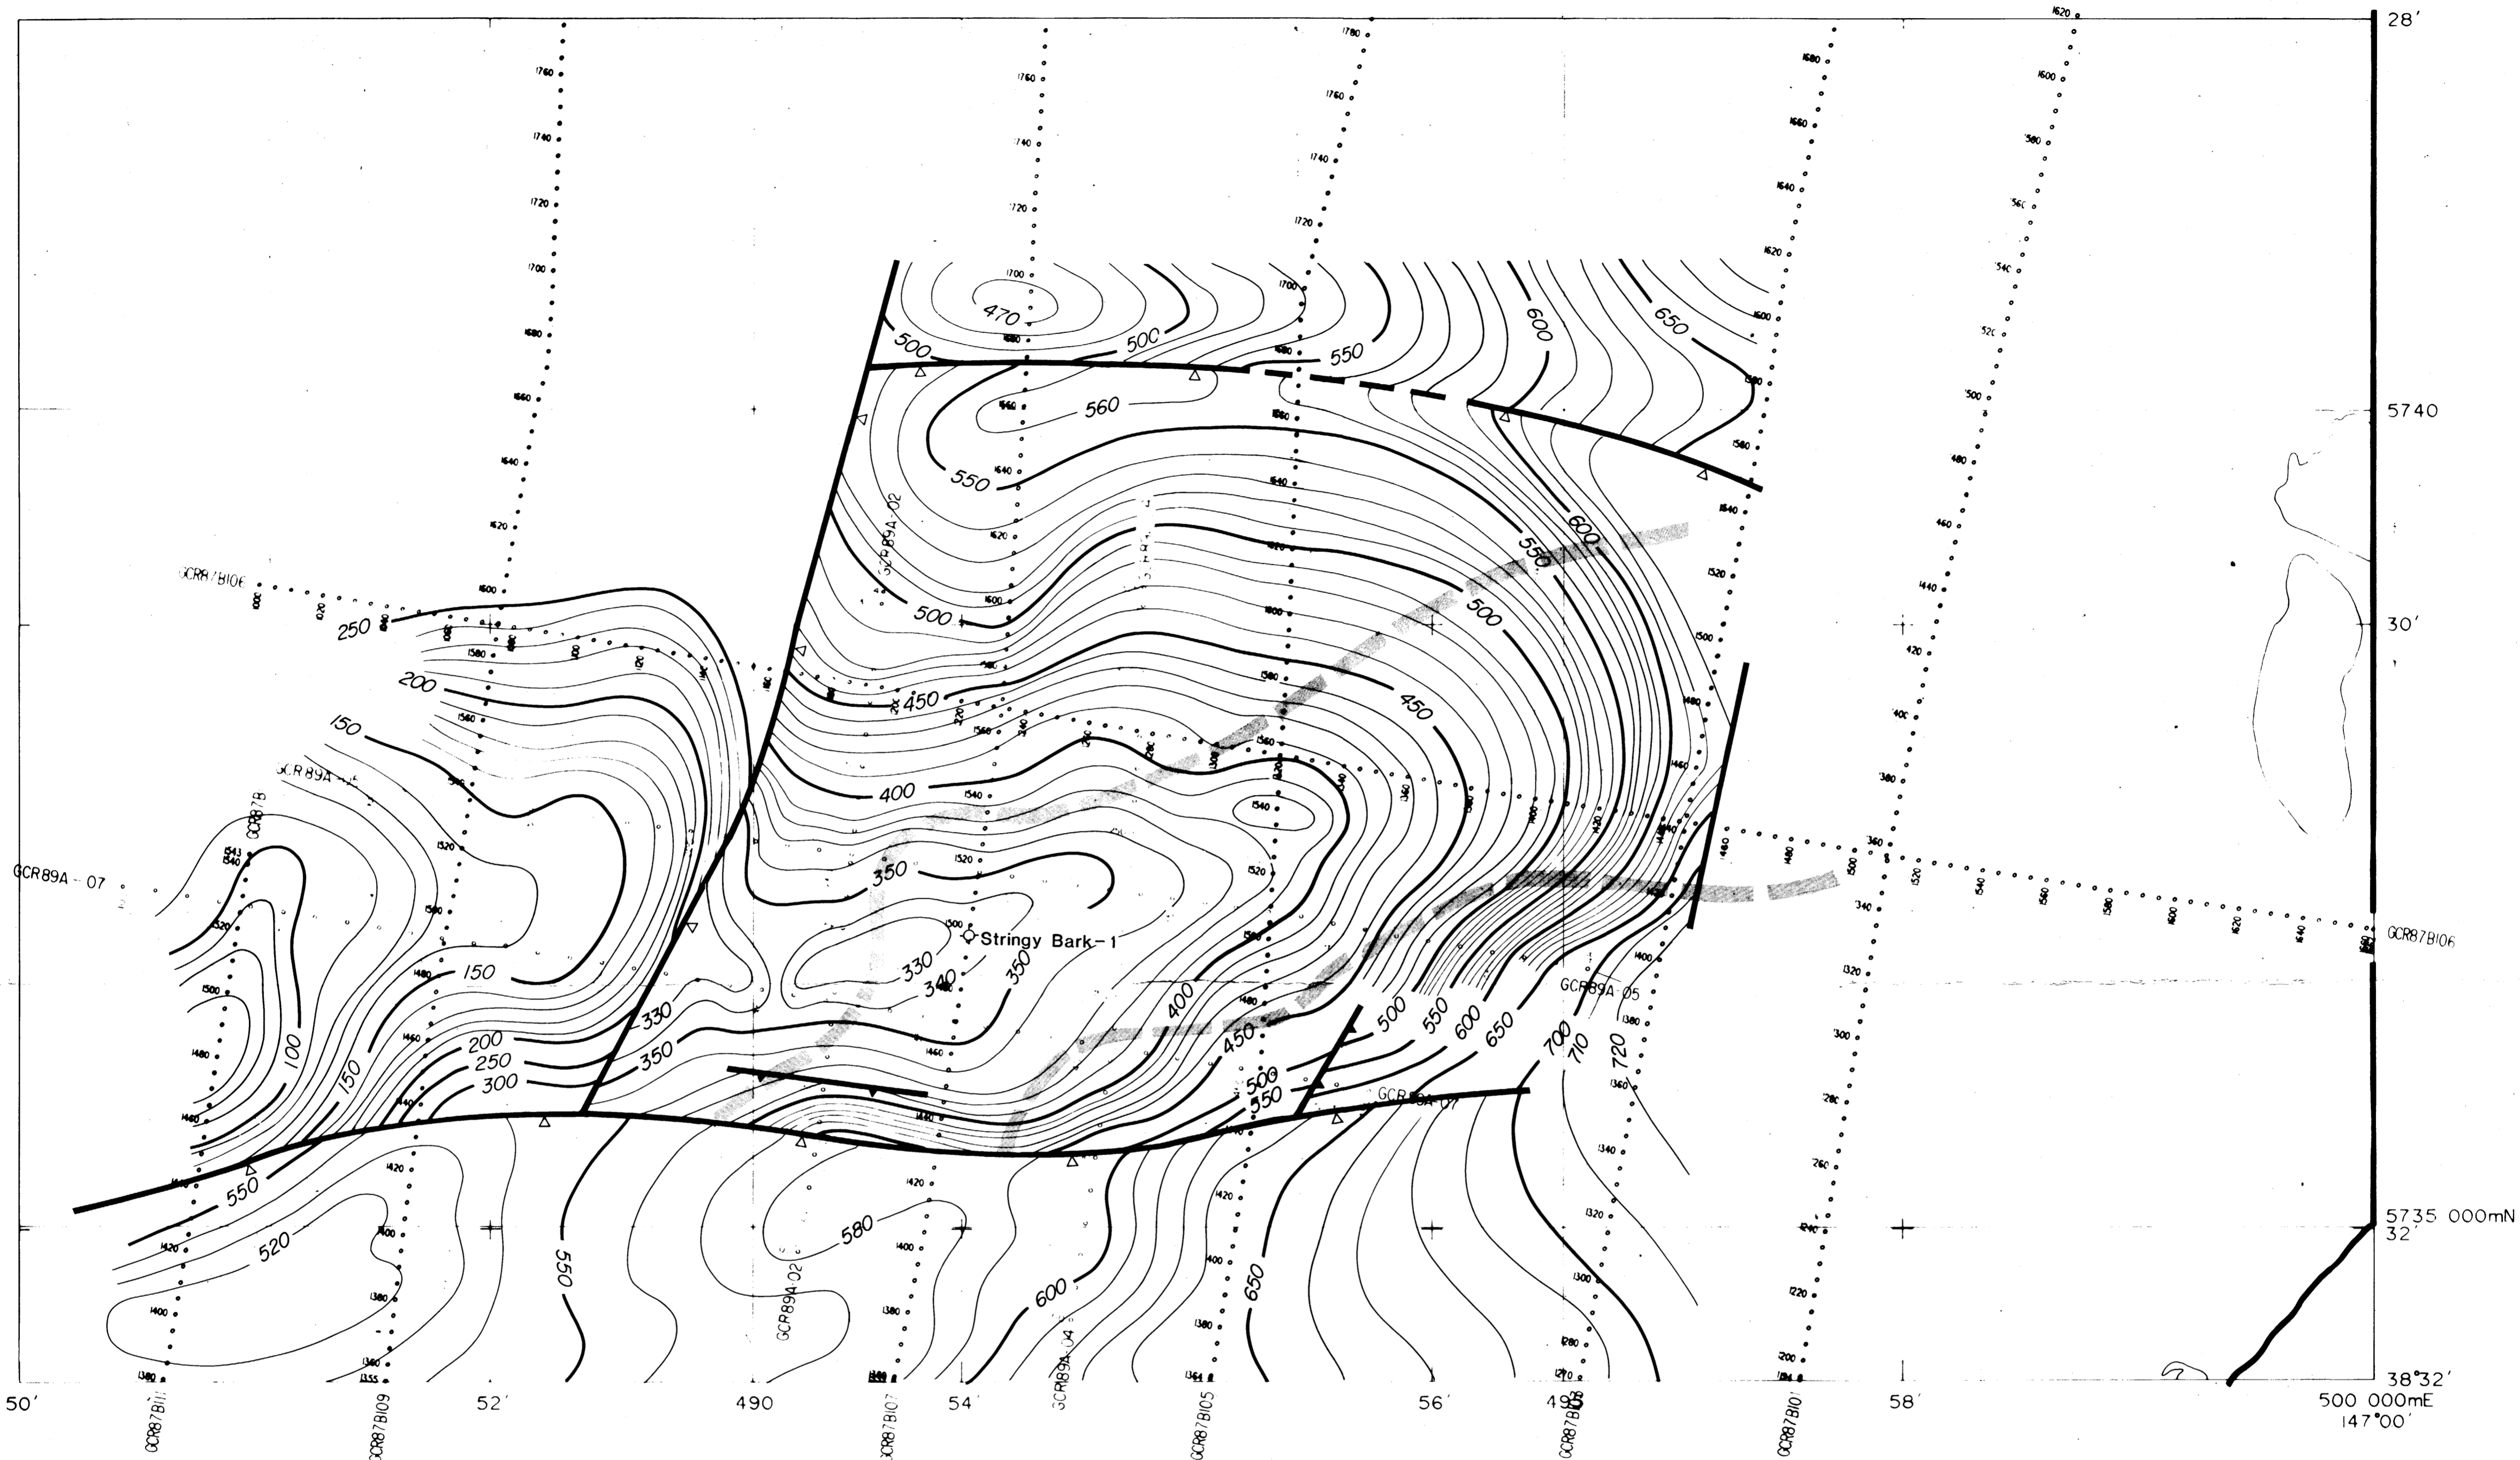
- Reverse Fault
- Normal Fault
- Minor Contour
- Major Contour
- Approx. edge of Top Latrobe 'Barrier Complex'

From WCR	BASE DRAWN :	BASE REVISED: June, 1989	SHEET	ENCLOSURE
	AUTHOR: P. Spraggon	DATE :	1	
CONTOUR INTERVAL : 10 ms TWT DATUM : MSL			DRAWING NO	
			C 2591/17
