2-98 Anemone 1A

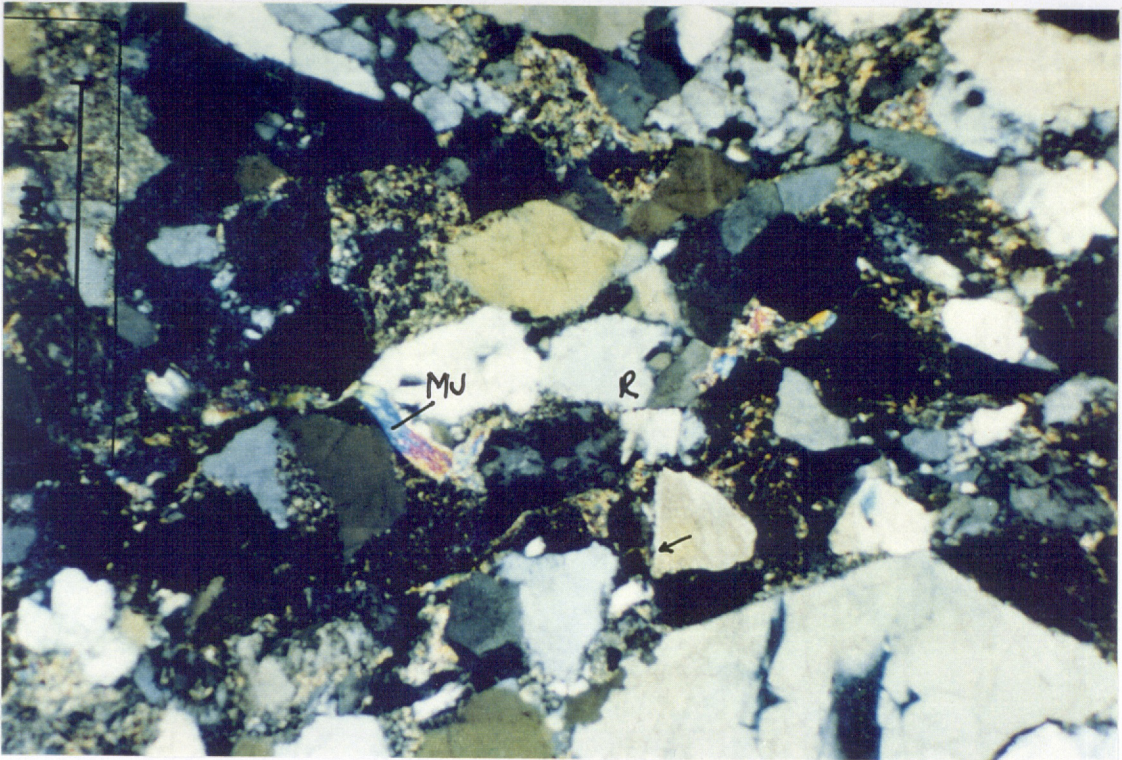
Figure 42 - Anemone #1A, junk sub sample, 4676d m. Under crossed polars, illite is seen scattered throughout the matrix. Muscovite (Mu) is bent by compaction and polycrystalline rock fragments are evident. An unaltered quartz overgrowth is arrowed.
