DEPT. NAT. RES & ENV
 PE904877

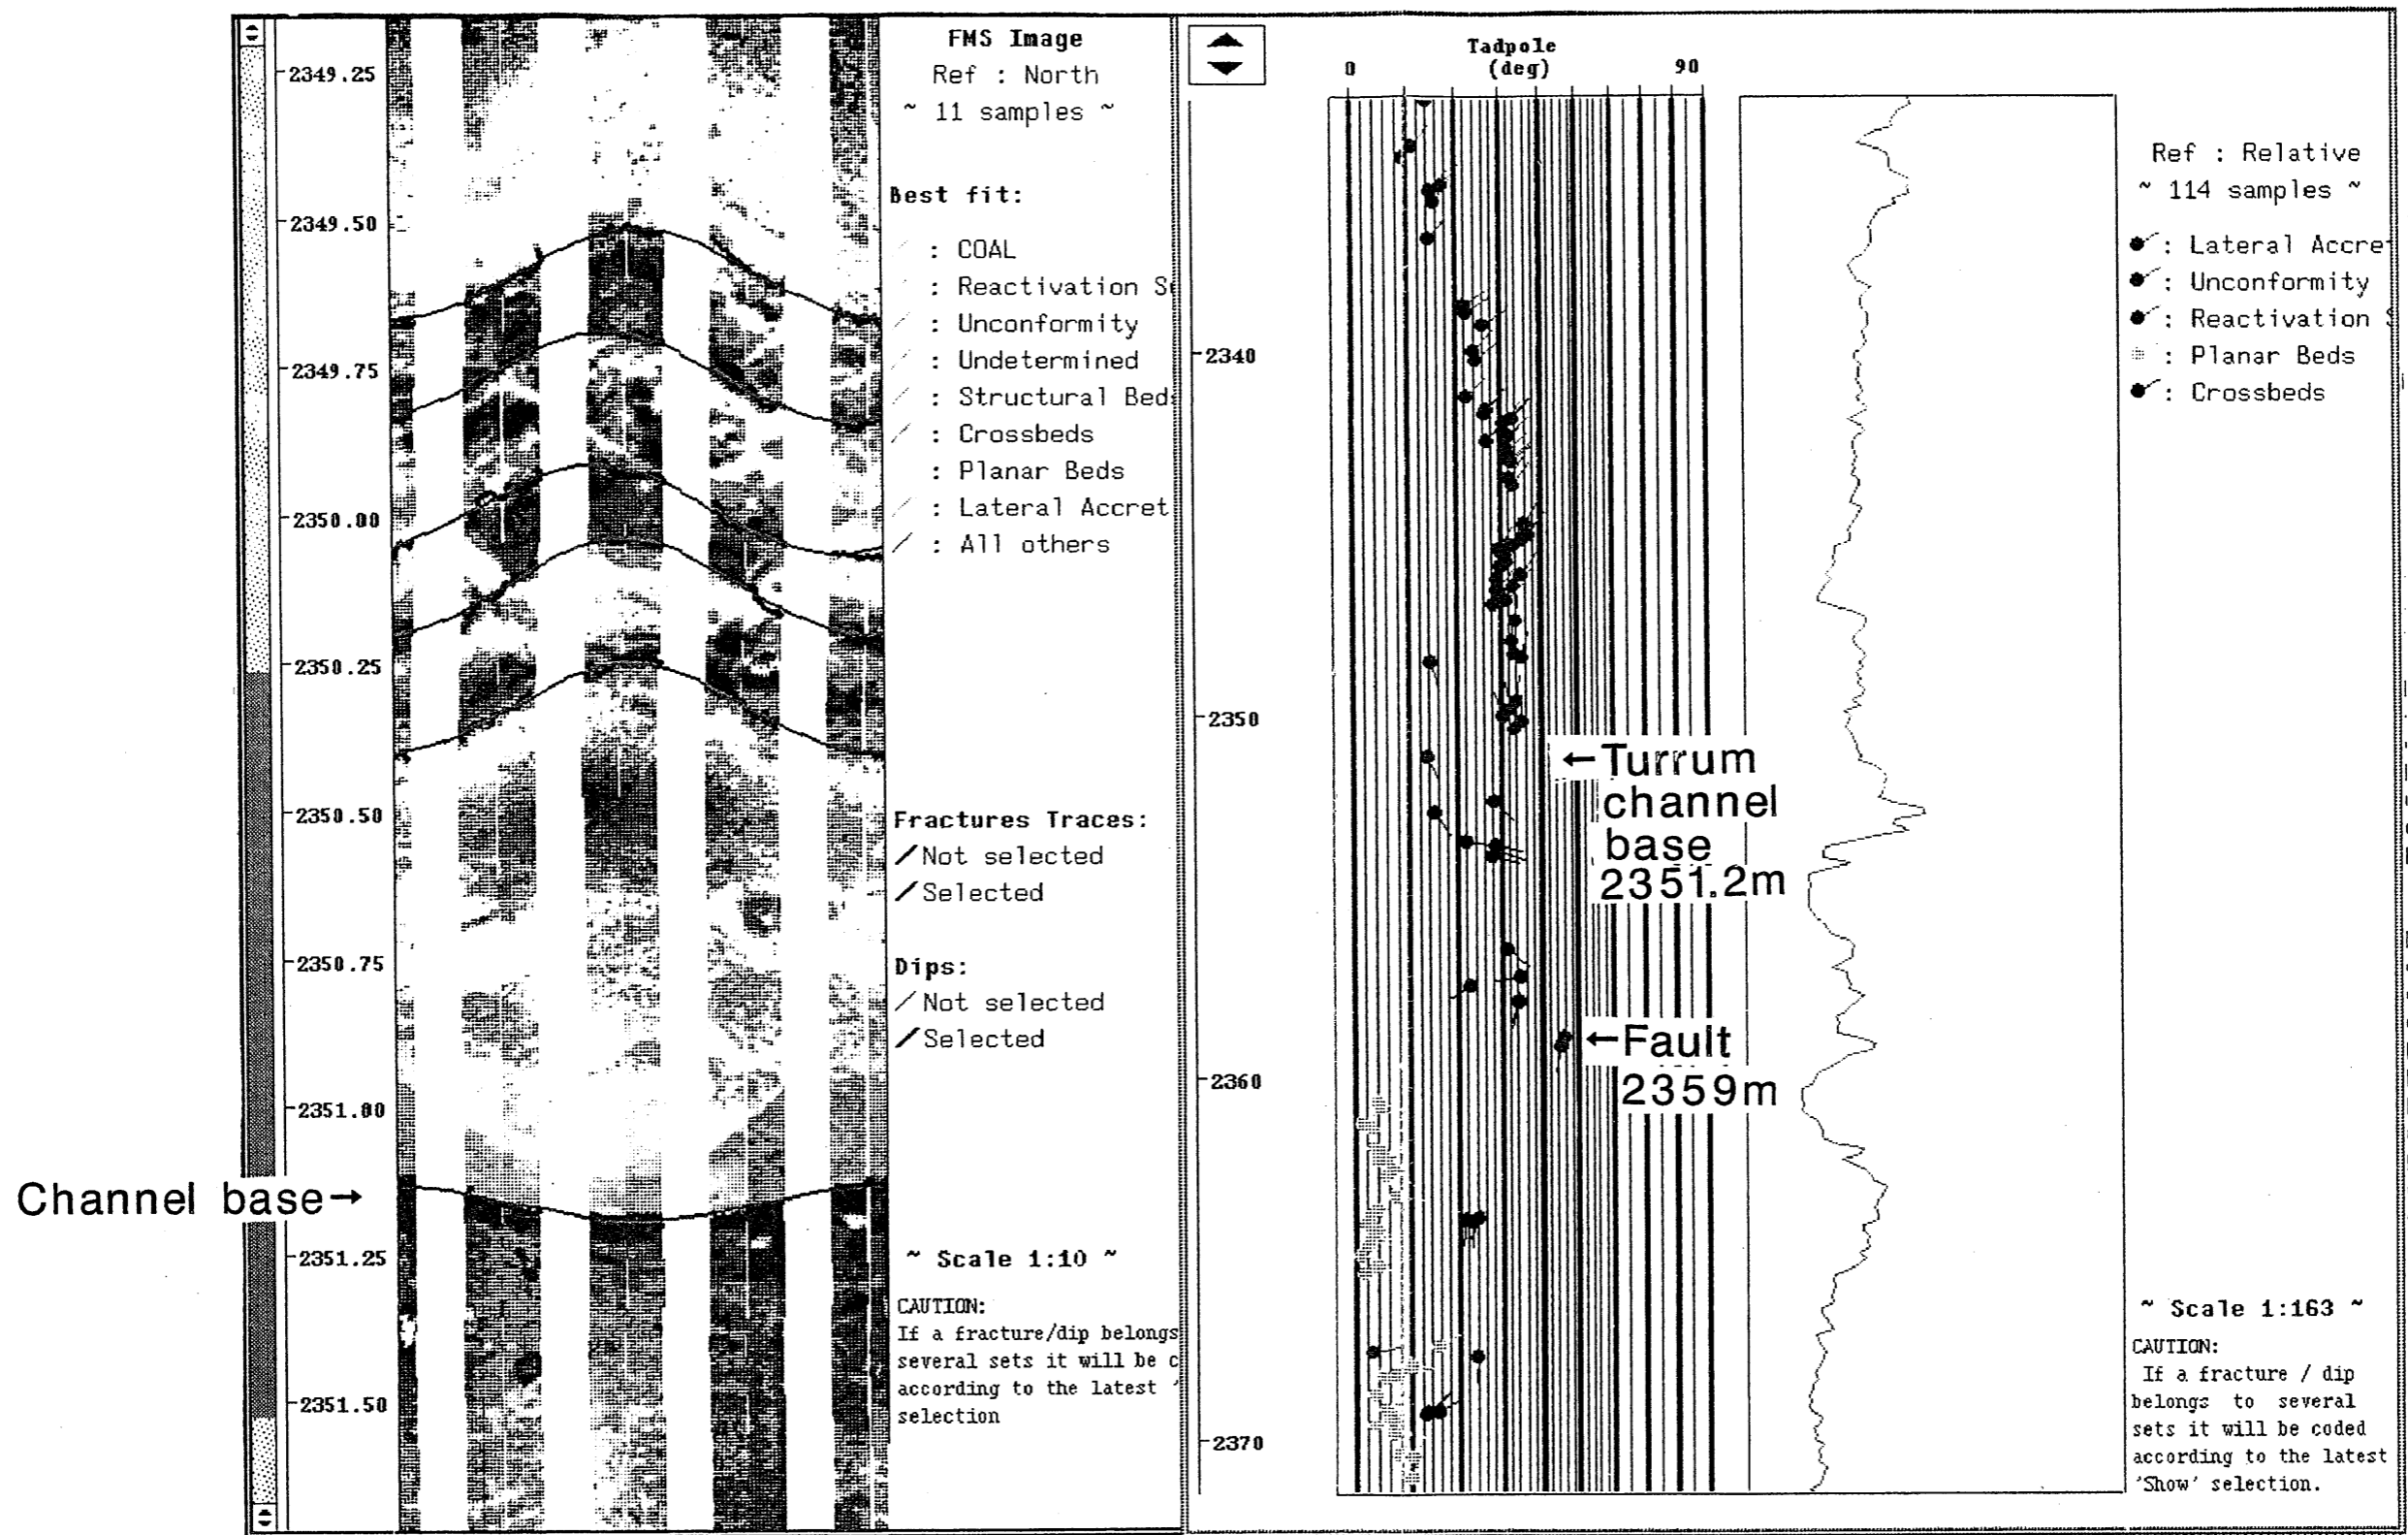
Figure 9 Erosional unconformity at base of Turrum channel (L.N. asperus) 2351.2m.
