DEPT. NAT. RES & ENV

PE904878

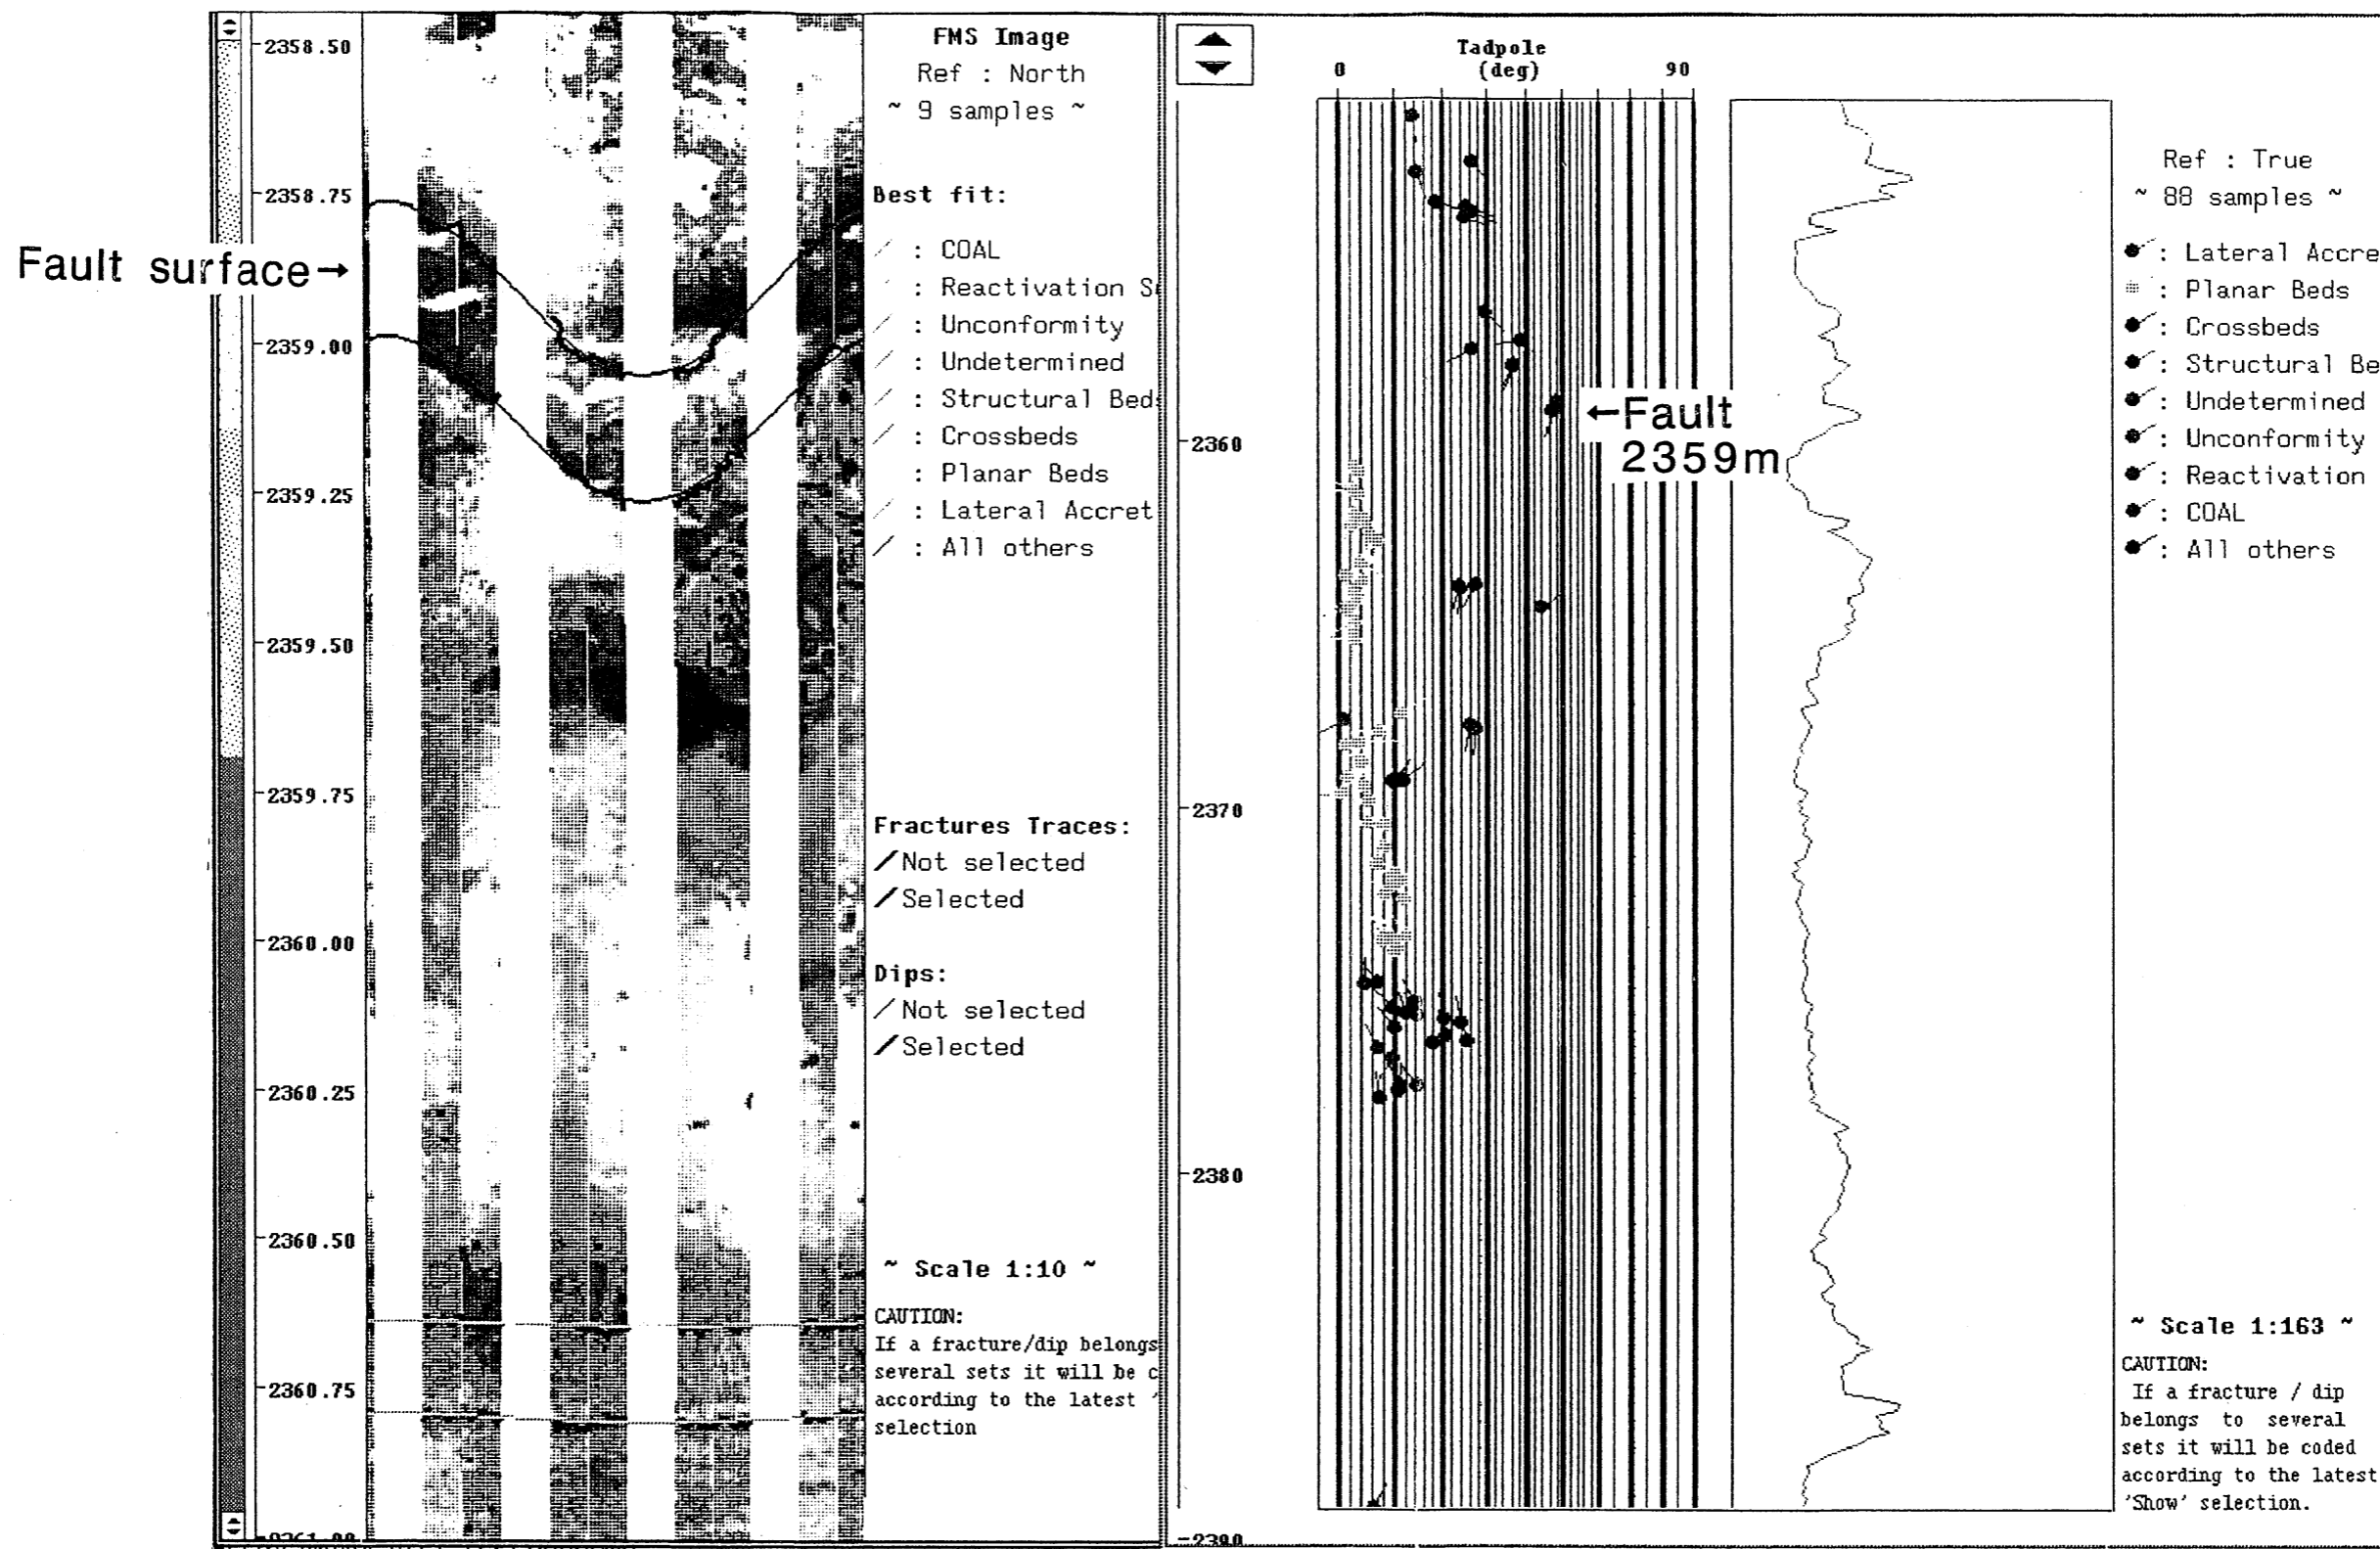
Figure 10 High angle fault surface within oil reservoir sequence, 2359m.
