DEPT. NAT. RES & ENV
PE906714

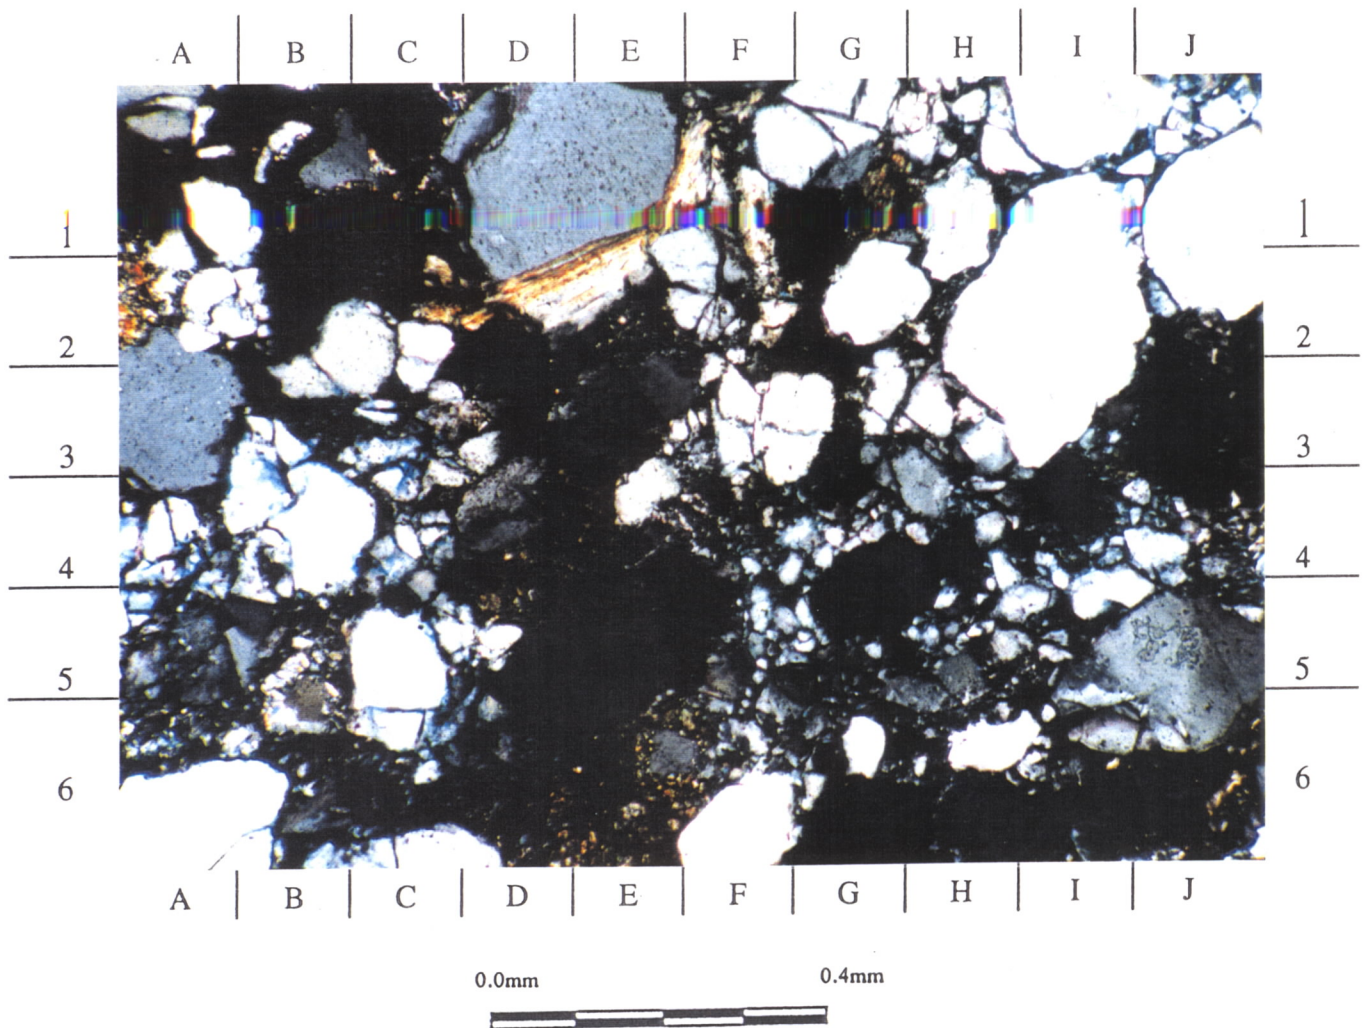
Figure 18. 1818.5m x75.6 XPL

The shattered and disaggregated nature of the sample is clearly evident. A muscovite lath at E2 can be seen to be expanding to fill pore space due to kaolinisation along its cleavage planes.
