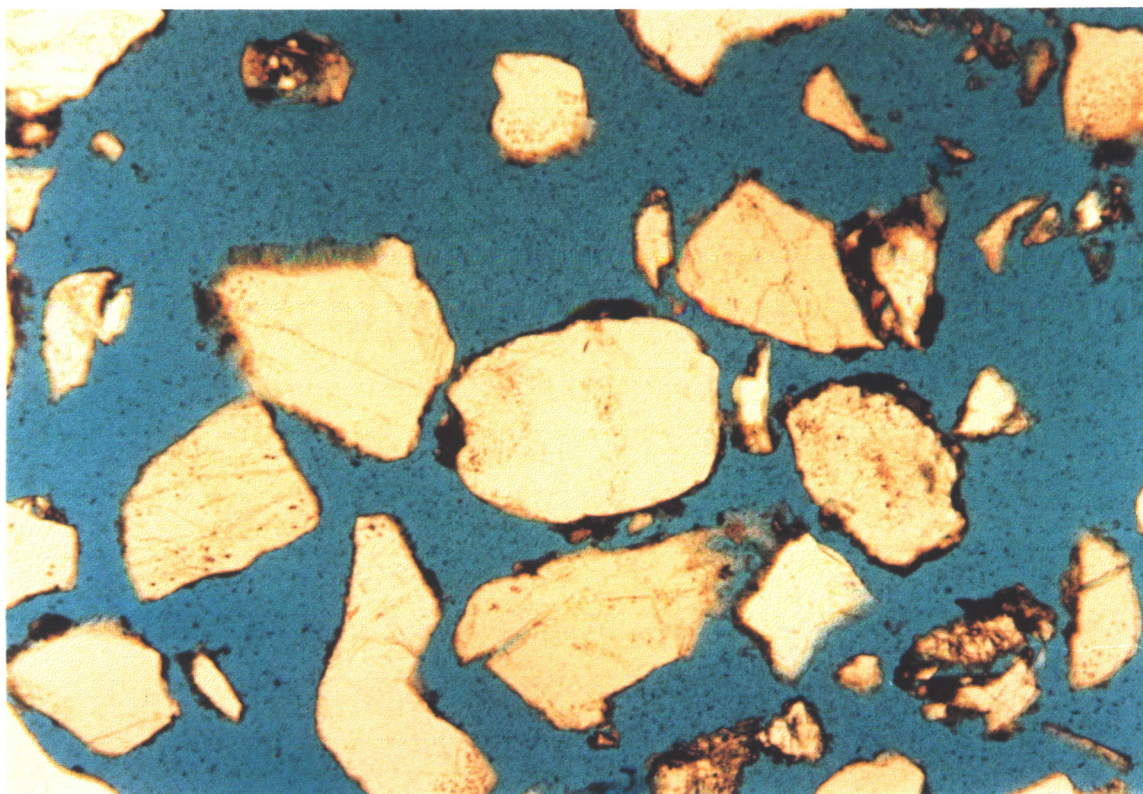
Figure 9a.

The disaggregated nature of this subarkose is clearly evident in this view. Note that dark drilling mud coats most grains. Very angular material may be fragments of grains broken during drilling. Mylor #1, sample 23, depth 1692.2m. Plane light. Field of view 2.6mm.

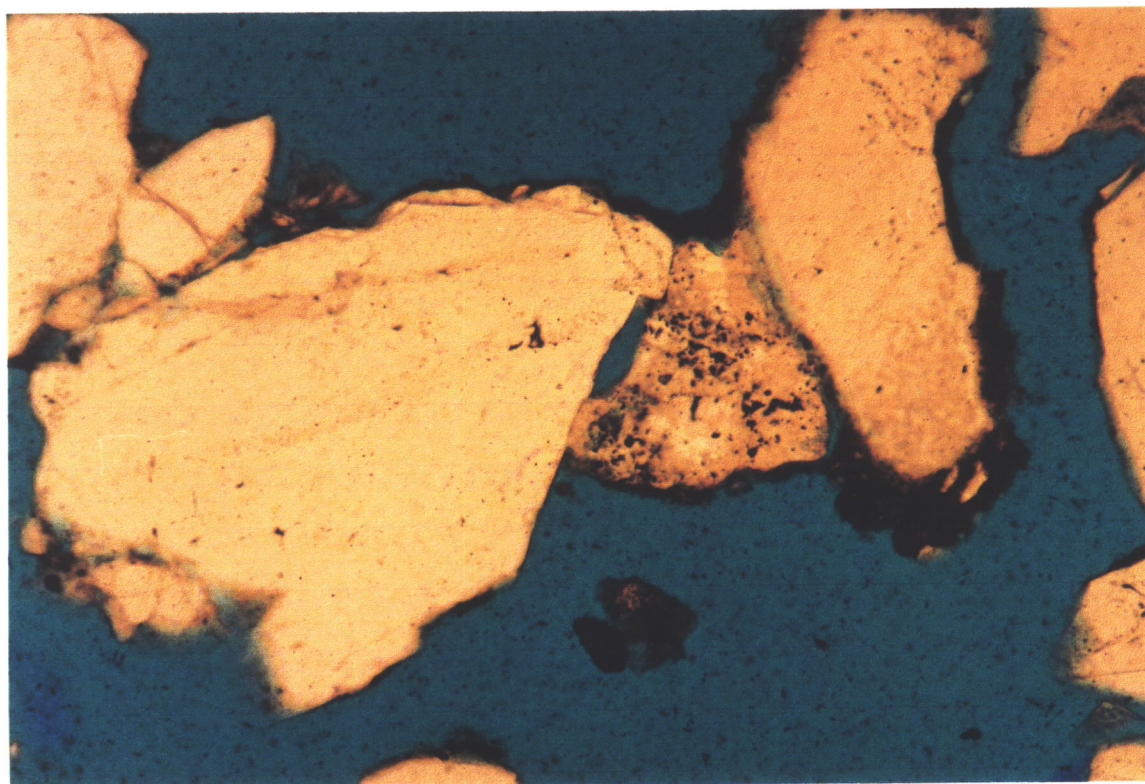
Figure 9b.

A rare portion of sample that retains cemented grains is apparent in this view. Note that grains are touching at minor points only. Mylor #1, sample 23, depth 1692.2m. Plane light. Field of view 1.0mm.
