PE907627

PLATE 1: 1746 m; SWC 23

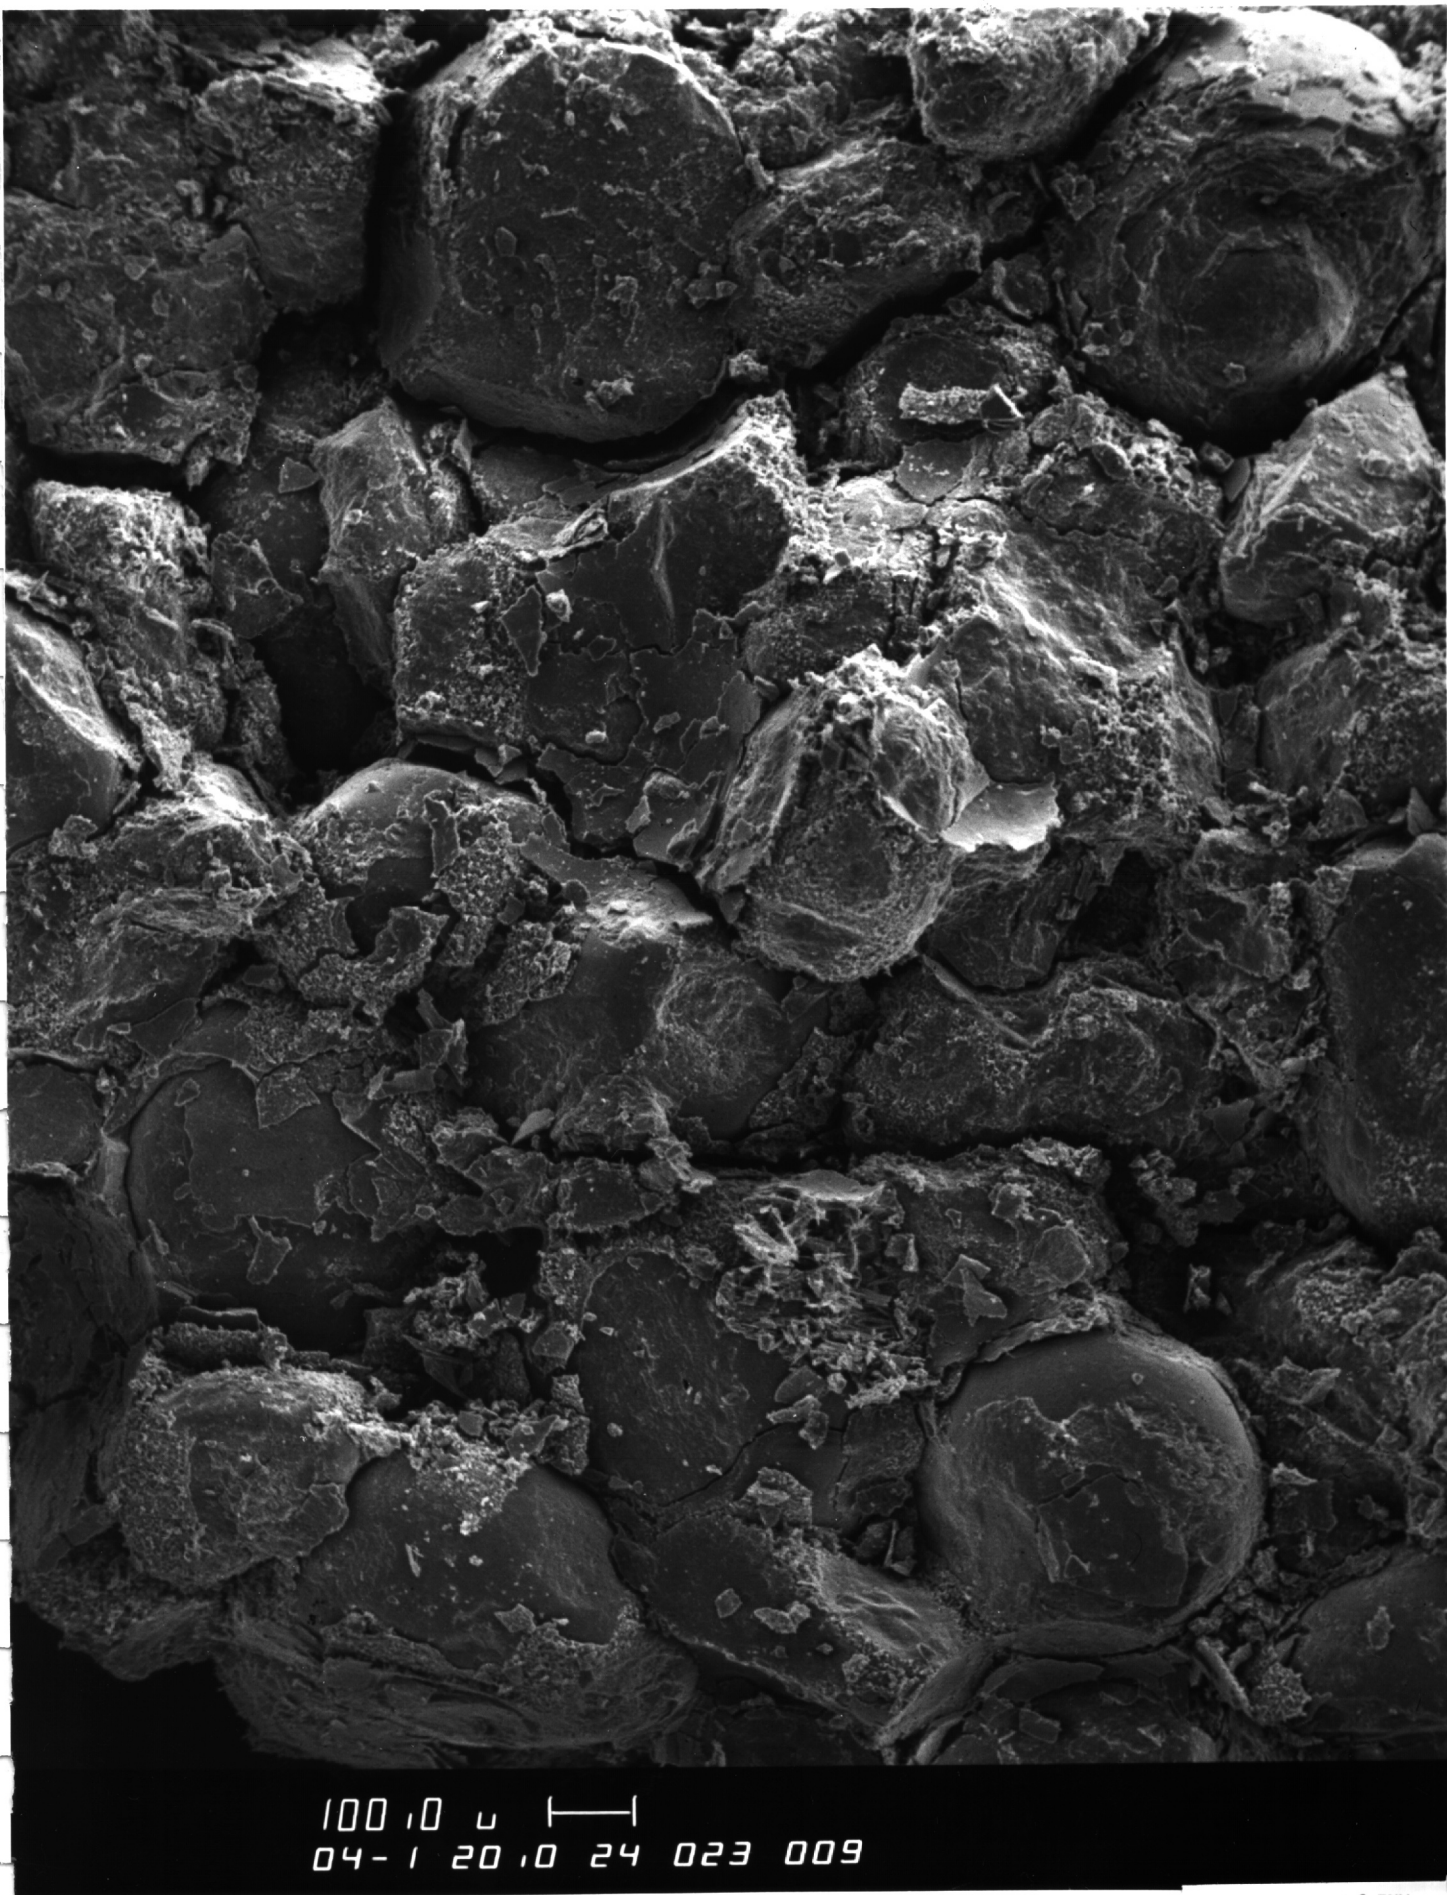
The rounded nodules in this sample are goethite. The apparent high porosity is due to fracturing of the sidewall core (probably during collection). Many of the nodules are coated with clay minerals.
