VIC/P25 (EAST)

**TOP OF LATROBE COARSE CLASTICS DEPTH (M.SS)**

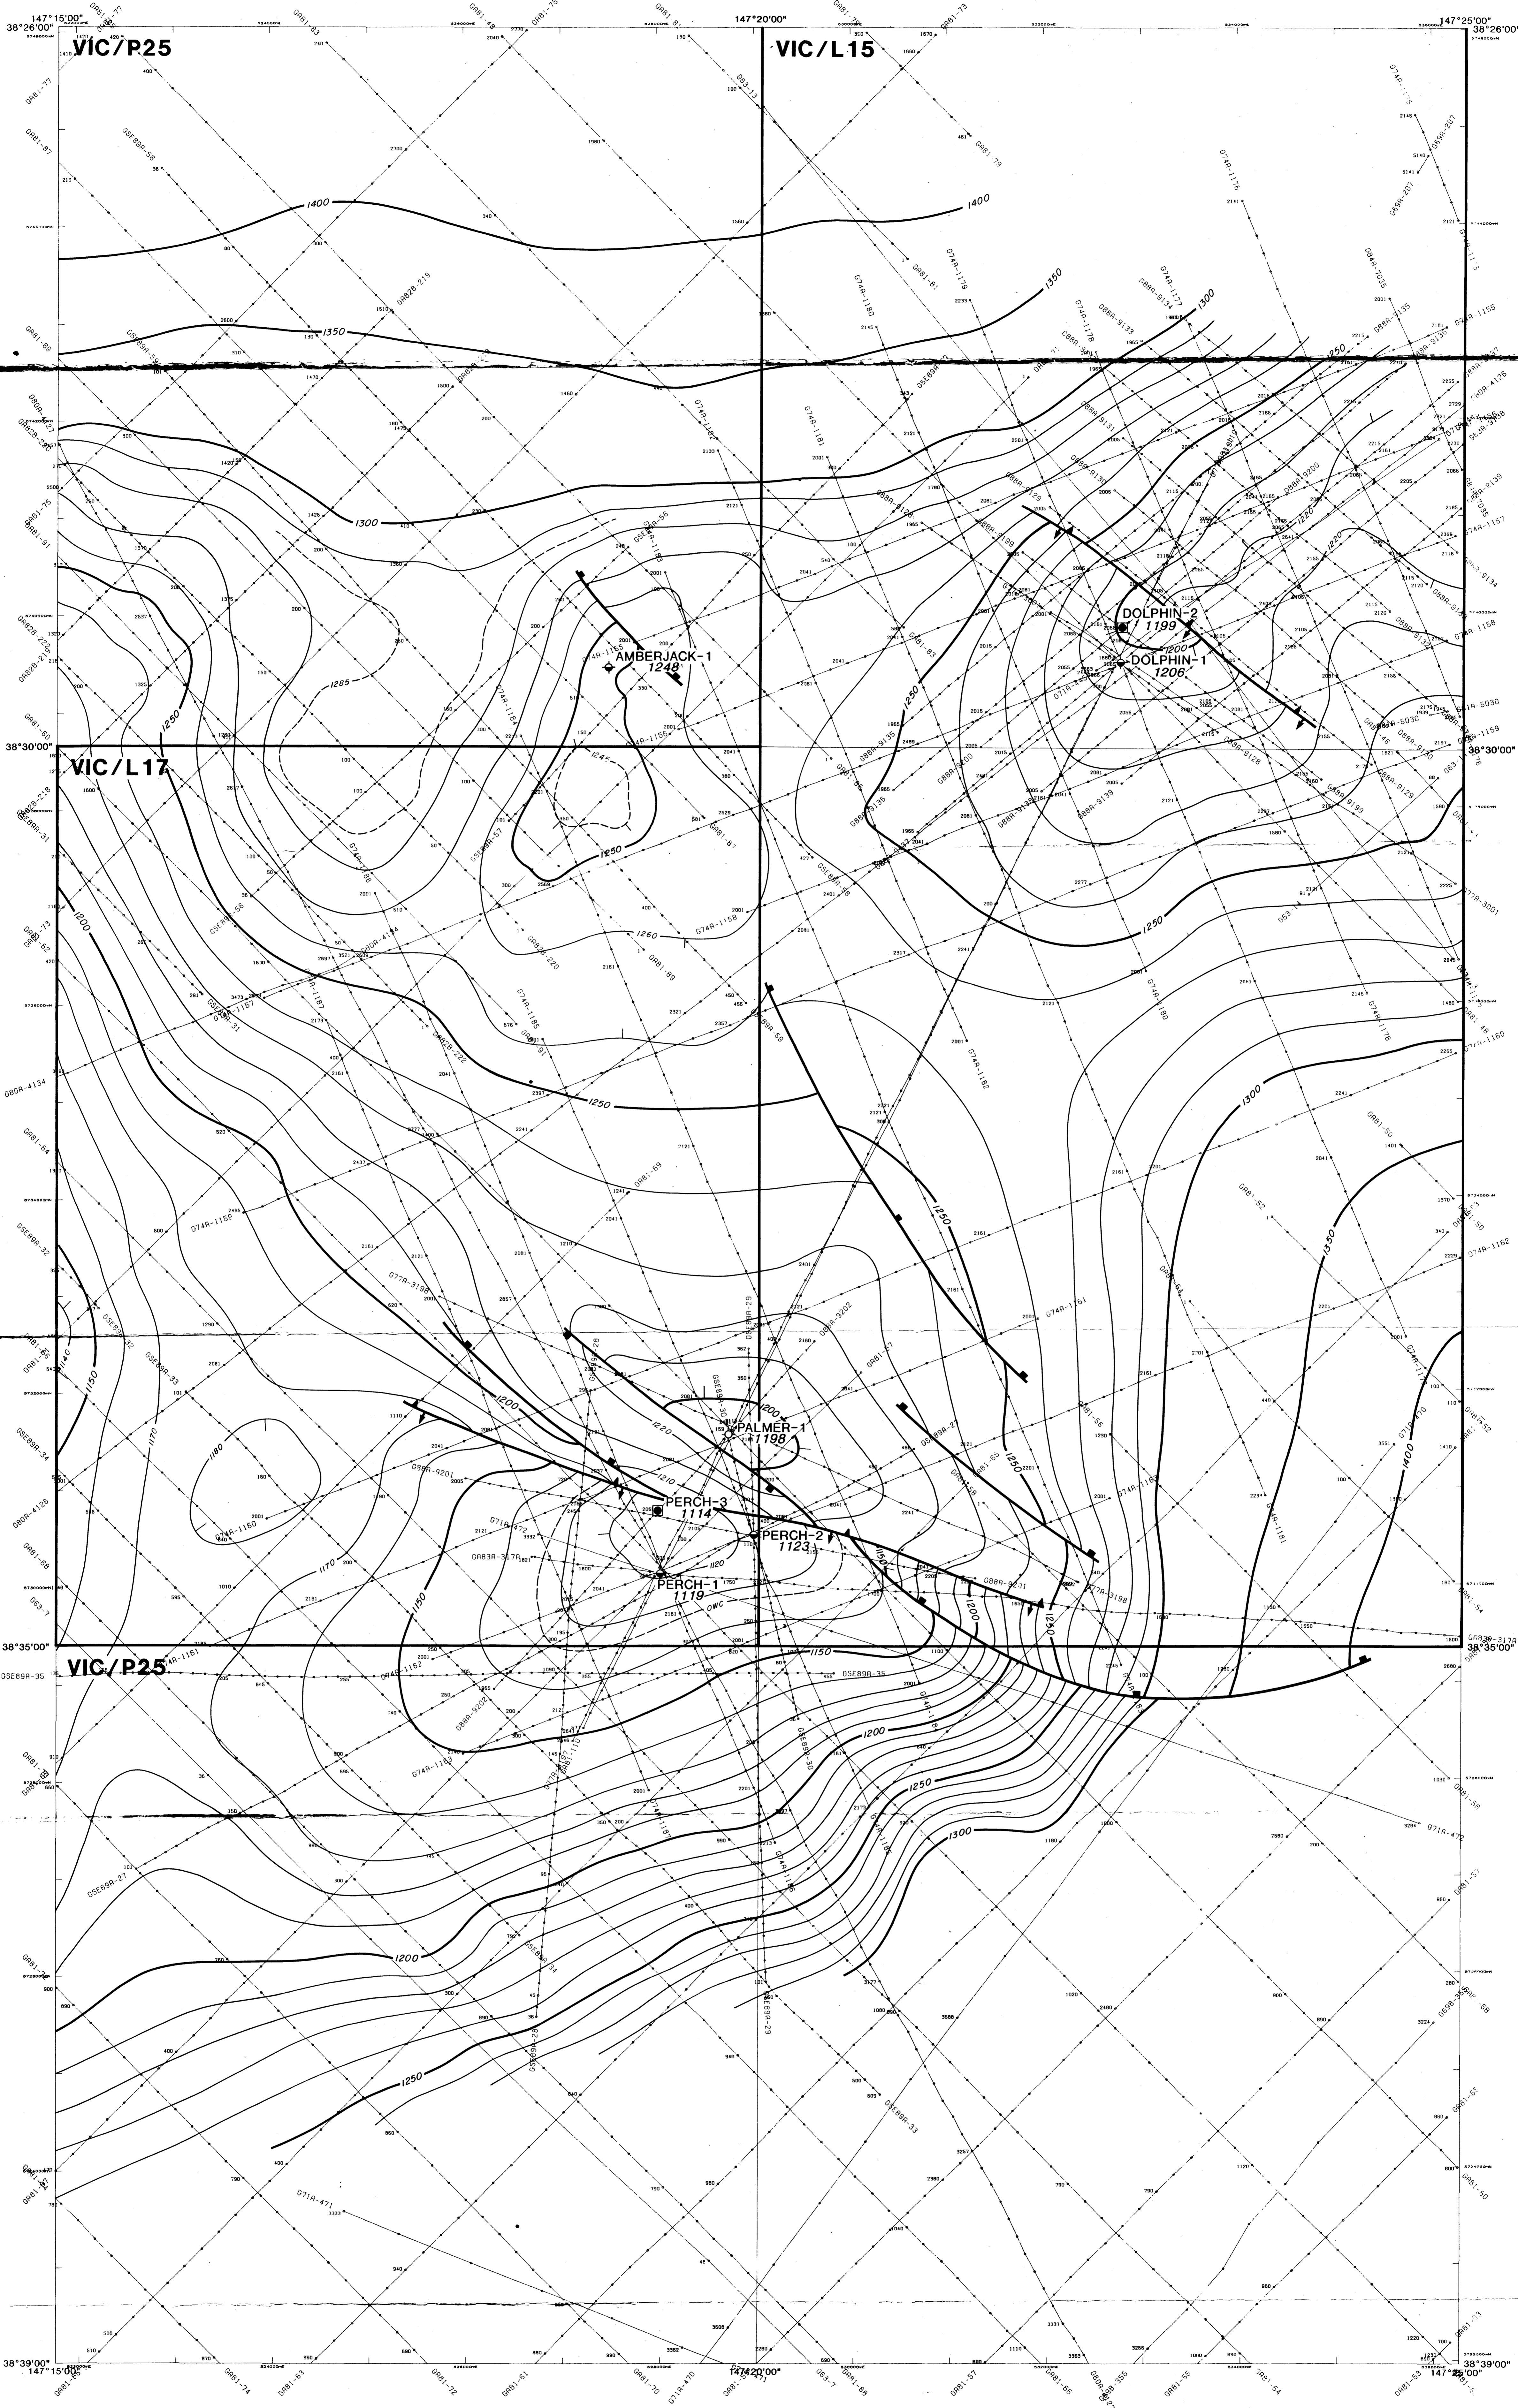
REVERSE FAULT (ARROW INDICATES DIRECTION OF FAULT PLANE DIP)

Contour interval: (5-) 10 (-50)m Datum: MSL  
 Author: T.Evans Drawn by: J.Cookson  
 Date: August 1990
