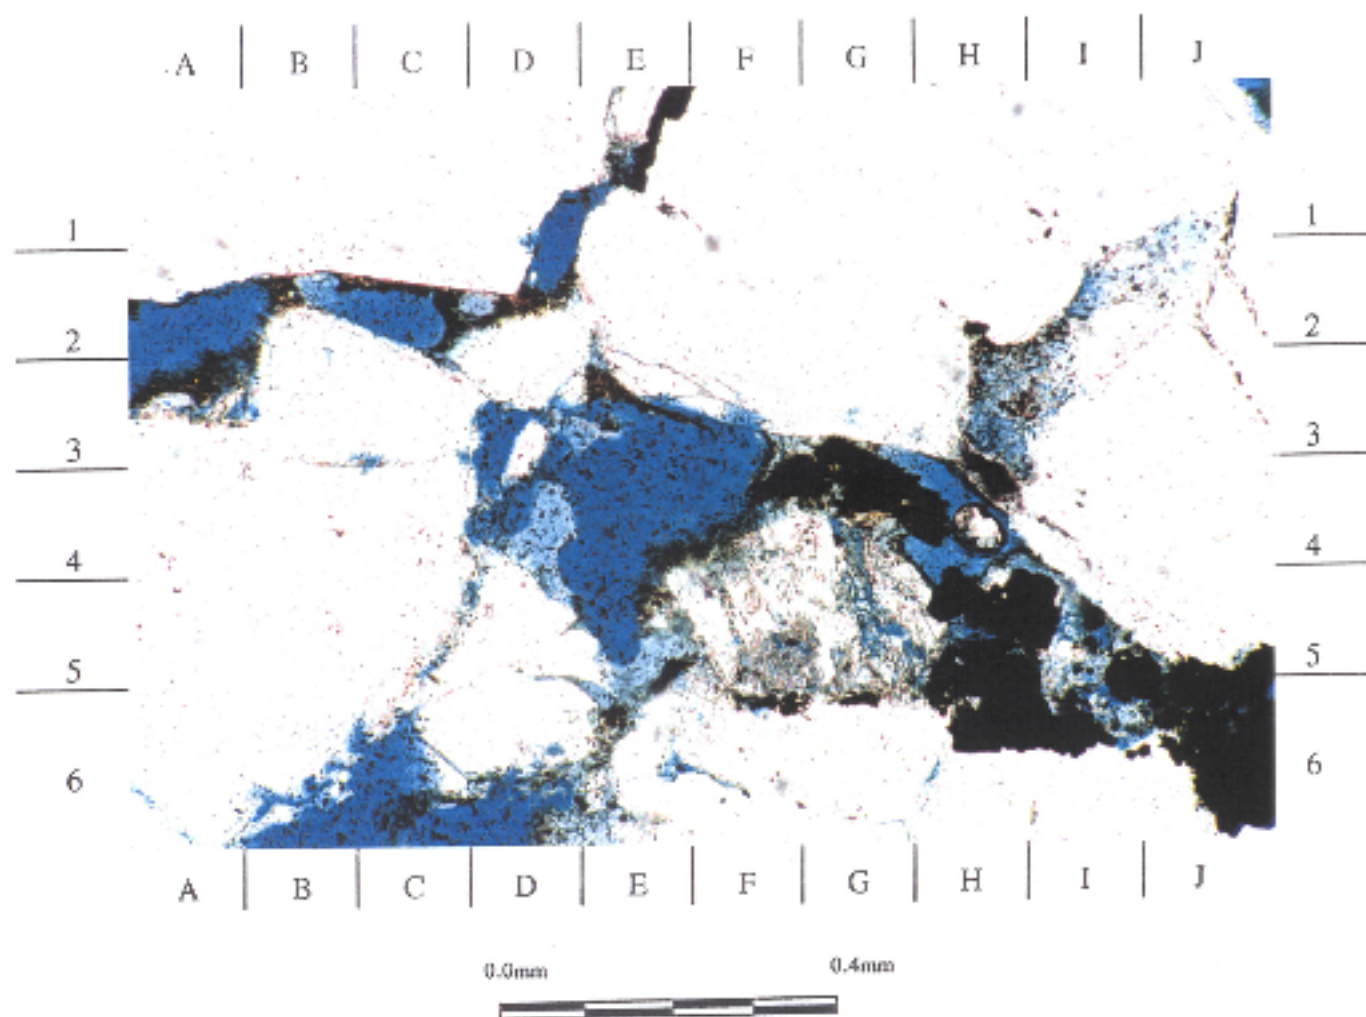
Figure 7. 1748.6m x75.6 PPL  
Massive quartz sandstone. Good primary intergranular porosity is evident (stained blue). A partially leached feldspar can be seen at G5. Authigenic pyrite is also evident at H5.
