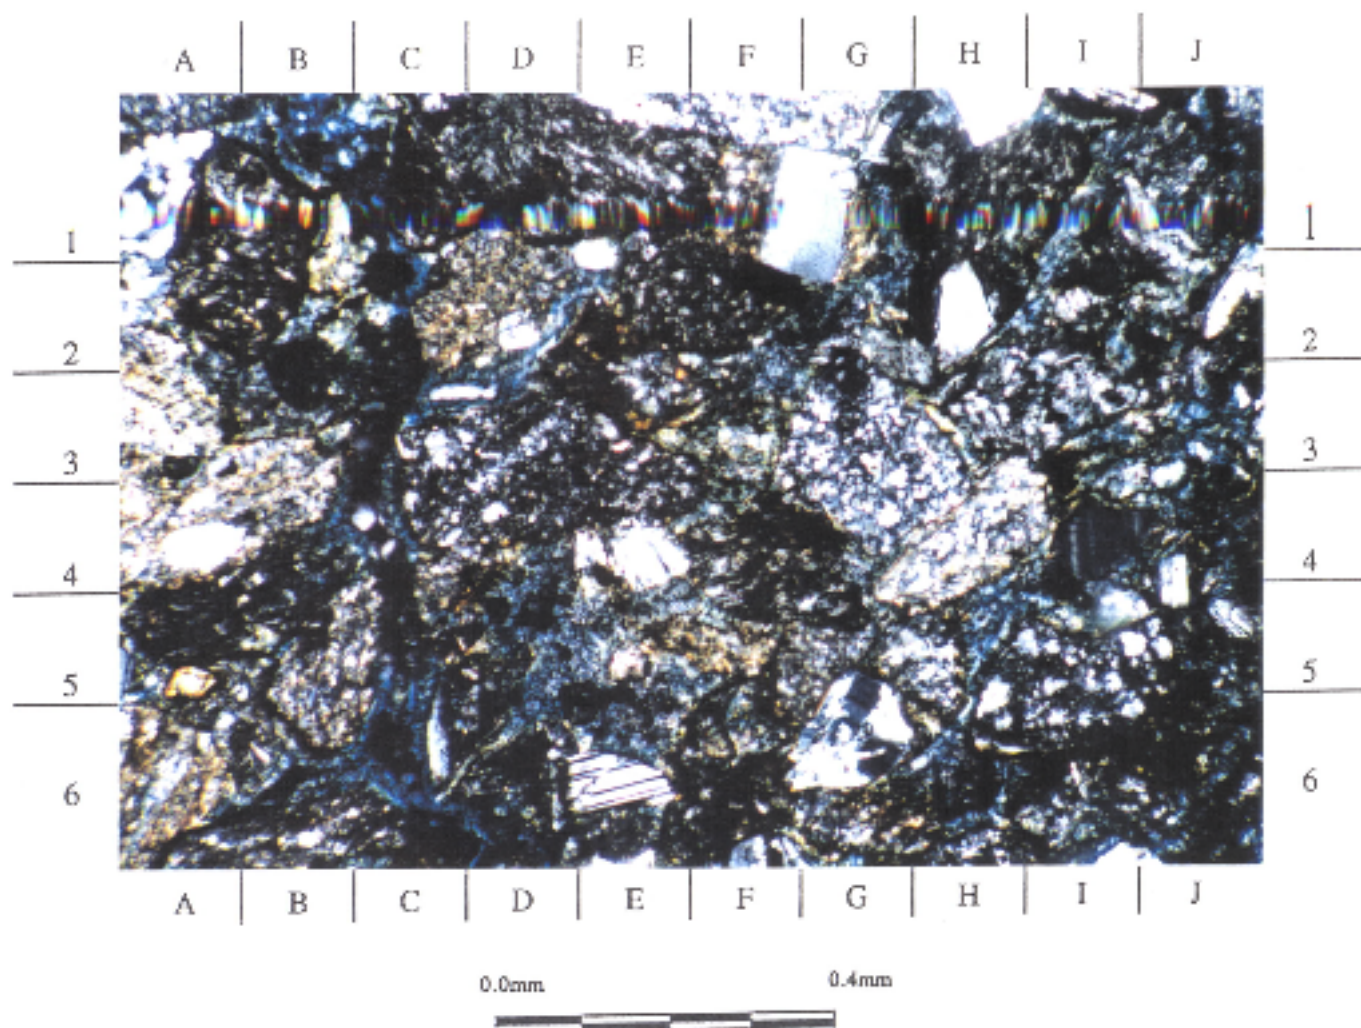
Figure 22. 1884.0m x75.6 XPL

Lithic fragments with detrital and authigenic clays infilling the pore space. In situ alteration of the lithic fragments is also evident.
