Project Seboa 2D

Project ID 6374-Vic

Client Bass Strait

Line Name GOBS08-14-008 (8)

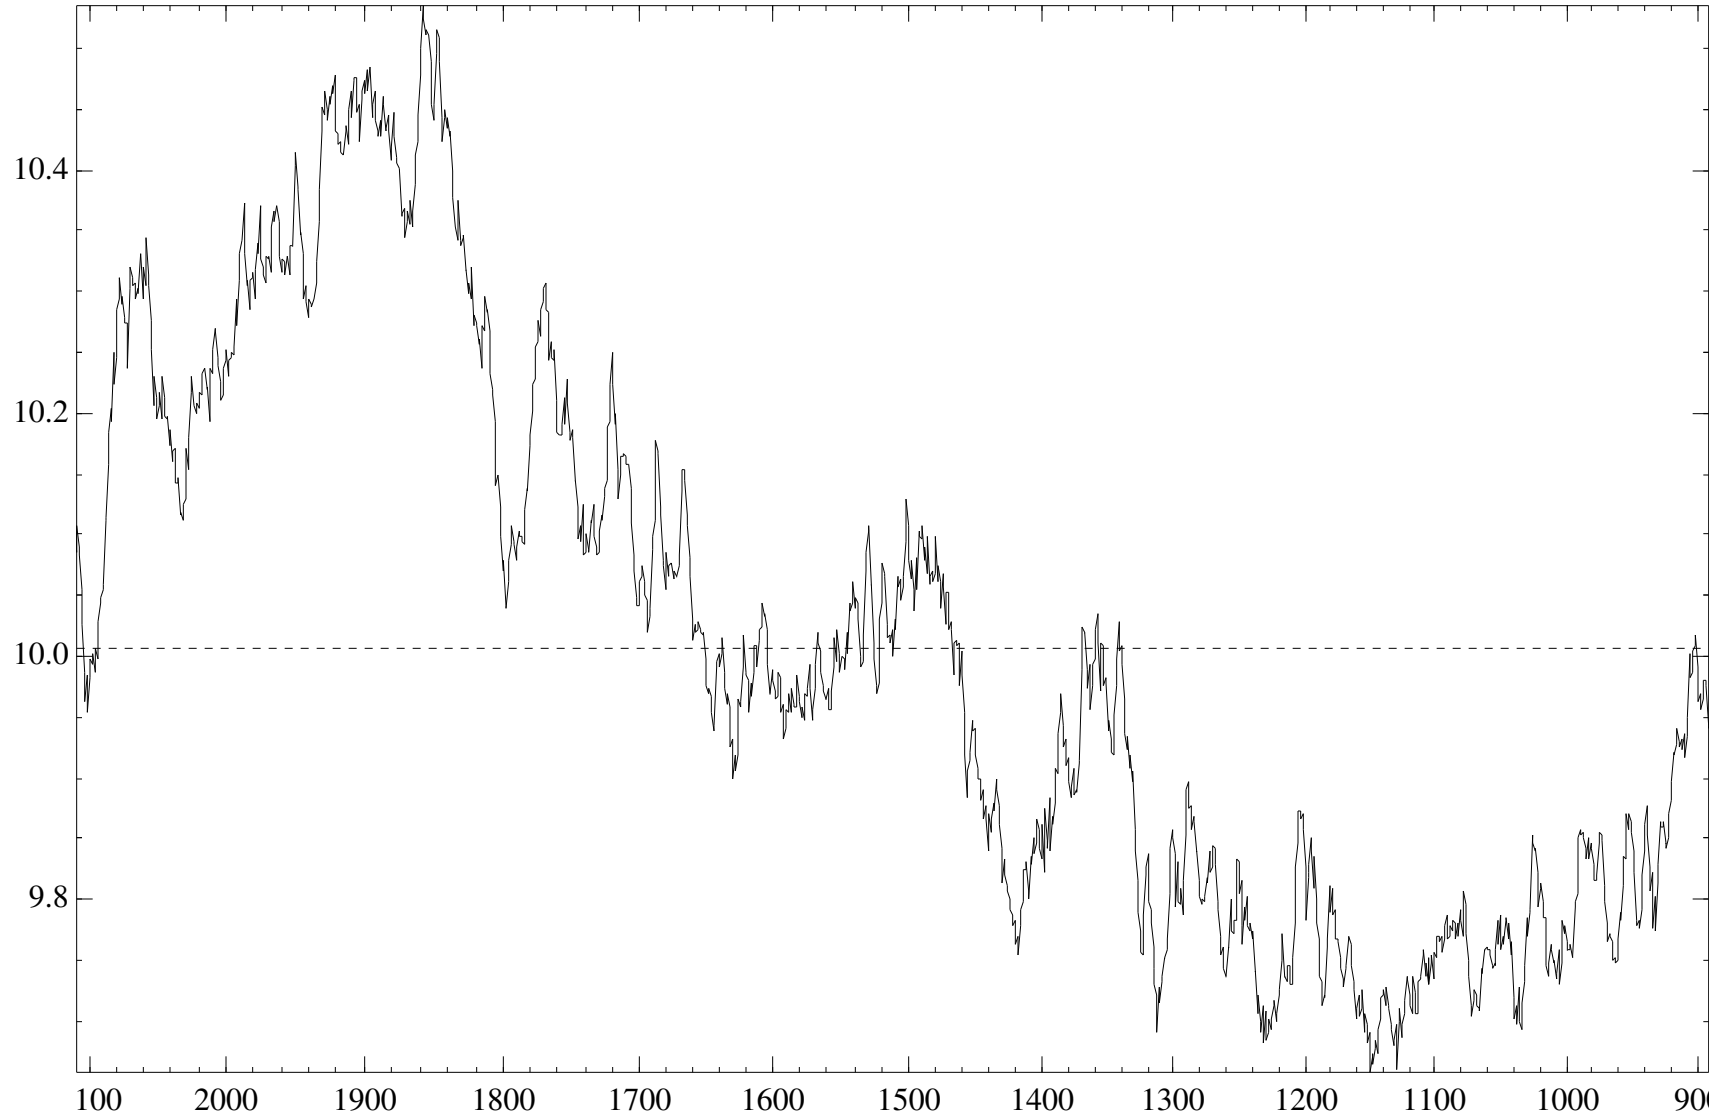
main V1 ShotTime dx

(Nobs 1230 Min: 9.657 Max: 10.534 Mean: 10.006 Sd: 0.223)

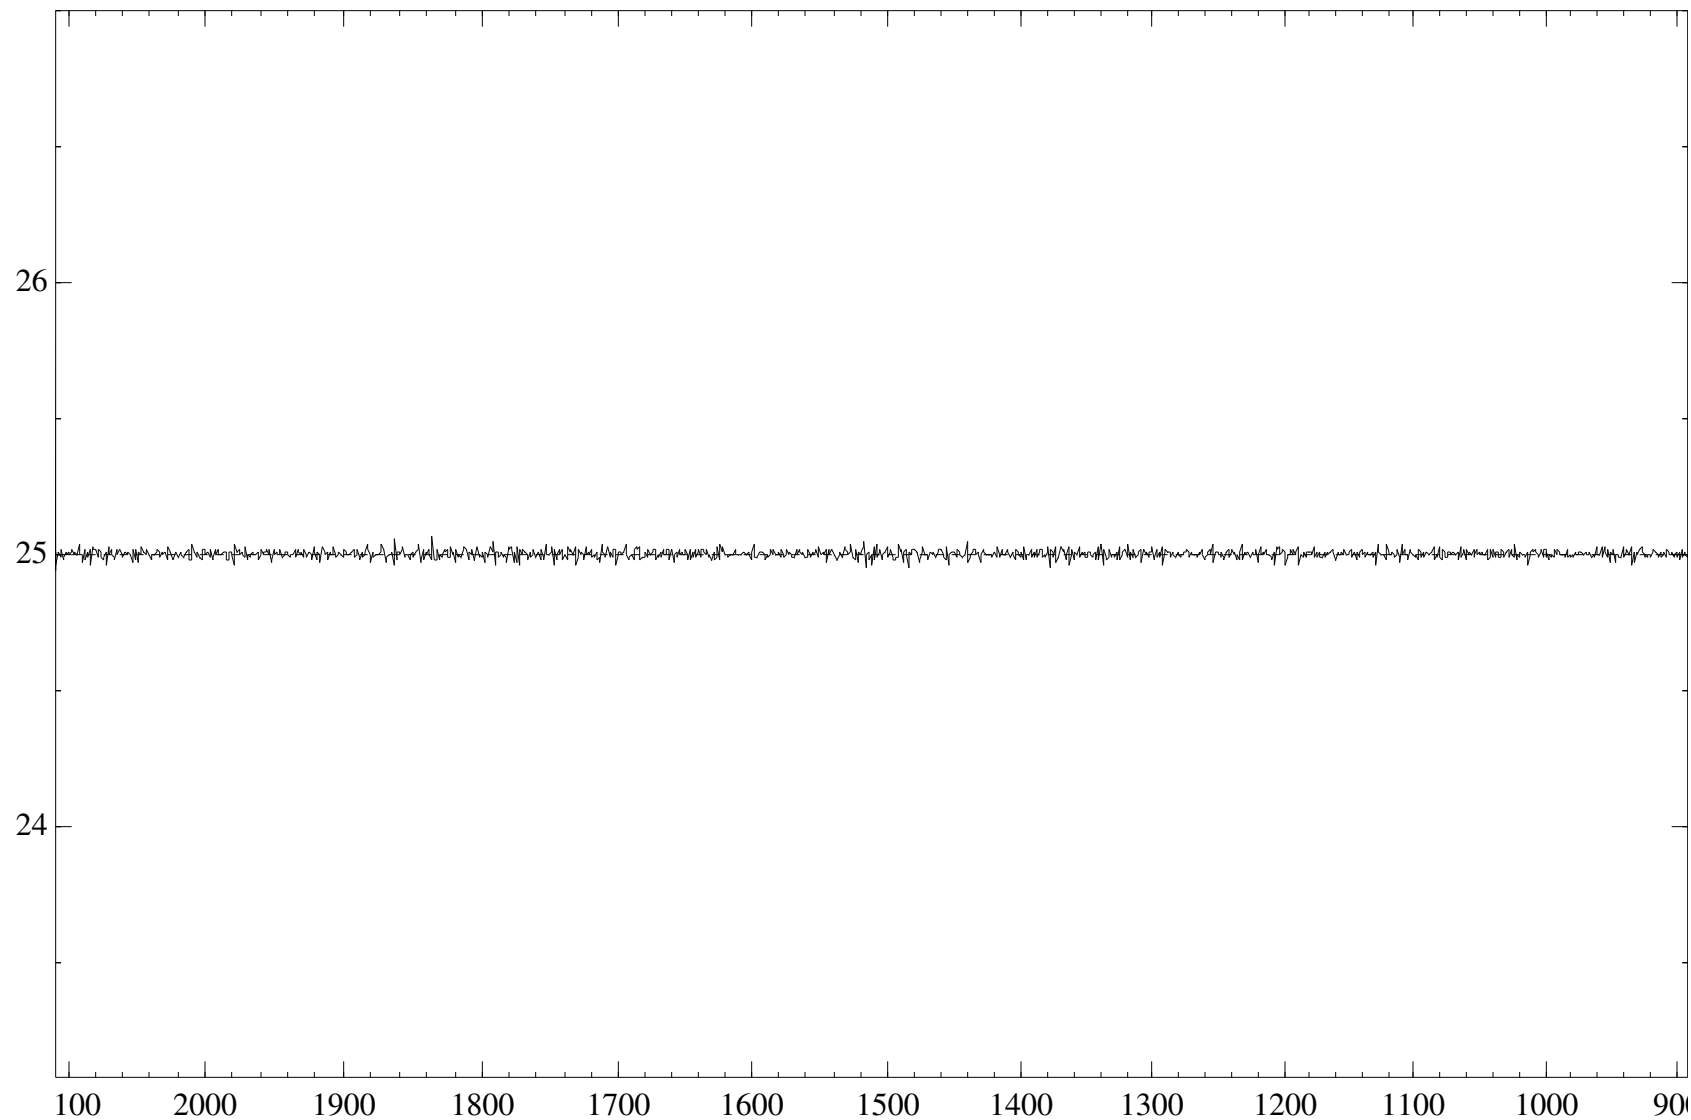
main V1 Dalong dx

(Nobs 1230 Min: 24.95 Max: 25.06 Mean: 25.00 Sd: 0.02)

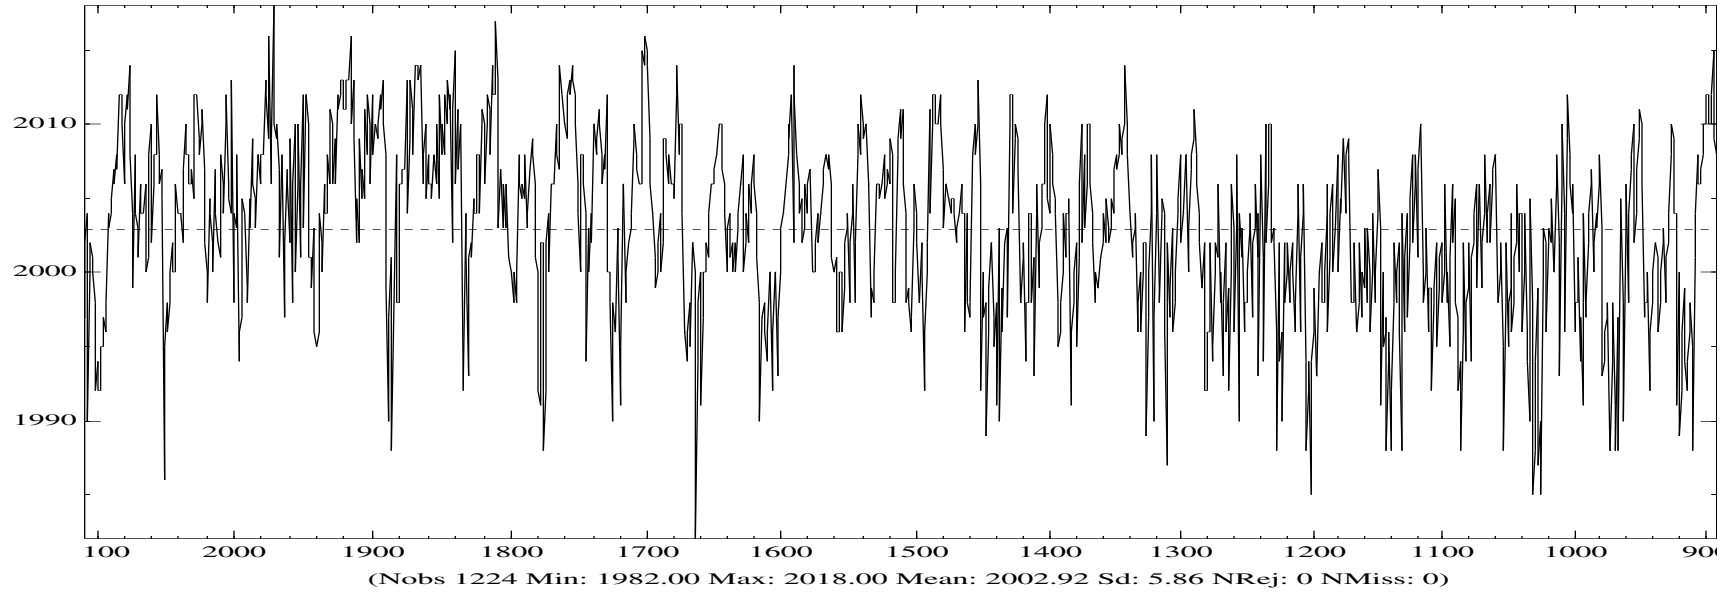
Raw: GN_SYNTRON_V2 Pressure 3 Data
